Iron Mountain Home Inspection Training Academy

SUMMARY PDF HOME INSPECTION REPORT FOR TRAINING PURPOSES (DEFECTS ONLY)

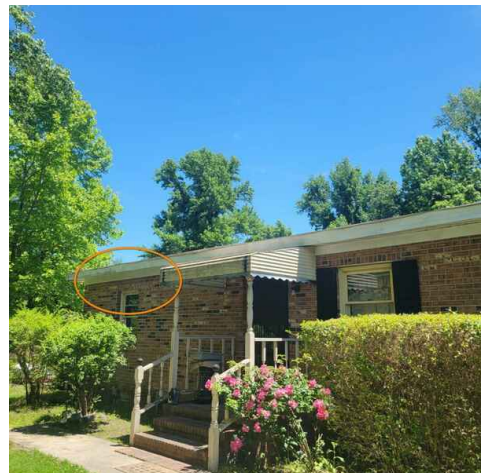
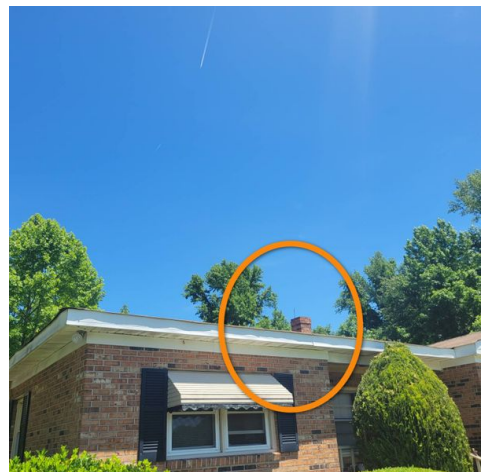
FASCIA AND SOFFIT LOOSE OR SEPARATED

During the inspection, it was observed that the Fascia and soffits exhibit signs of being loose or separated. Such conditions can lead to water infiltration around the roof edges. In some instances, the lumber beneath the metal flashing may have incurred damage due to this looseness. These components are typically secured to the home with nails and can be tightened to prevent moisture intrusion. It is recommended to seek evaluation and repair from a qualified contractor to address these issues effectively.

Contact a qualified roofing professional.

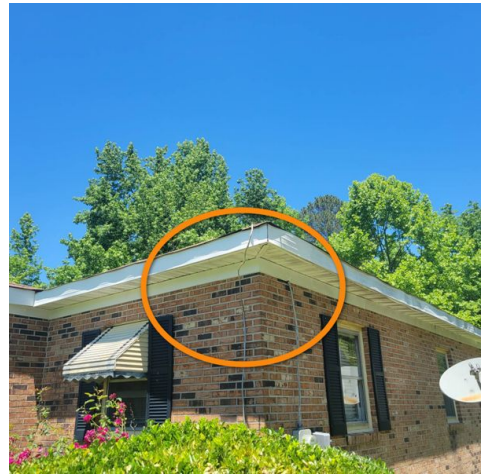
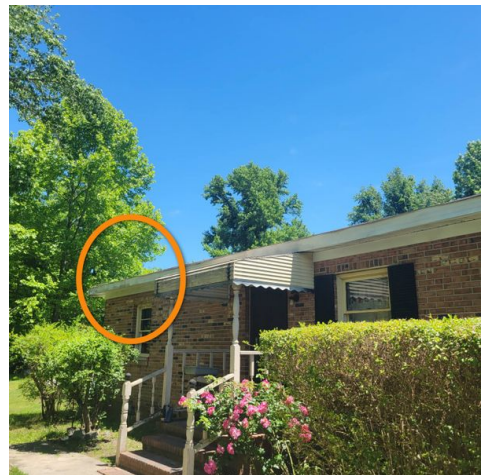
NO GUTTERS INSTALLED

It is advisable to install gutters to divert water away from the home, helping to prevent potential water damage. Additionally, the presence of a hipped roof provides ample space for gutter installation, as all four sides feature a fascia.

Recommendation
Contact a qualified gutter contractor

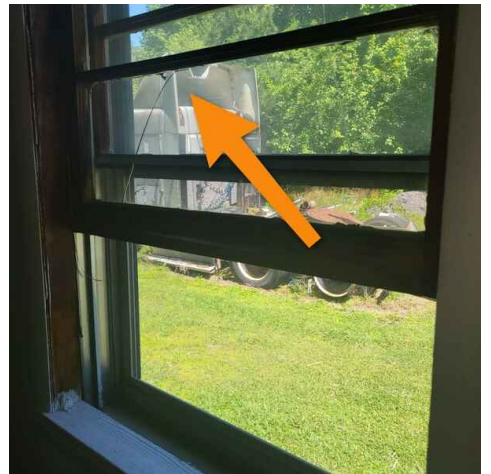
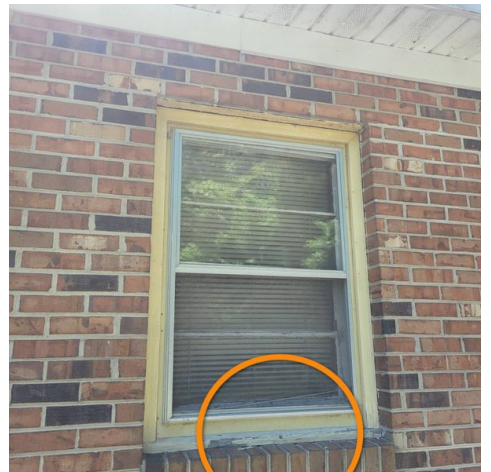
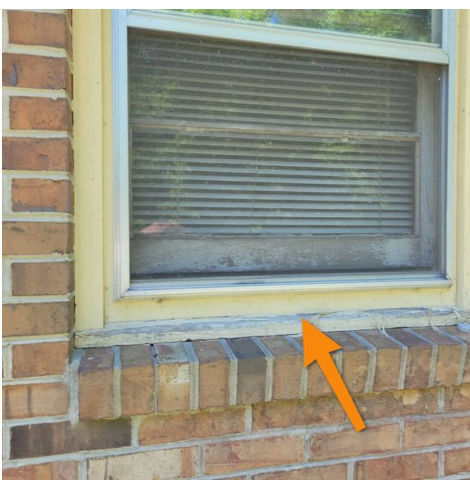
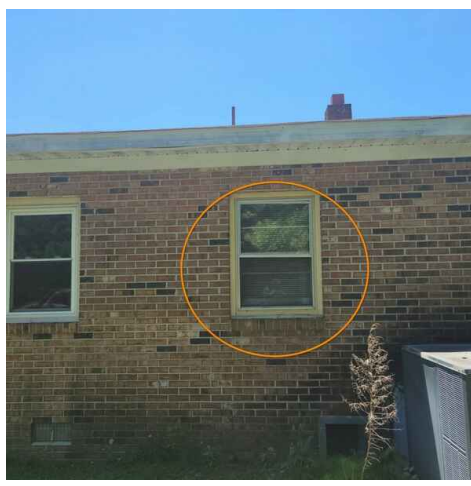
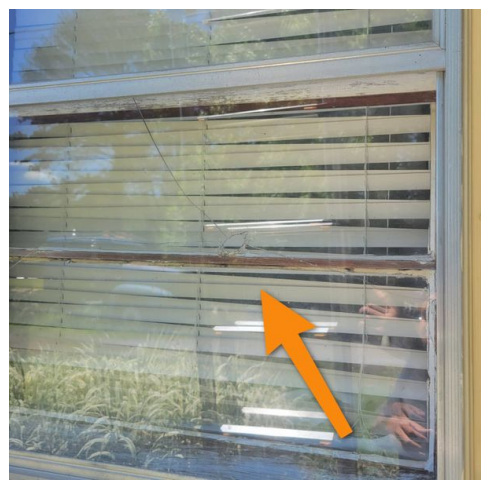
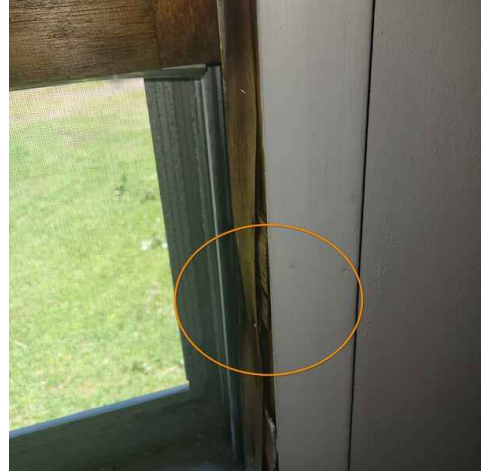
3.1.2 Siding, Flashing & Trim, exterior doors, eaves, soffit vents, windows and fascia
CRACKED OR DAMAGED WINDOW/WINDOWS ARE IN POOR CONDITION

1. Multiple windows are cracked or damaged. The majority of the windows in poor condition. These windows are wood-framed, and several have cracked glass and damaged locking mechanisms, while others are missing screens. It is recommended to have these windows replaced.
2. Rusted lintels are observed on the tops of the windows. This is common for the age of the home.

Recommendation
Contact a qualified window repair/installation contractor.

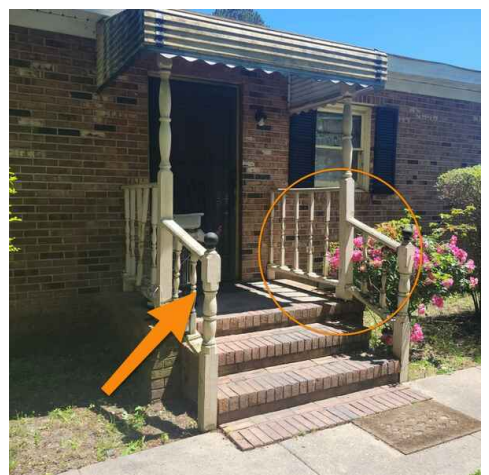
3.3.1 Decks, Balconies, Porches & Steps
LOOSE HANDRAIL/ROTTED LUMBER
EXTERIOR

1. A loose handrail was observed during the inspection. It is recommended to have a qualified contractor evaluate and repair it.
2. The handrails on the exterior of the home are rotted. While salvaging them is possible by sanding with an electric sander and applying paint, it's also advisable to apply waterproofing sealant for added protection.

Recommendation
Contact a qualified carpenter.

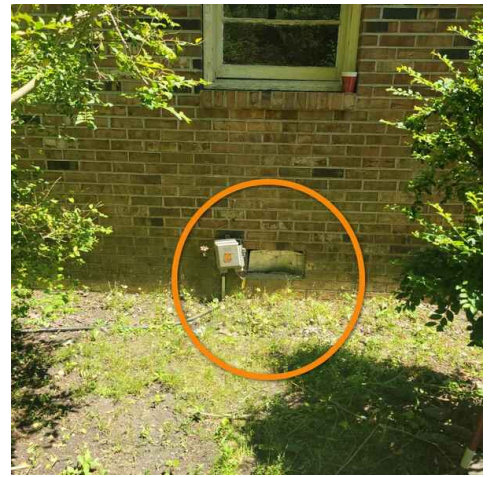
LOOSE CRAWL SPACE VENTS (AGED VENTS)

- 1. Loose vents observed at the time of inspection. Recommend a qualified contractor to evaluate and remedy.
- 2. Newer vents have two screws on the sides of the vents that screw behind the foundation wall.

Recommendation
Contact a qualified professional.

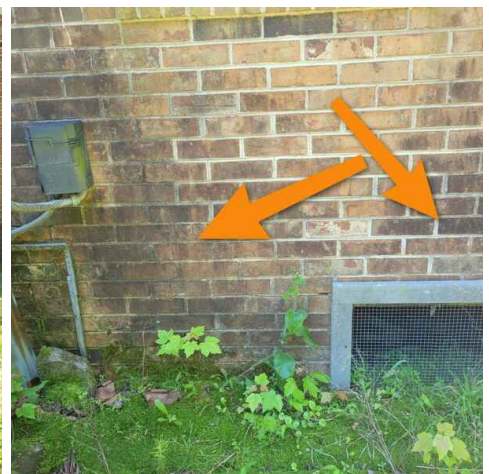
HEAVY SETTLEMENT/EXCESSIVE STAINING ON EXTERIOR BRICK WALL

- 1. Heavy settlement of the home's foundation is observed at the time of inspection. Recommend a qualified contractor to evaluate and repair.
- 2. Excessive staining observed on the exterior brick. Recommend having the home pressure washed.

Recommendation
Contact a foundation contractor.

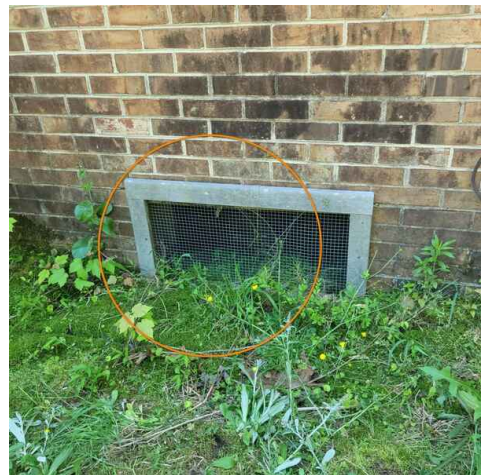
IMPROPER CRAWL SPACE COVER OR MISSING COVER

1. Damaged crawl space cover or no crawl space cover observed. A tight seal on a crawl space cover helps to keep moisture, rodents and insects out of the crawl space. Recommend a qualified contractor to evaluate and repair.
2. See the example below of a new crawl space cover. These covers are sold in two parts, the top cover slips over the base to create a seal.
3. *There is excessive mold/fungus like substance in the crawl space due to this cover having a screen on it and the crawl space not being sealed.*

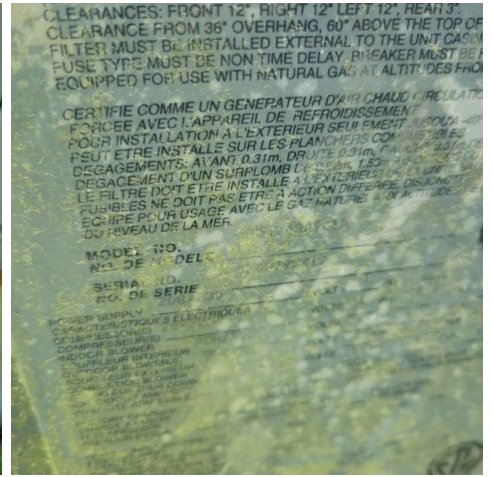
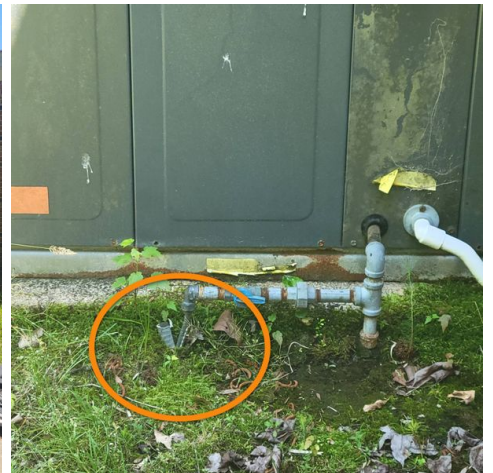
Modern air conditioners can typically last between 15-20 years, benefiting from advancements in technology. However, older units like this one generally have a lifespan of around 12-15 years. The longevity and efficiency of an A/C unit depend on various factors, including regular maintenance throughout its lifetime and adherence to manufacturer specifications.

It's advisable to prepare for the replacement of this unit. The unit is currently operational. The gas line also shows some signs of wear, and the main duct cover is rusted which is allowing water into the crawl space.

Recommendation
Contact a qualified heating and cooling contractor

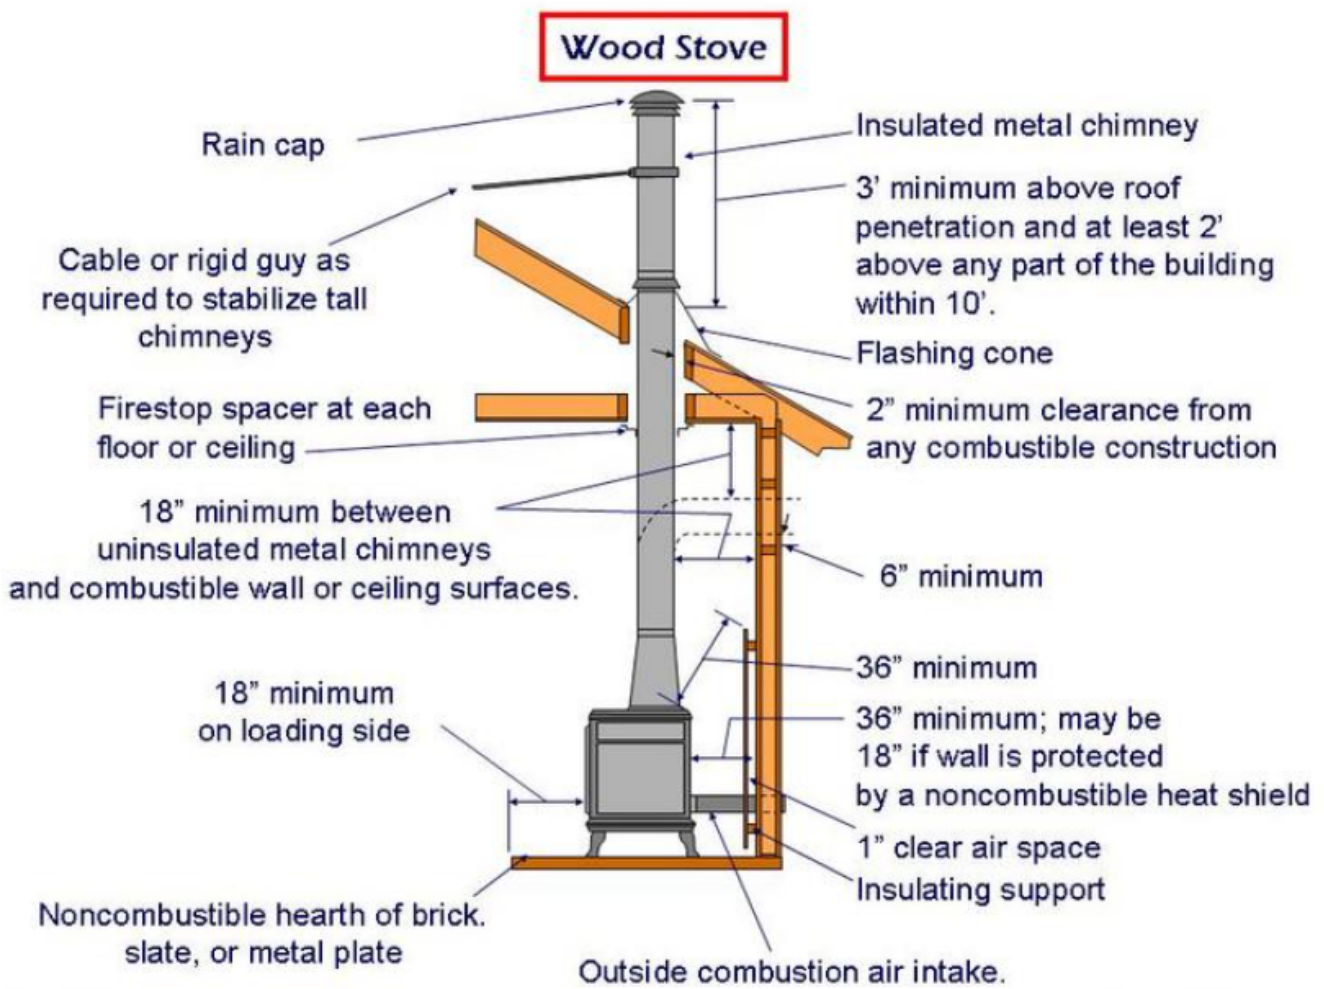
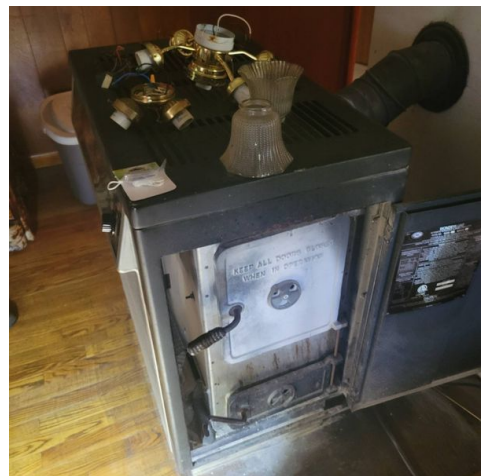
The living room contains an aged Wonderluxe wood/coal burning stove, which presents several concerns:

- The stove is currently situated on wood blocks, which is not recommended. It should ideally be placed on a masonry base that extends outward. This arrangement helps prevent fires caused by embers coming into contact with the wood floor.
- The flue is improperly installed, with a piece of fireproof drywall installed where the flue enters the wall. Additionally, the stove is positioned too close to the wall, posing a potential fire hazard.

Contact a qualified heating and cooling contractor

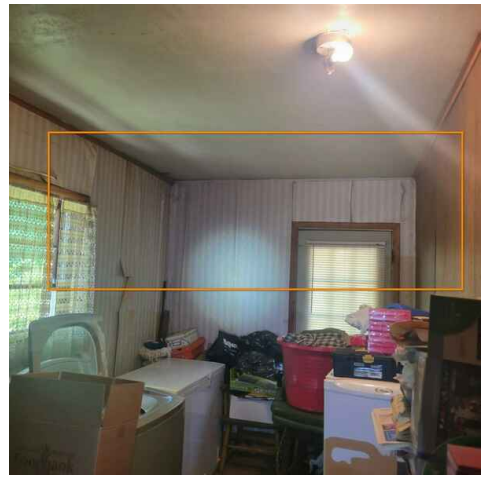
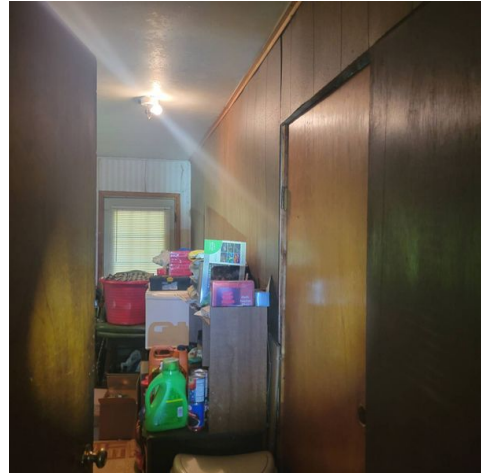
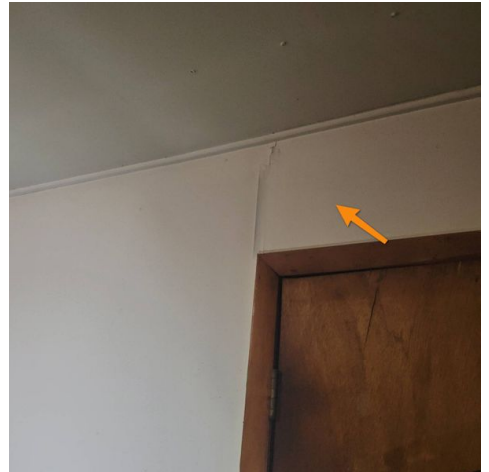
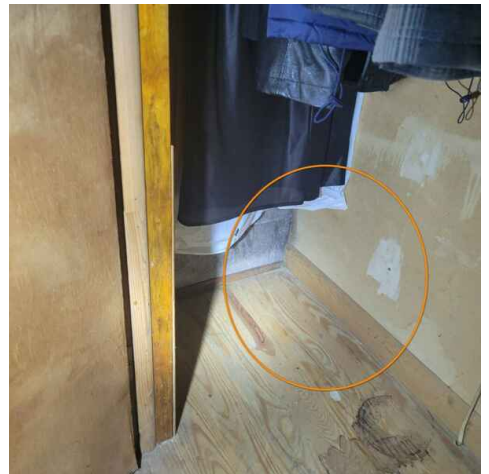
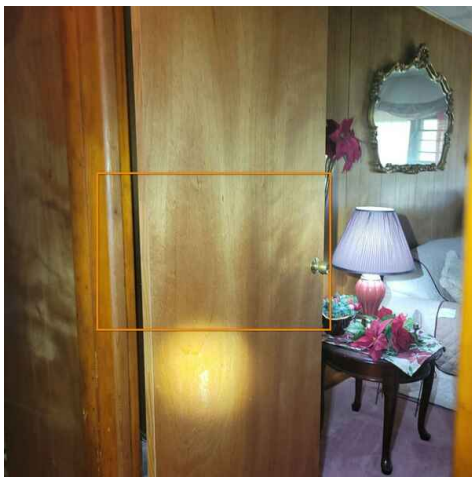
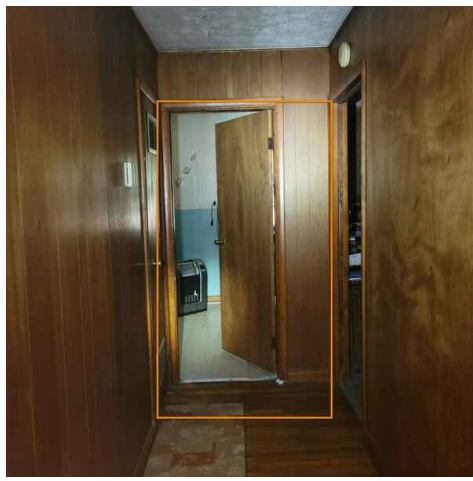
MULTIPLE DEFECTS: INTERIOR (GENERAL COSMETIC DEFECTS)

This home has numerous cosmetic defects attributable to its age, wear, and DIY construction. The laundry room's wallpaper is peeling, various walls show poor painting, and cracks have appeared due to settlement and issues in the crawl space (refer to crawl space recommendations). Additionally, the doors have loose hardware and general cosmetic damage, and several parts of the home remain unfinished. Walls and ceilings have stains and are generally in poor condition.

Contact a qualified professional.

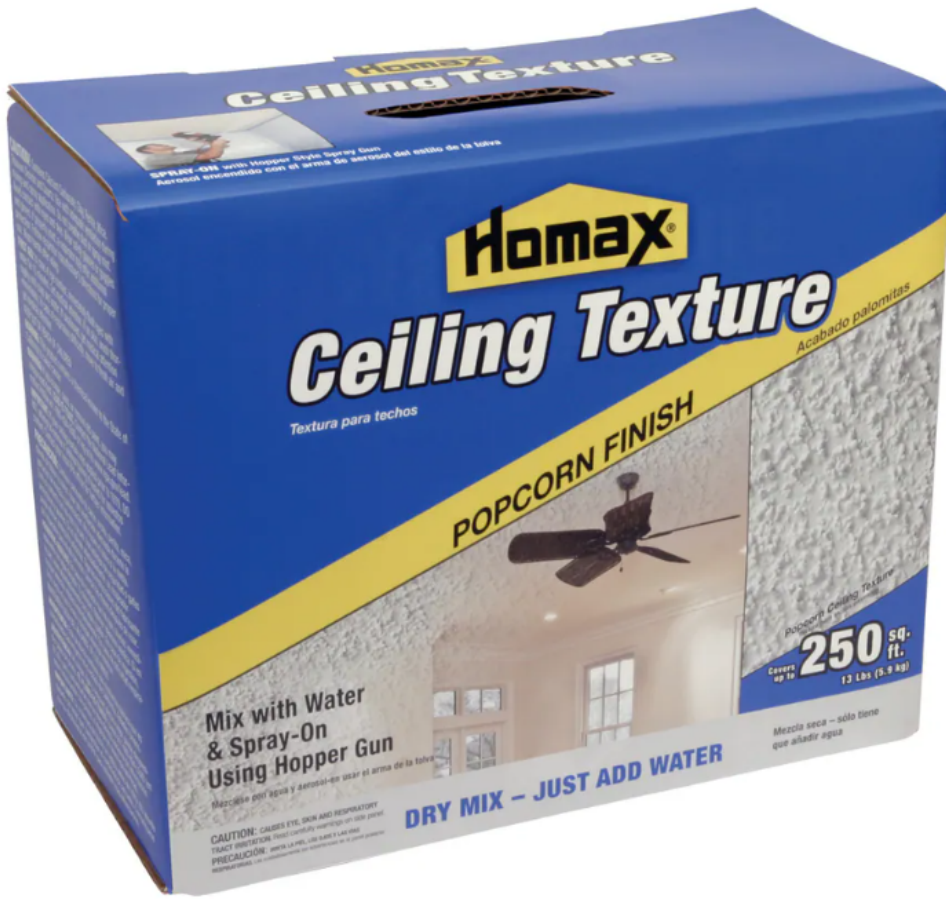
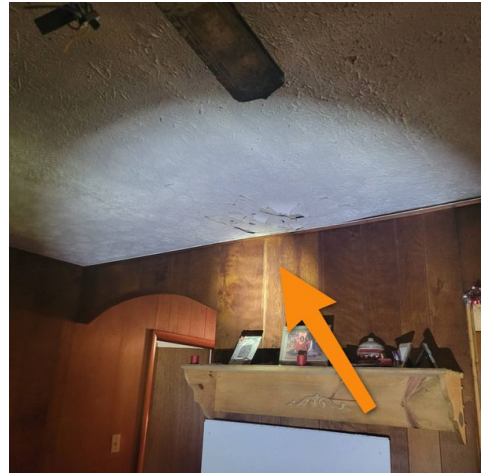
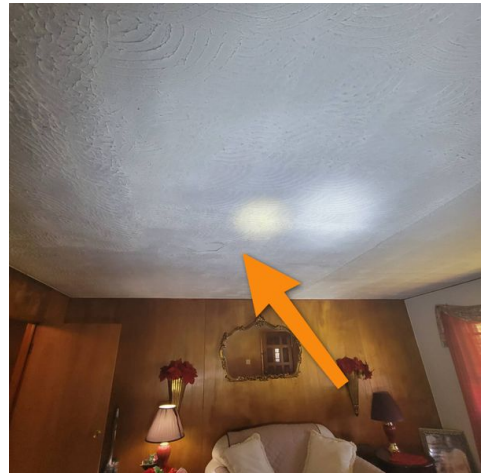
DAMAGED CEILING/DAMAGED CEILING TEXTURE MATERIAL/POSSIBLE COLLAPSING CEILING

Multiple sections of the ceiling display substantial cracks, with portions in the hallways and bathrooms showing signs of collapsing. Additionally, moisture stains are evident in multiple areas of the ceiling. The stains in the living room likely stem from a previous leak at the base of the chimney, which has been patched on the roof. Furthermore, the textured ceiling throughout the home appears aged, poorly installed, and is peeling in various areas. It is advised to enlist the services of both a drywall contractor and a painting contractor to assess and address these issues.

Contact a qualified professional.

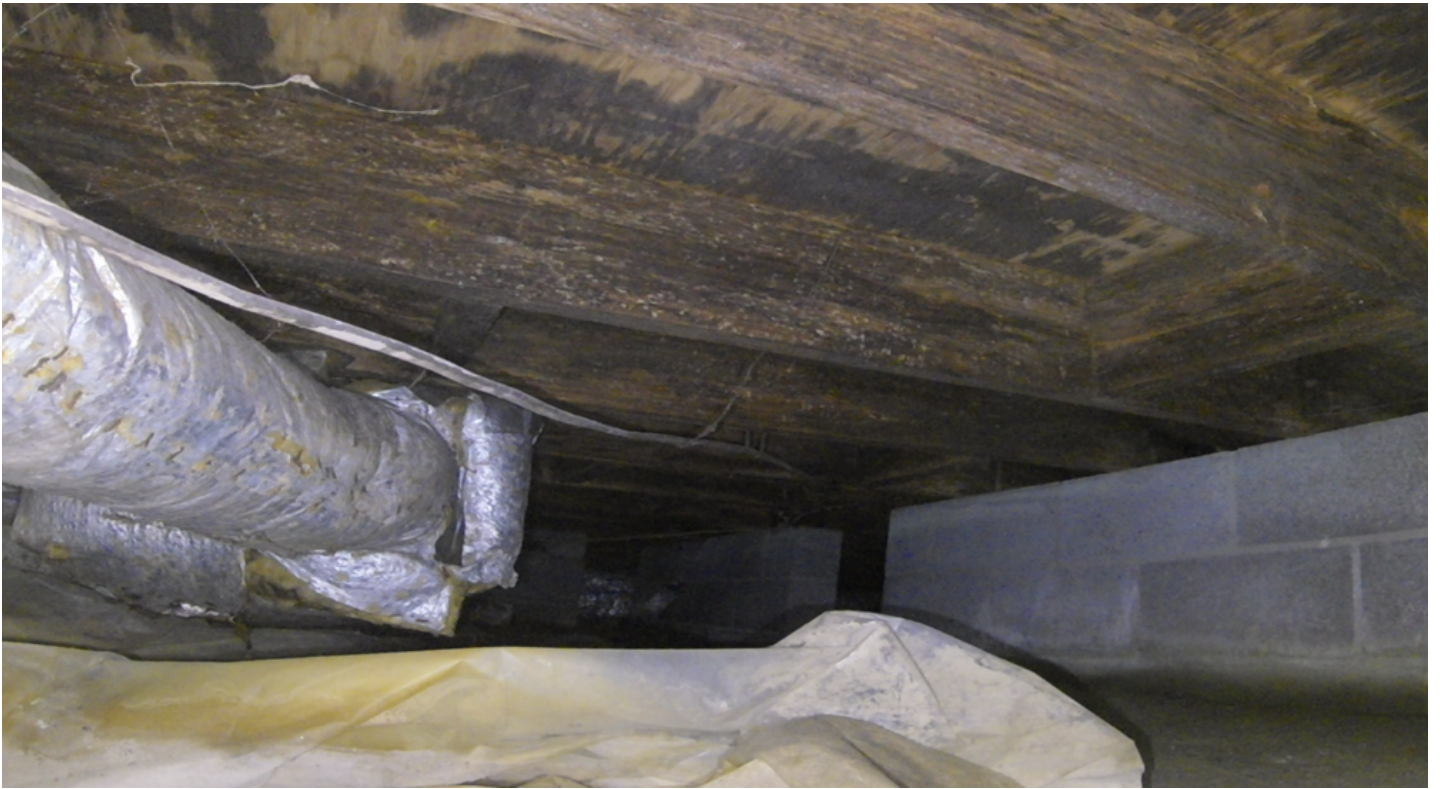
IMAGE: AREA UNDER UNLEVEL/SOFT FLOORING/CRAWL SPACE DEFECTS (SEE CRAWL SPACE SECTION)

1. Unlevel floors observed at the time of inspection. Recommend a qualified contractor to evaluate and repair.
2. Multiple areas of the floor in the home are soft. This is due to compromised floor joist and subflooring in the crawl space. Excessive mold growth has weakened the structure. Repair by a foundation contractor is recommended prior to replacing or refinishing the flooring in the home. See the crawl space section for recommendations.

Recommendation
Contact a qualified professional.

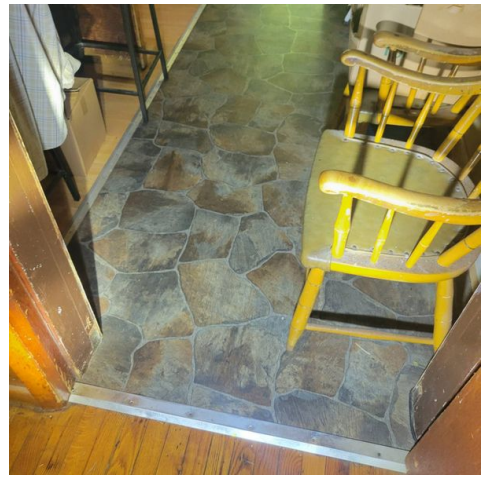
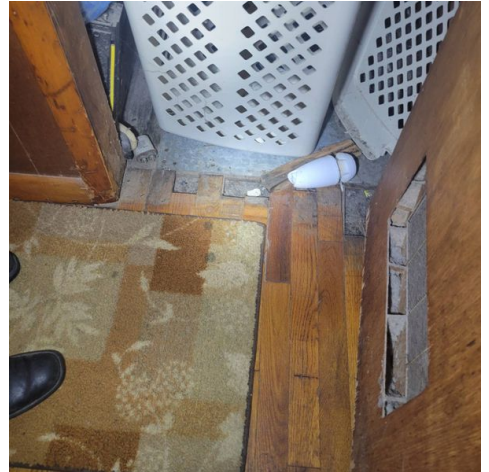
6.1.4 Interior doors, windows, floors, ceilings
WORN FLOORS/CARPET
INTERIOR

1. Worn floors/carpet/or unlevel floors observed at the time of inspection. Recommend a qualified contractor to evaluate and remedy.
2. Carpets can be steamed clean, patched or replaced. Carpet patching involves a contractor cutting out damaged pieces of the carpet then sewing in a new piece.
3. Hardwood flooring can be re-sanded and stained. This is recommended to be completed after large scale painting and drywall projects.

Recommendation
Contact a qualified flooring contractor

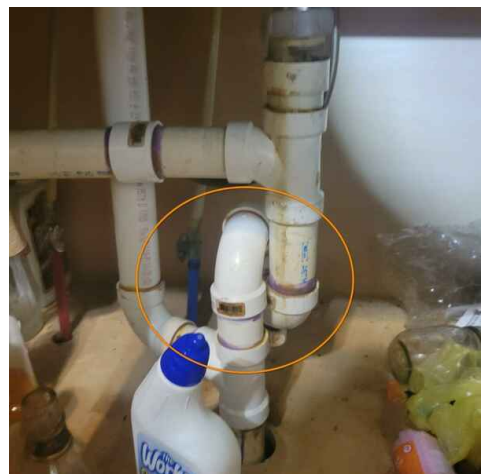
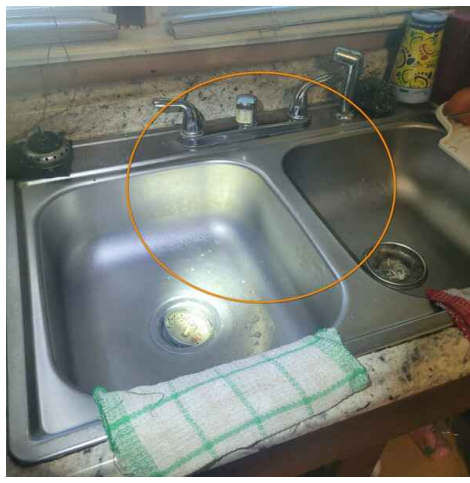
MULTIPLE DEFECTS: KITCHEN SINK

The sink exhibits signs of aging, with loose plumbing lines and a need for garbage disposal servicing. It's crucial to ensure the drain is configured as a P-trap rather than an S-trap or U-trap. A P-trap is necessary to prevent sewer gases from entering the home and to maintain proper drainage. Despite these issues, many of these defects are expected given the property's age and minimal updates.

Contact a qualified plumbing contractor.

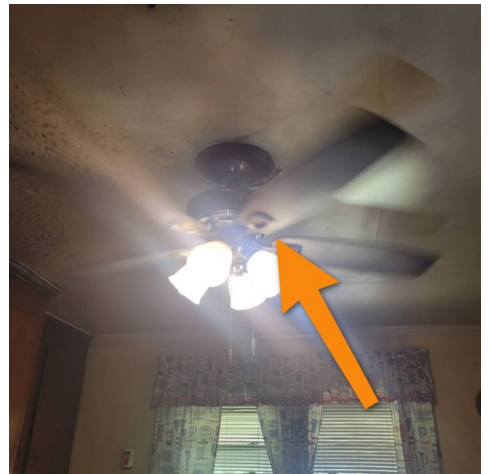
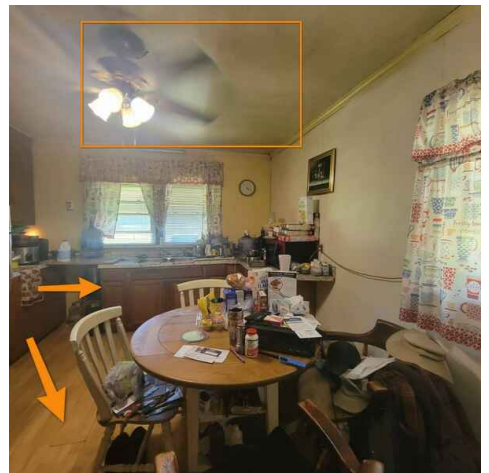
MULTIPLE DEFECTS: KITCHEN

The kitchen exhibits multiple defects including aged appliances, absence of an anti-tip device on the stove, worn and damaged cabinets, loose ceiling fan base, and worn floors with gaps. Additionally, burn markings on the ceilings suggest a past fire or neglect. Missing smoke detectors and light fixtures are observed, along with the absence of GFCIs near the sink. These issues require attention to ensure safety and functionality in the kitchen space. Recommend evaluation and repair. Natural wood cabinets can be sanded and stained.

Contact a qualified professional.

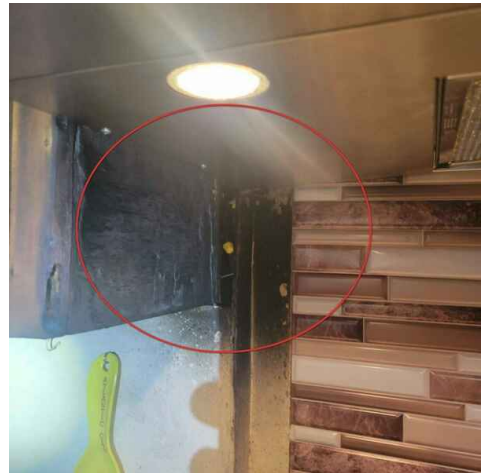
Evidence suggests a past fire in the kitchen, likely originating under the stove hood where capped wires are visible. This area likely served as the point of ignition, leading to burn markings on the ceilings, indicating a potential electrical fire. It is crucial to have the electrical system evaluated and upgraded by a qualified electrician to mitigate any further risks or issues. Immediate attention and repair are recommended to ensure safety and prevent potential future incidents.

Recommendation
Contact a qualified professional.

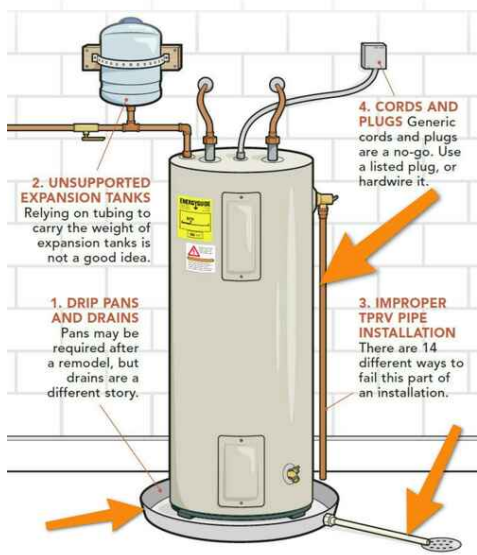
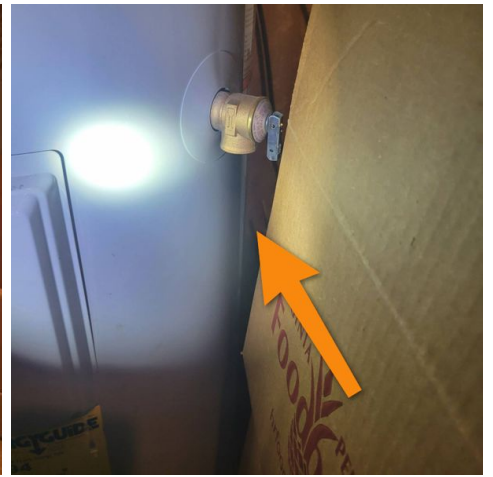
NO DRAIN PAN OR DRAIN LINE/MISSING TPR VALVE DRAIN LINE

The water heater was replaced in 2023; however, it lacks a drain pan and a drain line exiting the home. Additionally, the TPR (Temperature Pressure Relief) valve should have a CPVC line running to the pan to drain its discharge. The TPR valve serves as a pressure relief measure. The absence of these safety-related items suggests a potentially amateur installation, as licensed plumbers typically ensure all safety-related items are installed in modern times.

Contact a qualified plumbing contractor.

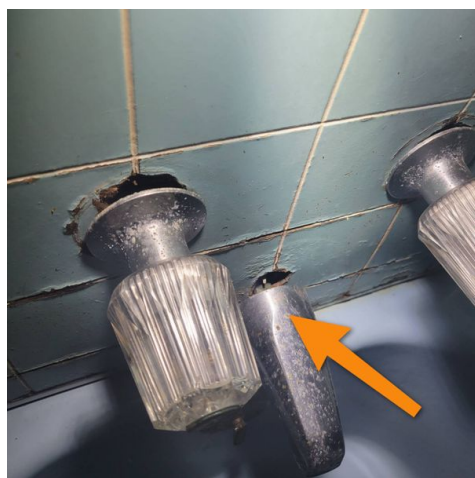
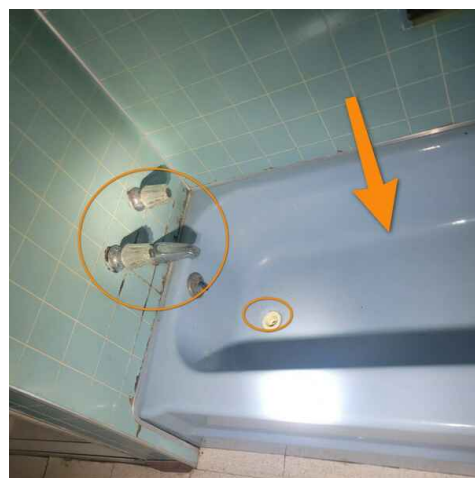
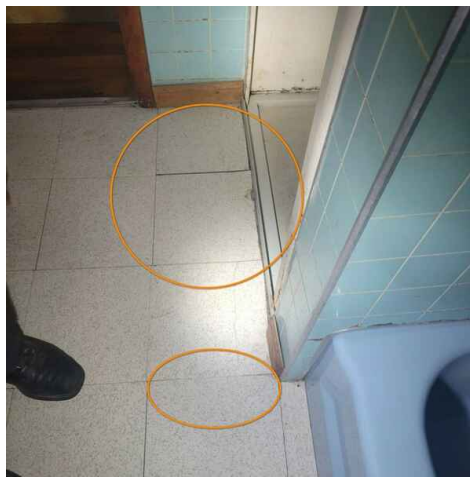
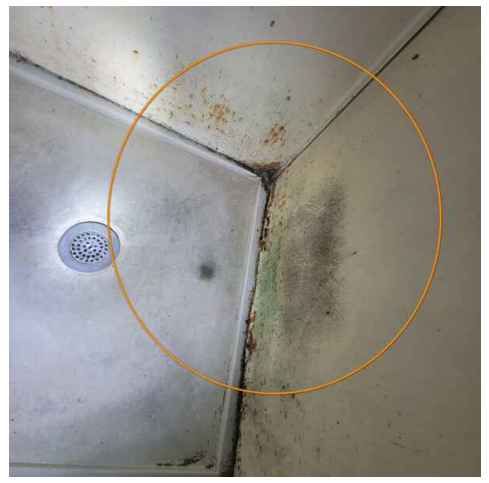
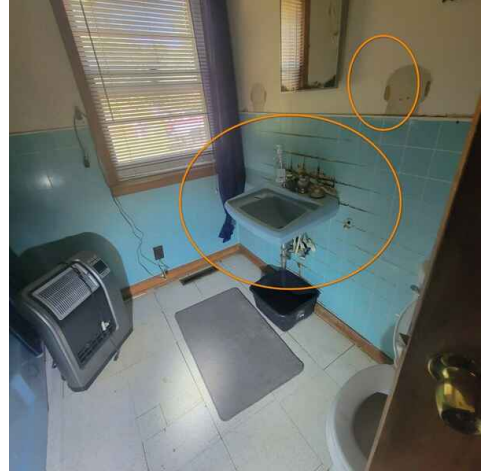
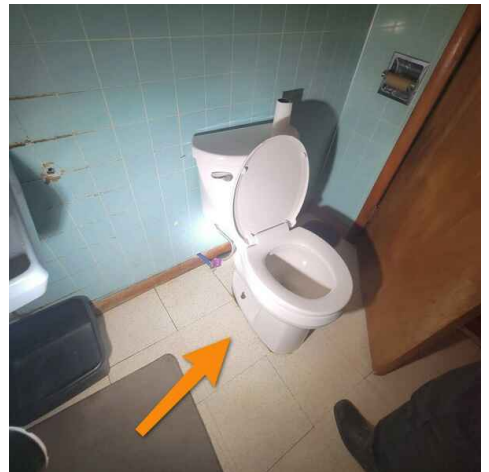
7.4.1 Bathrooms
MULTIPLE DEFECTS: SHARED BATHROOM
 BATHROOM (SHARED)

- The ceiling shows signs of impending collapse.
- The sink and walls exhibit damage.
- The faucets and tub are loose and damaged (but are operational).
- The toilet base is loose, resulting in a slow flush.
- There is no GFCI protection installed.
- The flooring is damaged.
- The fan is non-operational.
- The shower stall base shows signs of rust and requires attention.
- Loose PEX plumbing lines were observed.
- A blue PEX line was used for the shower head instead of a metal shower pipe.
- The sink drain is leaking.
- Possible issues with the drainage system in the tub and the shower.
- Despite these issues, the bathroom does have functioning hot and cold water, and the toilet flushes.
- Evaluation and repair by a qualified contractor are recommended.

Recommendation
Contact a qualified professional.

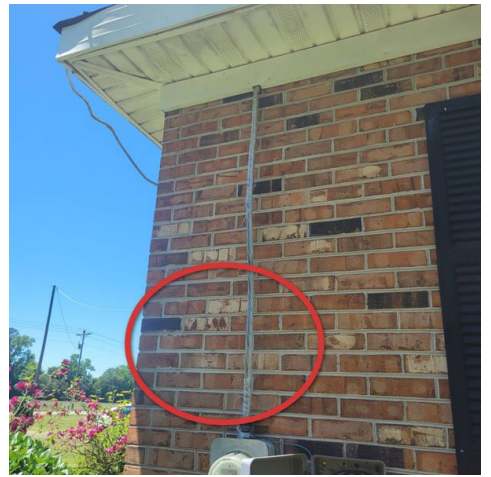
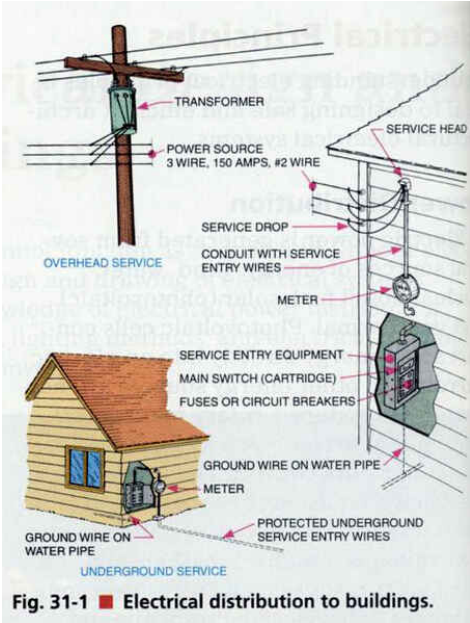
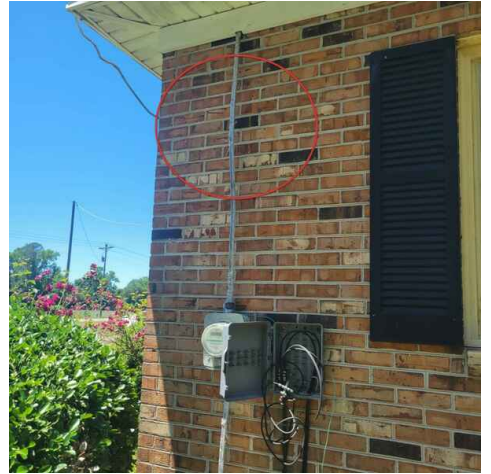
ENTRANCE CABLE IS IN POOR CONDITION

The service entrance wires are damaged, indicating a safety issue. Contact the utility company or an electrician for evaluation and repair. Additionally, consider upgrading or replacing the meter base, as multiple meters are installed on the property. Ownership and responsibility for maintenance of the utility pole on the property should be clarified, especially concerning wiring for additional structures. Consulting professionals will provide clarity and ensure compliance with safety standards.

Contact your local utility company

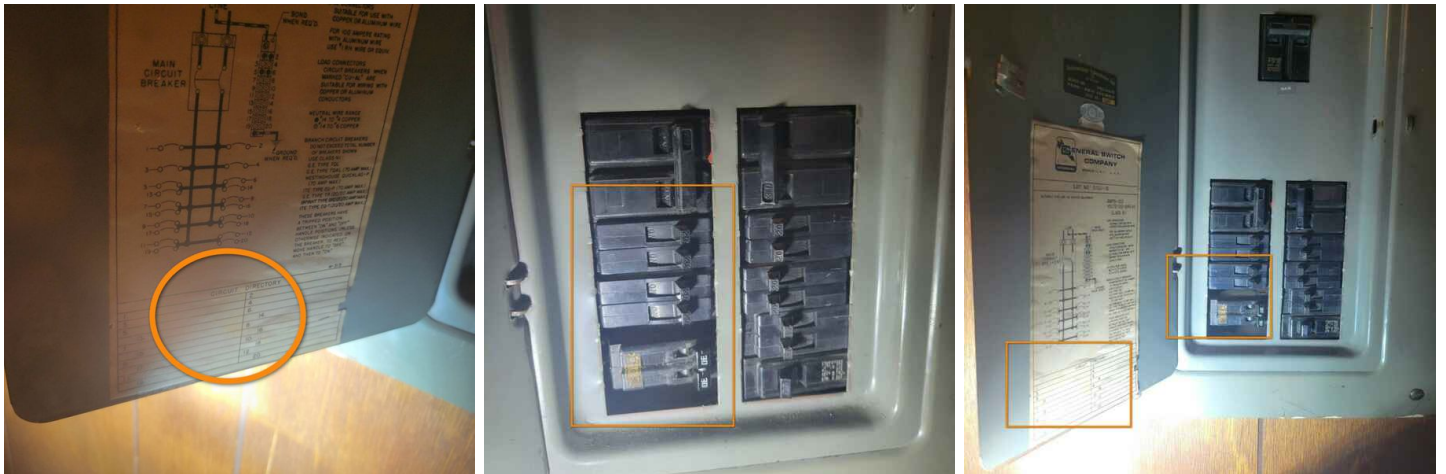
8.2.1 Main & Subpanels, Service & Grounding, Main Overcurrent Device
MULTIPLE DEFECTS: ELECTRICAL PANEL (UPGRADED RECOMMENDED)
 PANEL

The electrical panel lacks labeling, and there are signs of an electrical fire in the kitchen area. Additionally, the presence of two-prong receptacles throughout the home indicates a lack of grounding. Upgrading the panel, which currently operates at 100 amps, is advisable, considering that modern standards typically recommend 200 amps for safety and efficiency. A buzzing sound emanating from the panel suggests potential issues with its connections. Due to safety concerns, the panel cover couldn't be removed for further inspection. It's common for older homes to encounter these issues, indicating a need for thorough evaluation and upgrades by a qualified contractor. Typically, panels in older homes undergo upgrades at least once since their initial construction.

Contact a qualified electrical contractor.

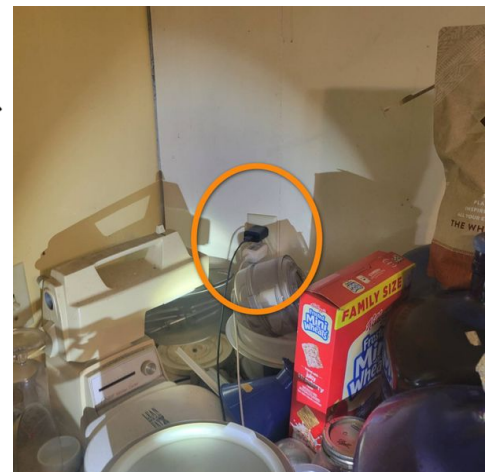
MULTIPLE DEFECTS: ELECTRICAL RECEPTACLES

1. The receptacles throughout the home are loose and show signs of aging. As they are two-pronged, they lack proper grounding. Additionally, the absence of GFCIs poses a safety concern, particularly in areas where water is present, such as within 6 feet of sinks. Several light fixtures also exhibit instability and potential wiring issues, suggesting possible DIY installations. Cover plates are missing or damaged. There most likely will be some degree of electrical problems in this home that will be experienced that require a diagnostic from an electrician. Upgrading these elements is recommended to ensure electrical safety and compliance with modern standards.

Contact a qualified electrical contractor.

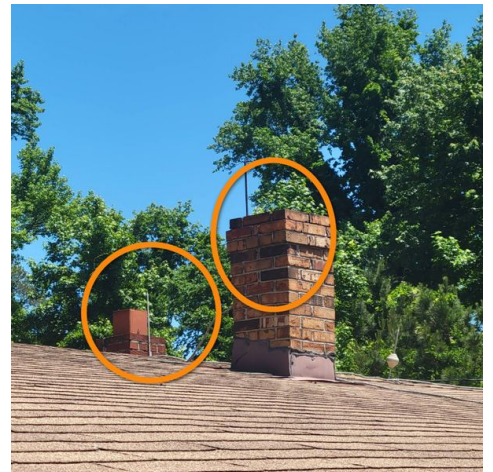
MISSING CHIMNEY CAP/COMMENT REGARDING THE LINER

Missing chimney cap observed at the time of inspection.

One of these is the flue for the wood stove. The flashing around the chimney is damaged (area that seals the roof). The flue is possibly damaged from age. These clay flues are generally fitted with a metal liner. Over time the clay flues crack and become unsafe to use.

Recommend a qualified contractor to evaluate and remedy.

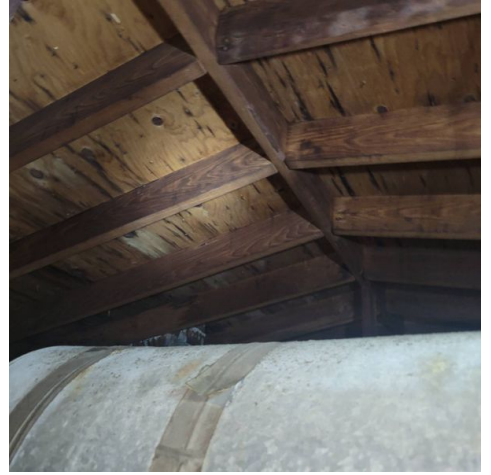
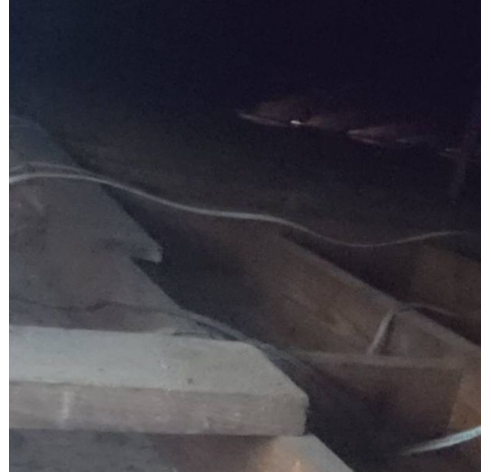
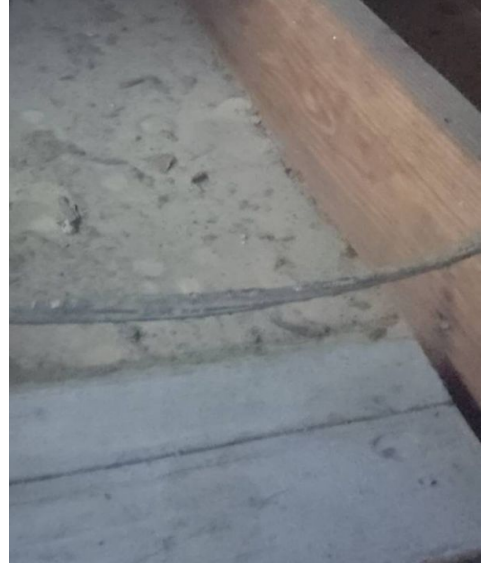
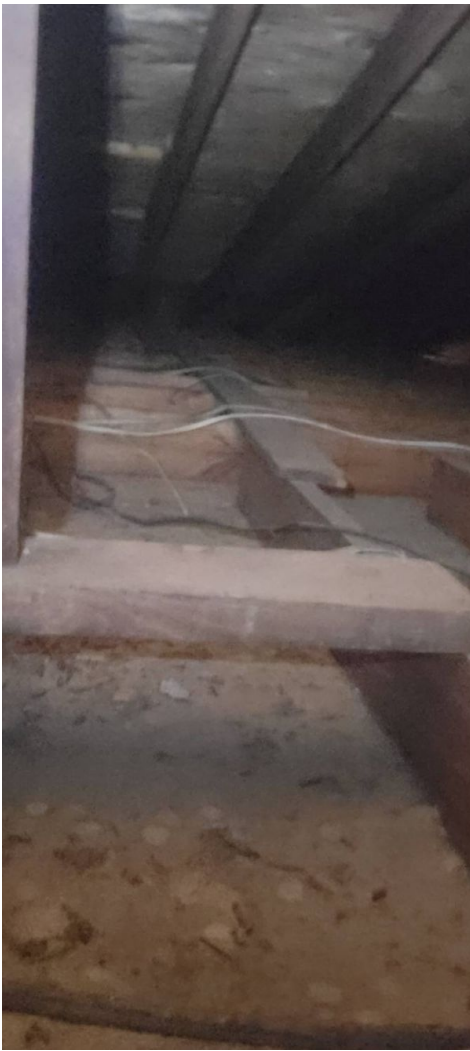
Limited access to the attic was noted due to an undersized door. Moreover, insulation is absent in this space, necessitating blown-in insulation using specialized equipment. Moisture damage to the roof sheathing was observed, a common issue addressed during roof replacements. Typically, new sheathing is installed, and chimneys are reflashed before re-insulating the area. Old ductwork from previous appliances remains in the attic. Prior to adding insulation, it's advisable to address any repairs to ceilings and light fixtures. The lack of insulation facilitates easier access for electrical cable securing. Installing a properly sized attic door is recommended for convenient entry. Additionally, due to its spaciousness, additional storage can be accommodated in this attic, typical for hip roofs with sloping sides. Evaluation and repair by a qualified contractor are advised.

Recommendation
Contact a qualified professional.
