SAMPLE REPORT FOR TRAINING (SUMMARY/DEFECTS ONLY)

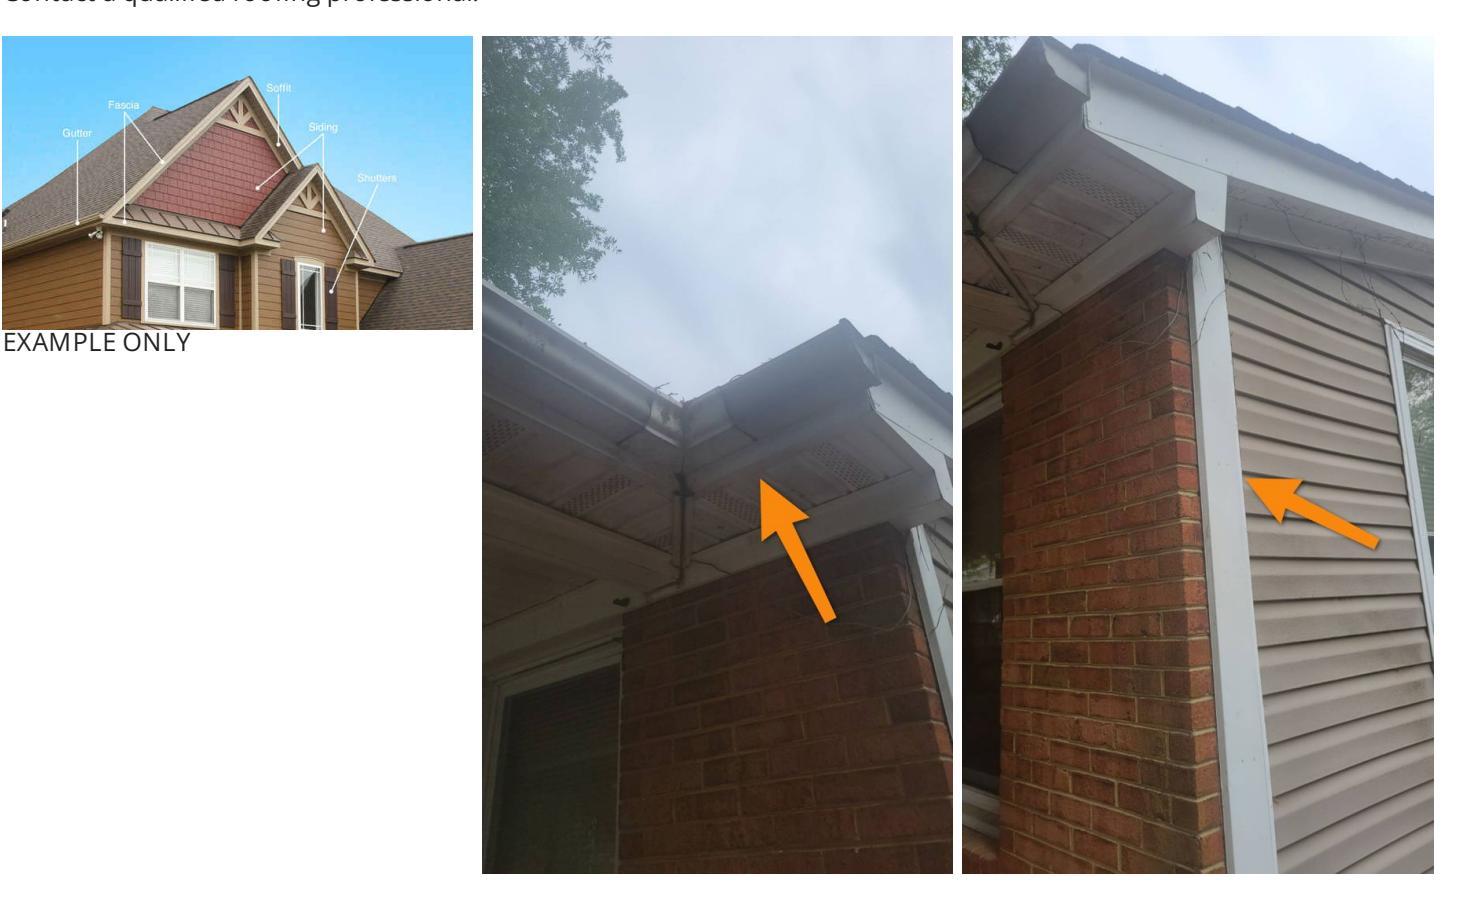
DAMAGED FASCIA, SOFFIT, AND TRIM

Several sections of the fascia, soffit, and trim around the residence display signs of damage. It is advisable to address these areas promptly by securing them and subjecting them to a thorough pressure washing process. These components play a crucial role in safeguarding the home against water infiltration.

Recommendation Contact a qualified roofing professional.

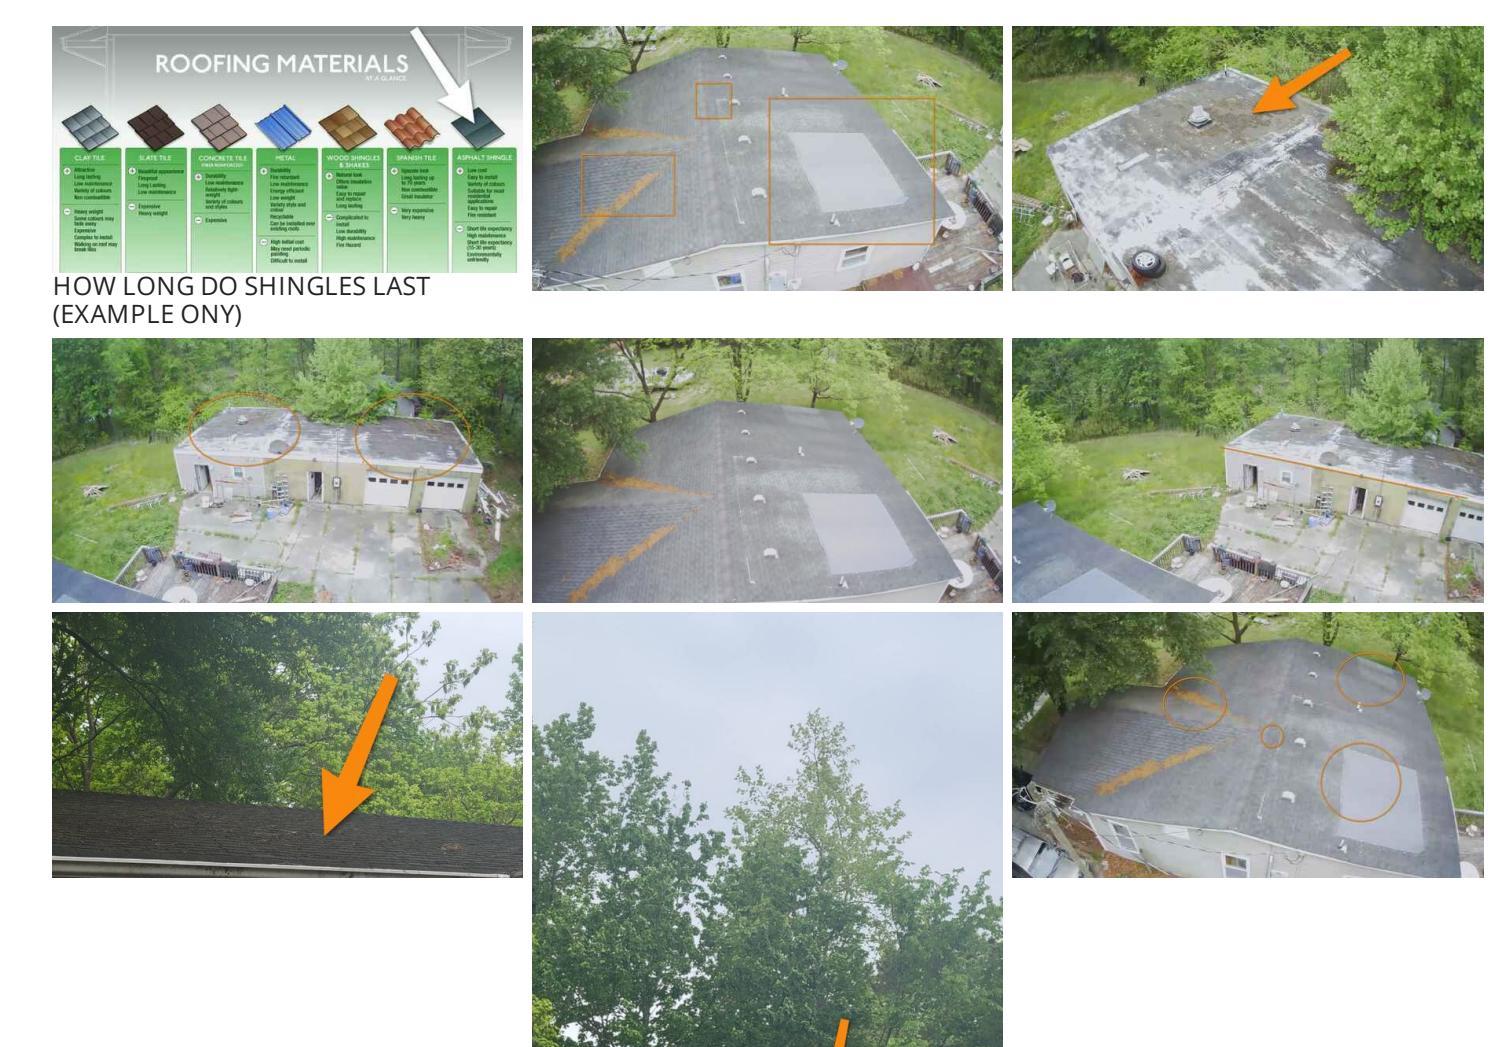
2.1.2 Coverings, roof drainage systems, flashing, skylights, chimney and other roof penetrations DAMAGED ROOF EXCEEDING SERVICE LIFE, RESULTING IN EXTENSIVE WATER LEAKAGE AND STRUCTURAL DAMAGE ROOF

This property comprises two structures, both exhibiting signs of roofing deterioration. The roofs of both buildings have exceeded their anticipated service life, resulting in water ingress into their interiors. Additionally, mold and fungus proliferation have been observed in both areas.

On the main house, a tarp is currently deployed to mitigate water infiltration into a bedroom section. This structure features asphalt shingles. Conversely, the rear building is outfitted with EPDM membrane roofing, characteristic of flat roofs. Regrettably, the flat roof suffers from improper sloping, leading to water accumulation. Corrective measures necessitate the adjustment of the roof slope and the installation of gutters on both buildings.

The severity of the roofing issues is evident through multiple damaged areas, precipitating significant moisture intrusion. Water has breached the walls and permeated the roof framing and sheathing, indicating the need for comprehensive repairs. This entails the evaluation and remediation of the affected areas by a qualified roofing contractor.

Given the presence of EPDM roofing on the rear building, consultation with a roofing company proficient in handling both roofing materials is strongly recommended. Damage to the electrical system and or wiring in the ceiling or edges of the walls are present. The effects the rear building due to the lighting fixtures being in the area.

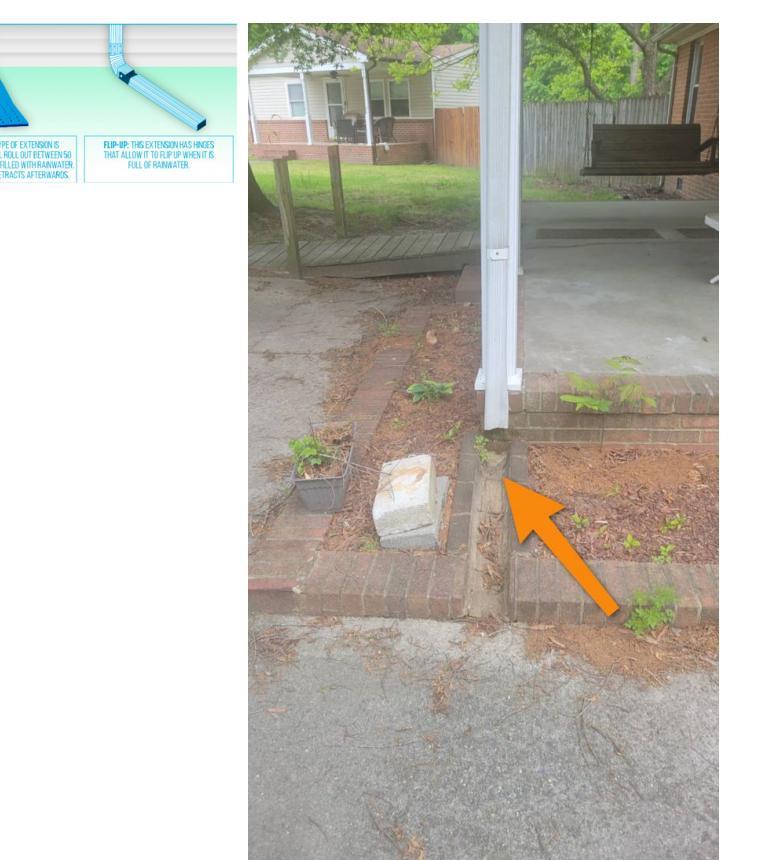
DOWN SPOUTS DRAIN NEAR HOUSE

Down spouts drain near the homes foundation, this can cause water to seep near or under the home. Down spout extensions should be installed.

Recommendation Contact a qualified professional.

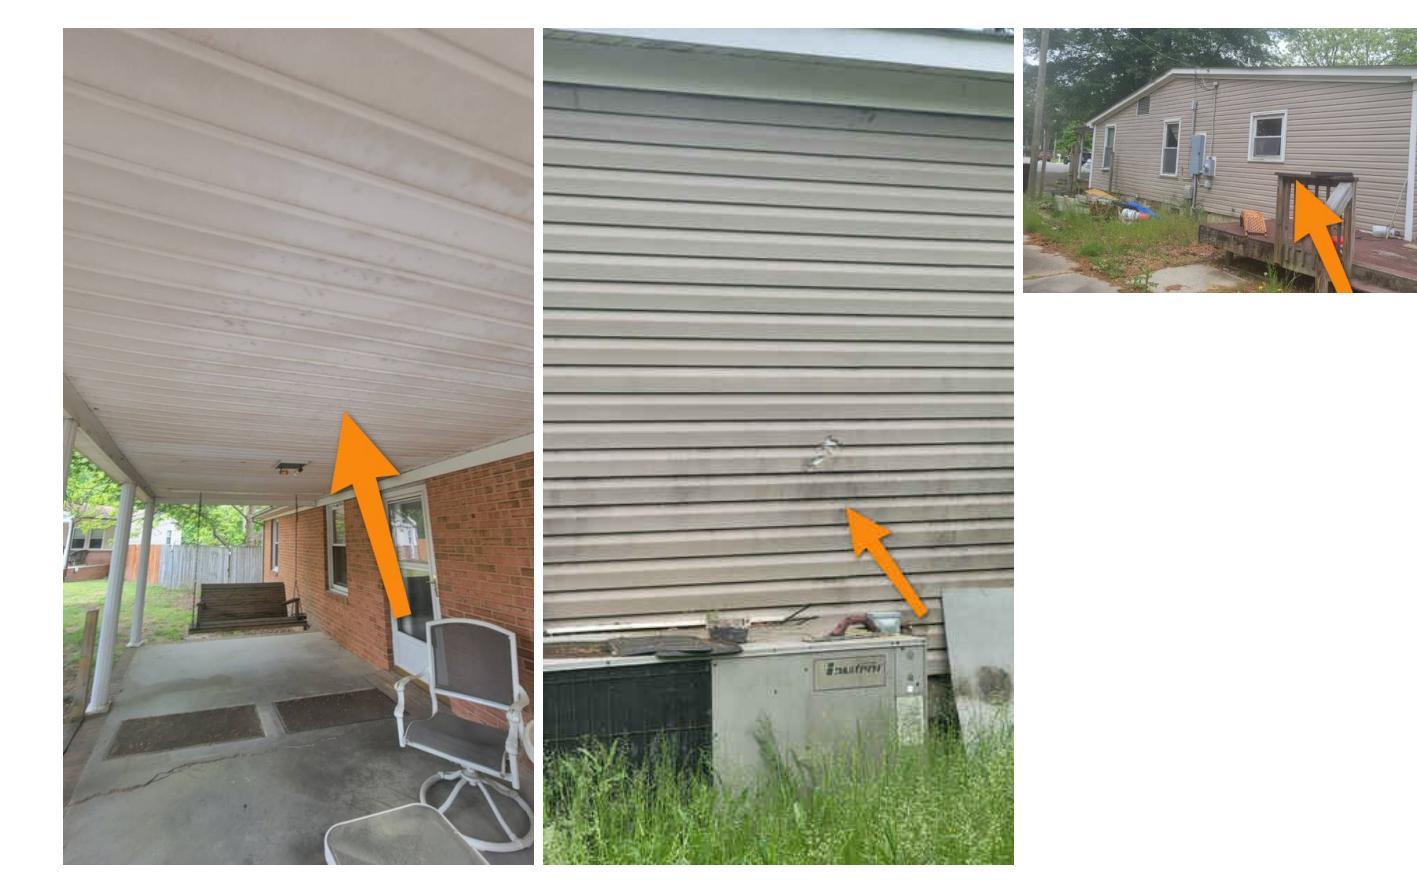
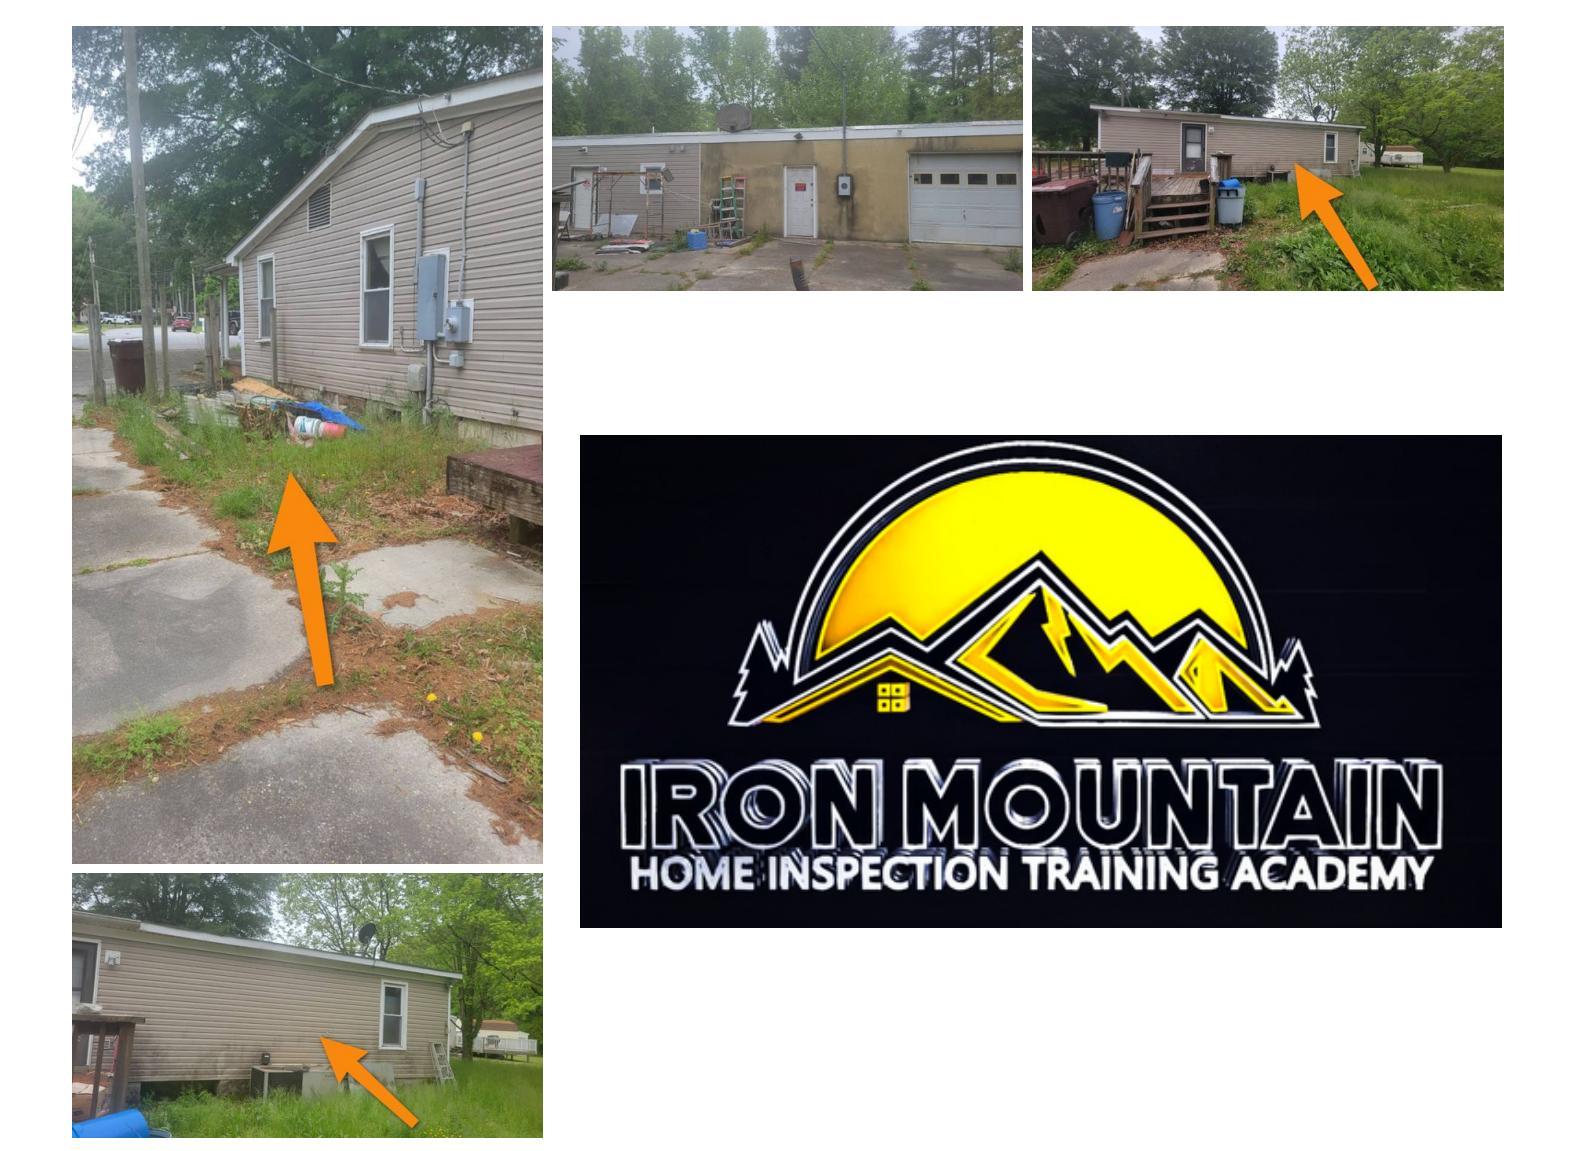
3.1.1 Siding, Flashing & Trim, exterior doors, eaves, soffit vents, windows and fascia PROPERTY EXTERIOR ASSESSMENT AND RECOMMENDATIONS FOR SIDING MAINTENANCE AND DEBRIS MANAGEMENT

- 1. The siding on the main home exhibits signs of deterioration including looseness, staining, and cracks in multiple areas.
- 2. The rear building features a mix of vinyl siding, concrete, and a material resembling stucco.
- 3. Debris is scattered across the yard, detracting from the property's appearance and cleanliness.

- Secure and pressure wash the siding on both structures to restore their appearance and integrity.
- Arrange for the removal of debris from the yard to enhance aesthetics and safety.
- Consider refinishing the material on the rear building to improve its condition and visual appeal.
- Engage a siding contractor to conduct a thorough evaluation and perform necessary repairs for both structures.

Contact a qualified siding specialist.

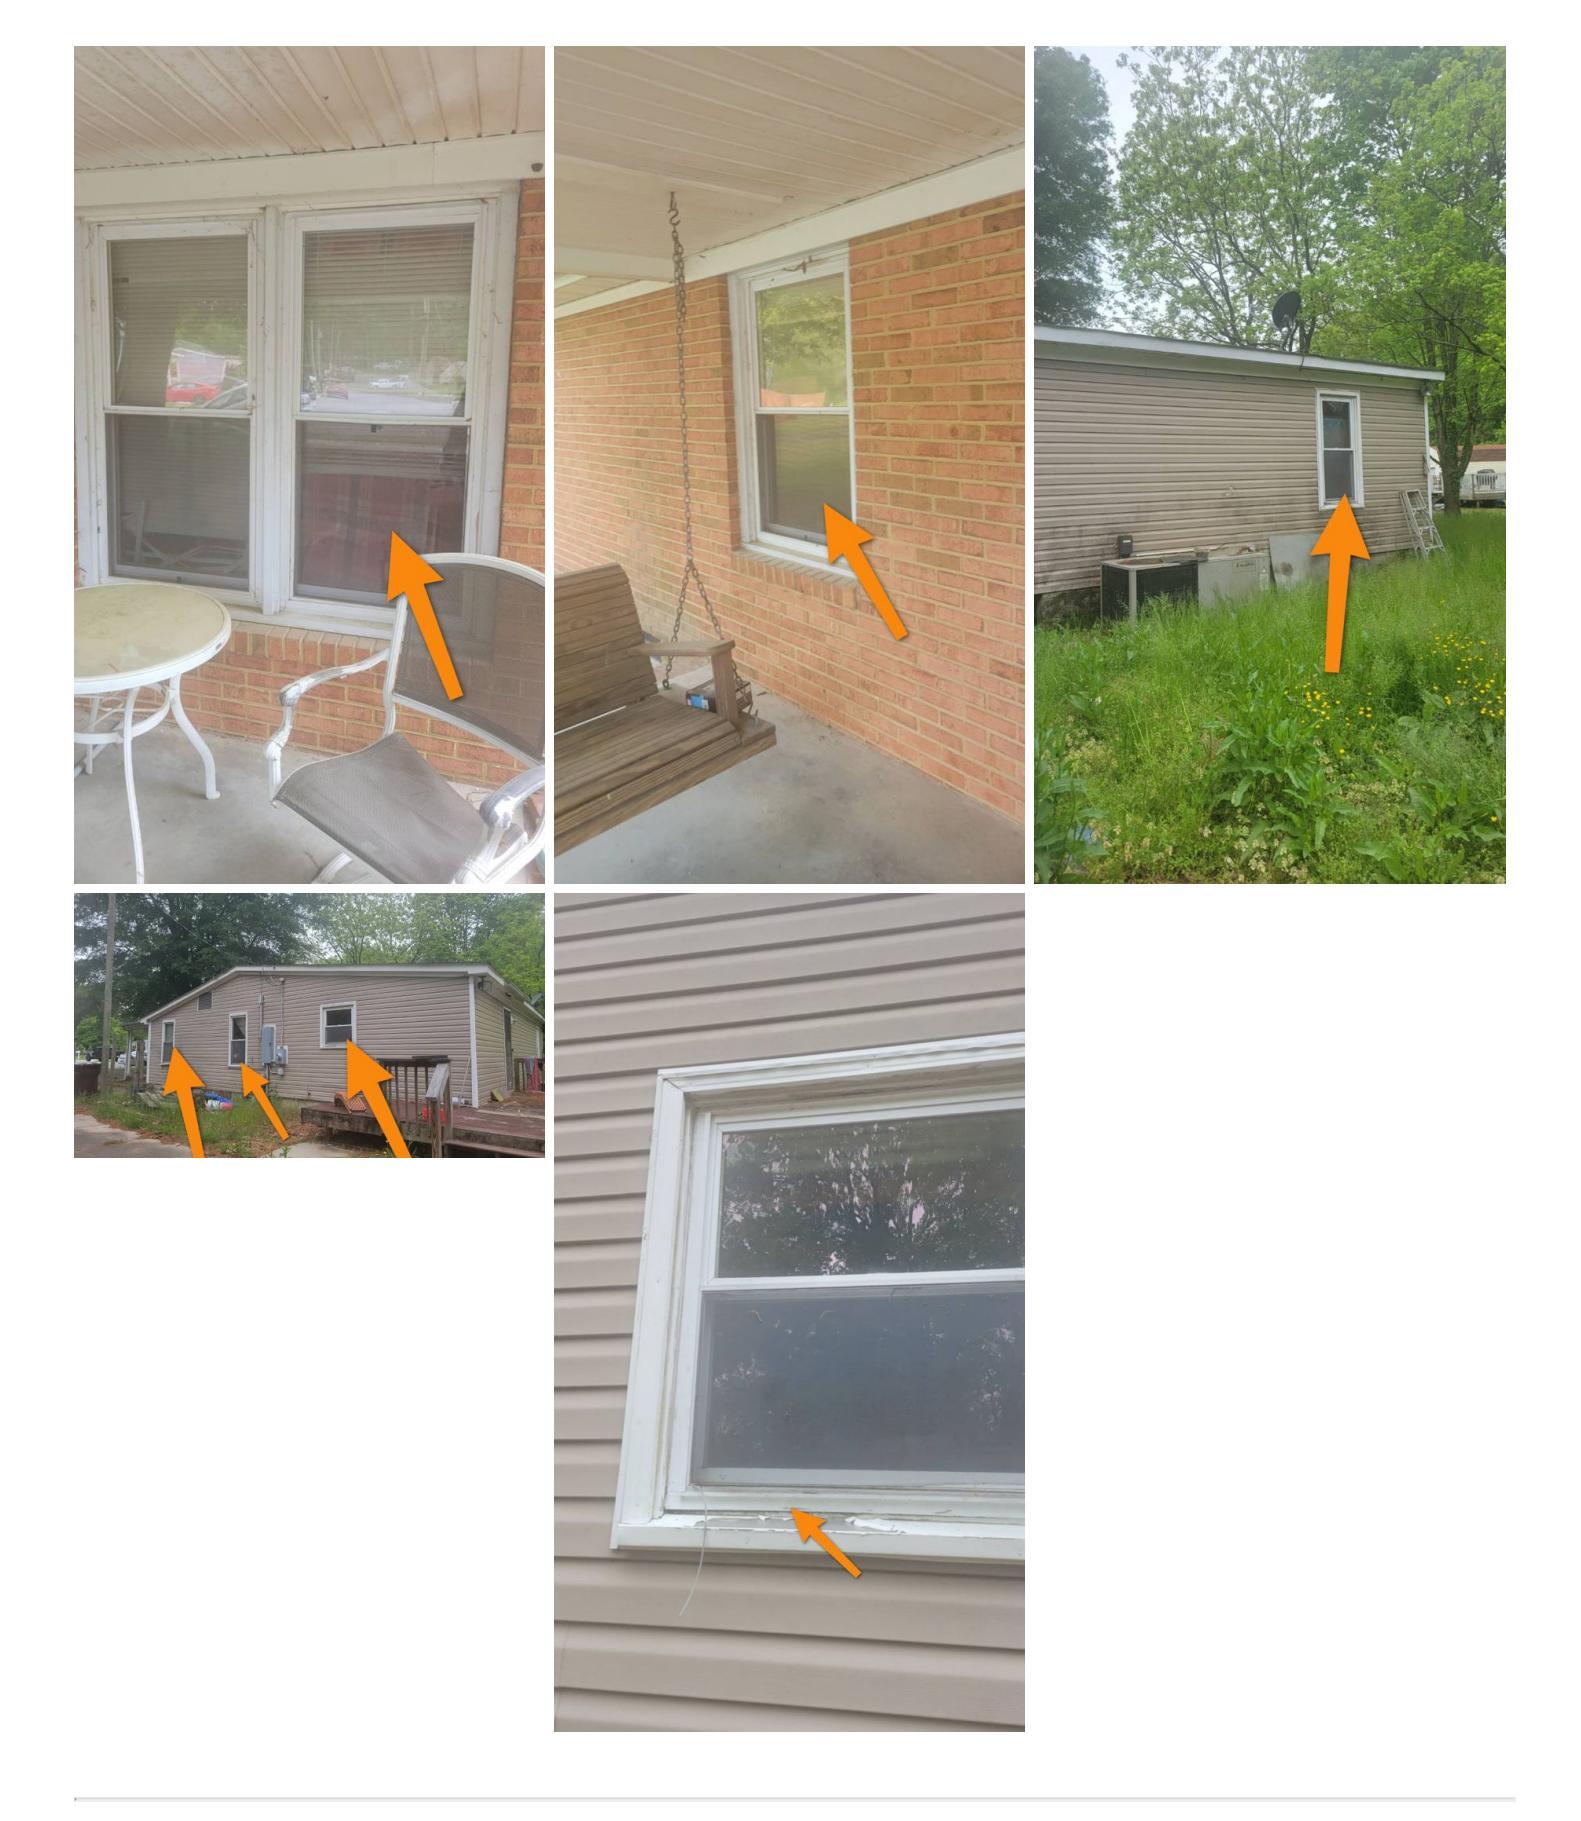
3.1.2 Siding, Flashing & Trim, exterior doors, eaves, soffit vents, windows and fascia EXTERIOR WINDOW TRIM CONCERNS AND OPERATIONAL ISSUES EXTERIOR

Damage is visible around the exterior trim of the windows, with torn screens also noted. While the windows can be opened and closed, some may require extra effort and show signs of wear on their hardware and framing components.

Contact a qualified window repair/installation contractor.

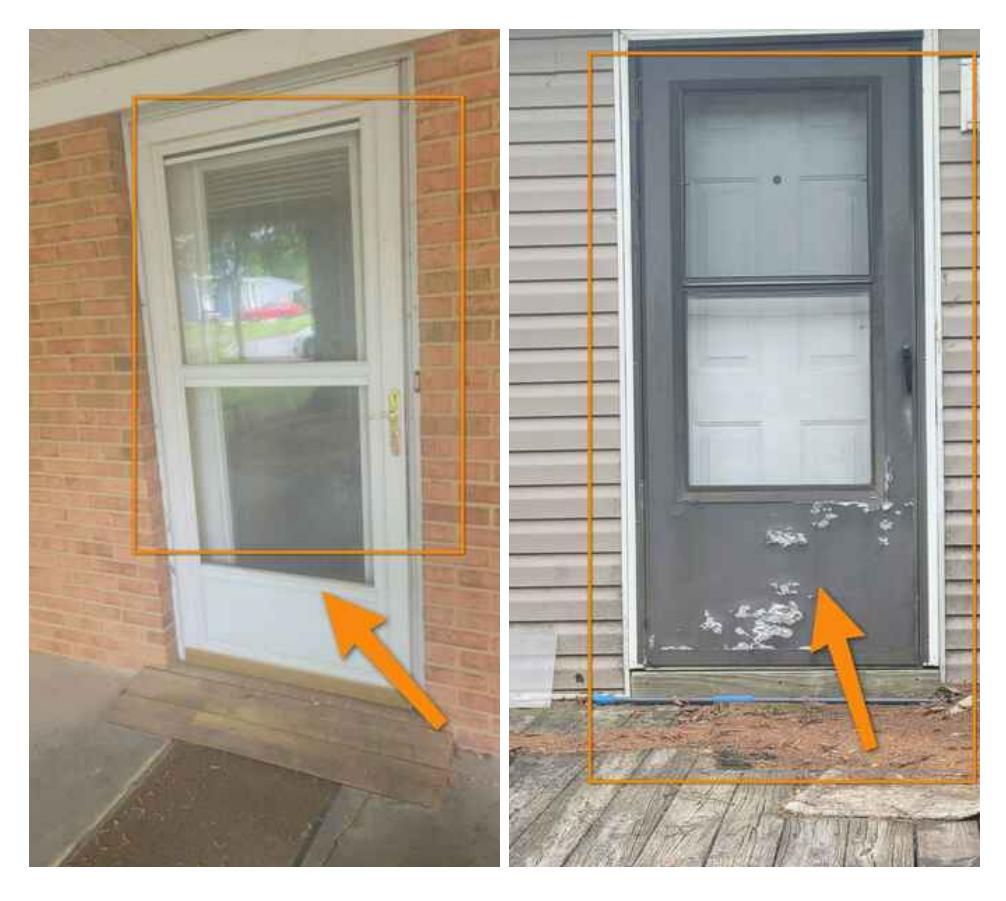
3.1.3 Siding, Flashing & Trim, exterior doors, eaves, soffit vents, windows and fascia **DAMAGED DOORS**

The exterior doors exhibit noticeable signs of wear and damage. The screen doors are damaged, with loose door hardware and visible dents and markings. Additionally, alignment issues are observed. It is recommended to assess and repair these issues promptly.

Recommendation Contact a qualified door repair/installation contractor.

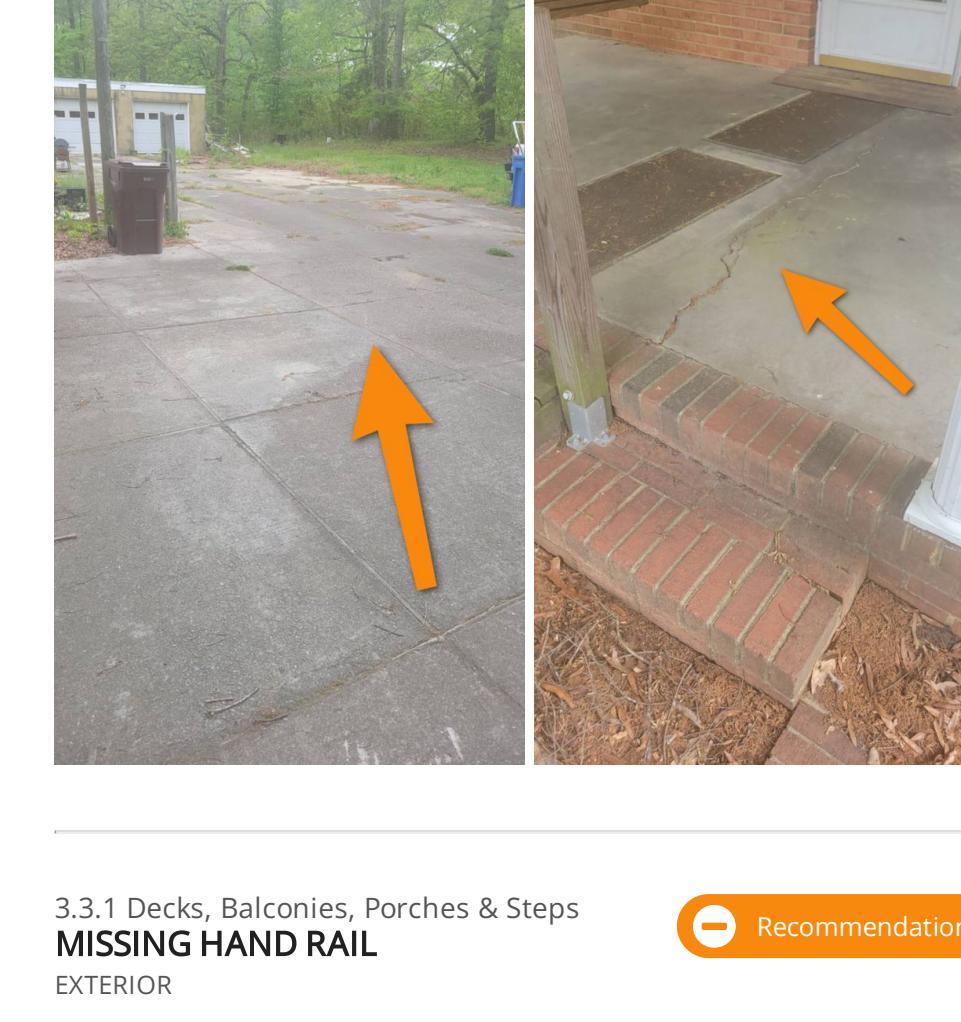
3.2.1 Walkways, Patios & Driveways DRIVEWAY CRACKING/WALKWAY CRACKING

Driveway and walkway cracks observed, which may indicate movement in the soil. Recommend monitor and/or have concrete contractor patch/seal.

Recommendation Contact a qualified concrete contractor.

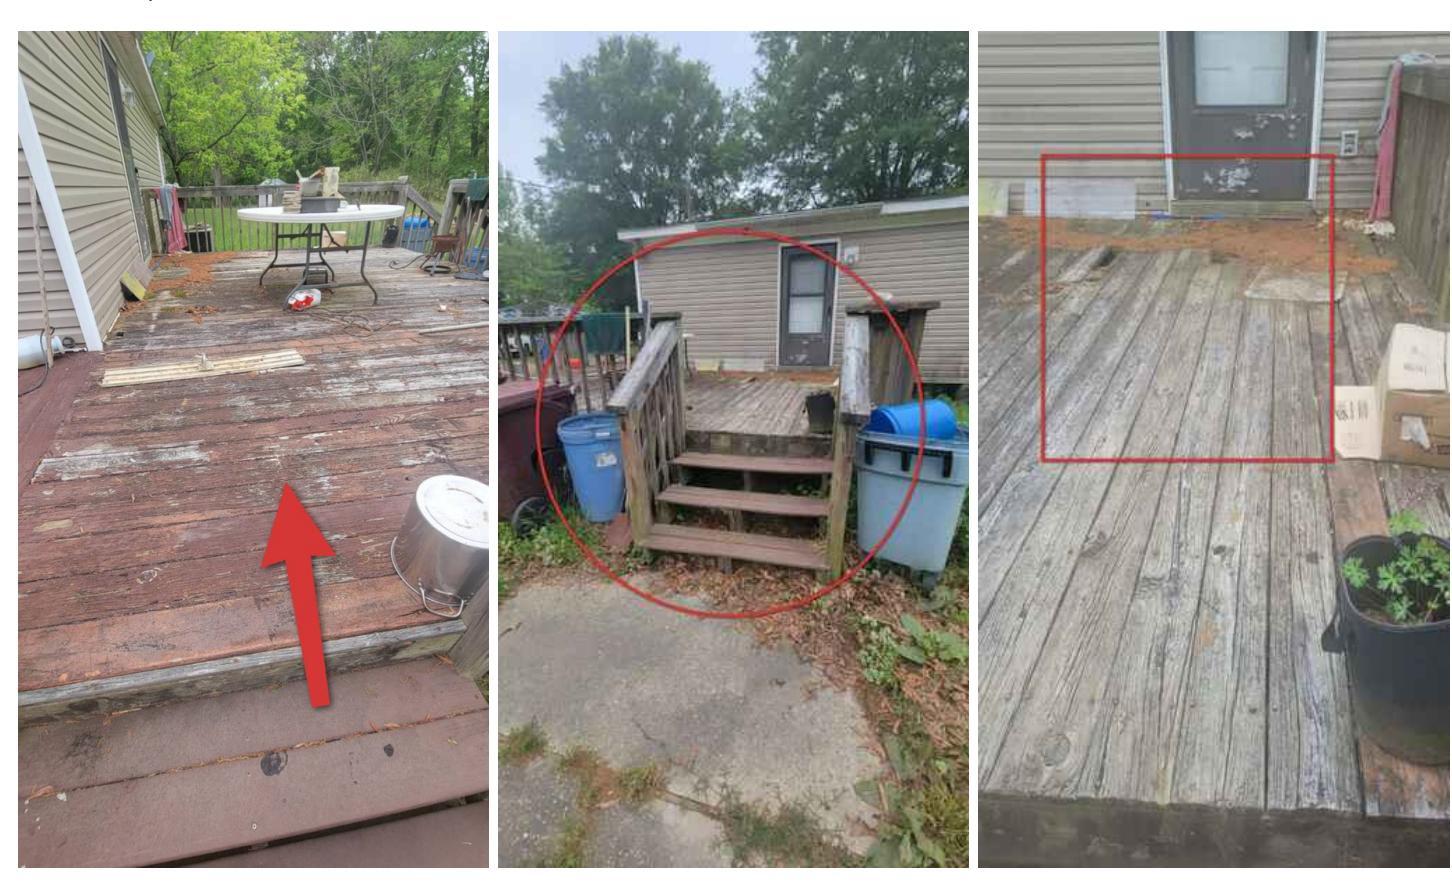
3.3.2 Decks, Balconies, Porches & Steps DECK - DECK IN POOR CONDITION (CLOSE TO FAILURE) EXTERIOR (REAR)

The rear deck is in a state of disrepair, with the majority of the deck boards exhibiting rot. Additionally, a section of the handrails is missing, and multiple types of materials have been utilized in its construction. The deck shows signs of deterioration, including holes, and is nearing failure. It is strongly recommended to engage a deck contractor for a thorough evaluation and necessary repairs.

To address the dangers of rotted deck boards, it is essential to replace the damaged boards as soon as possible. Ensure that any underlying structural components, such as joists or beams, are inspected for rot as well. Additionally, consider taking preventive measures, such as regular inspections, proper maintenance, and using materials that are resistant to rot, to avoid future problems. If you're unsure about the extent of the damage or how to proceed, it's recommended to consult a professional contractor experienced in deck repair and construction for proper assessment and guidance.

Recommendation Contact a qualified deck contractor.

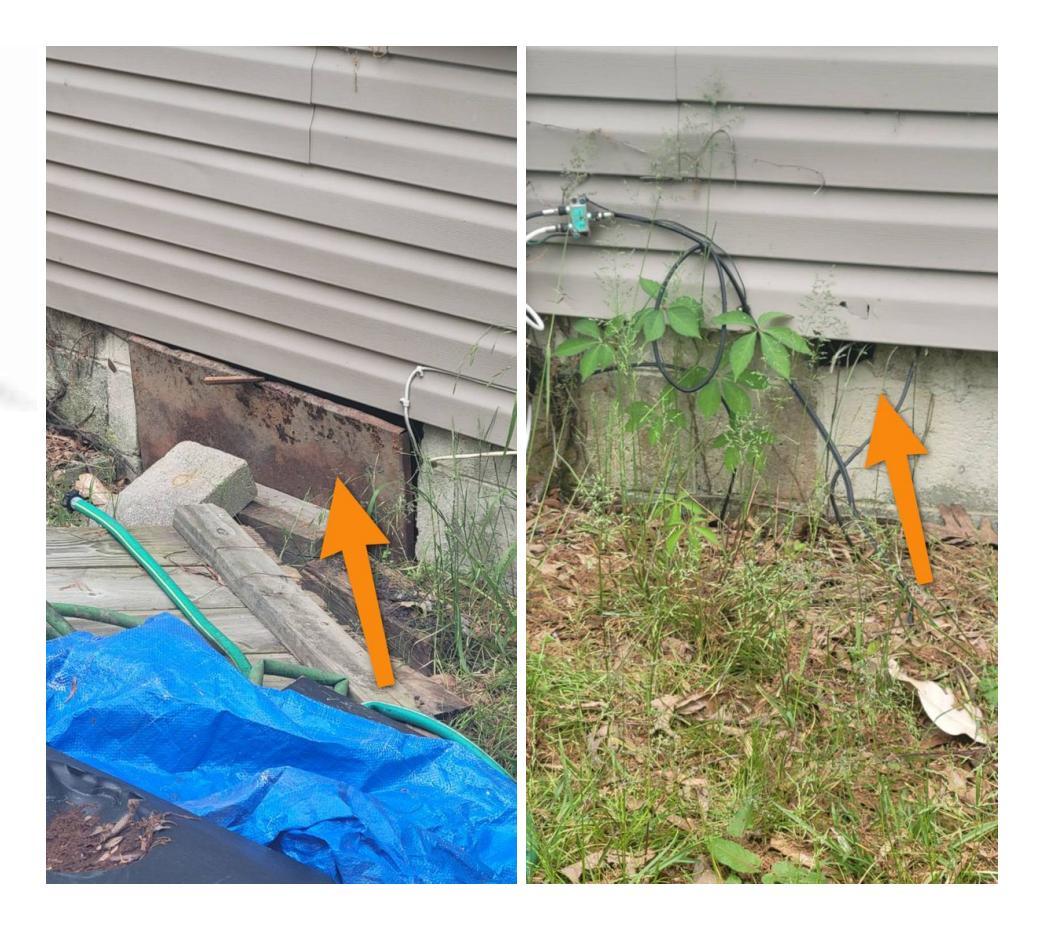
4.1.1 Basements & Crawlspaces IMPROPER CRAWL SPACE COVER OR MISSING COVER

1. Damaged crawl space cover or no crawl space cover observed. A tight seal on a crawl space cover helps to keep moisture, rodents and insects out of the crawl space. Recommend a qualified contractor to evaluate and repair.

Recommendation Contact a qualified professional.

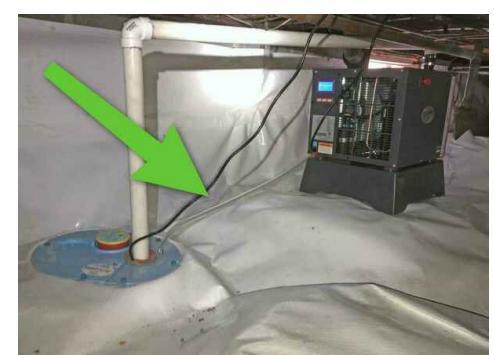
4.1.2 Basements & Crawlspaces CRAWL SPACE ASSESSMENT AND RECOMMENDATIONS CRAWL SPACE

The crawl space presents several issues, including loose insulation, a damaged moisture barrier, junction boxes lacking covers (posing a fire hazard), damaged ductwork, and signs of common wood fungus. Crawl space remediation is strongly advised to address these concerns. Additionally, parts of the floor are uneven.

Prior to listing the property, it is recommended to obtain a termite and moisture letter to provide assurance to potential buyers. Installing a 6-mil barrier and considering the installation of a dehumidifier can help mitigate moisture-related issues.

Contact a foundation contractor.
