SAMPLE REPORT FOR TRAINING (SUMMARY/DEFECTS ONLY)

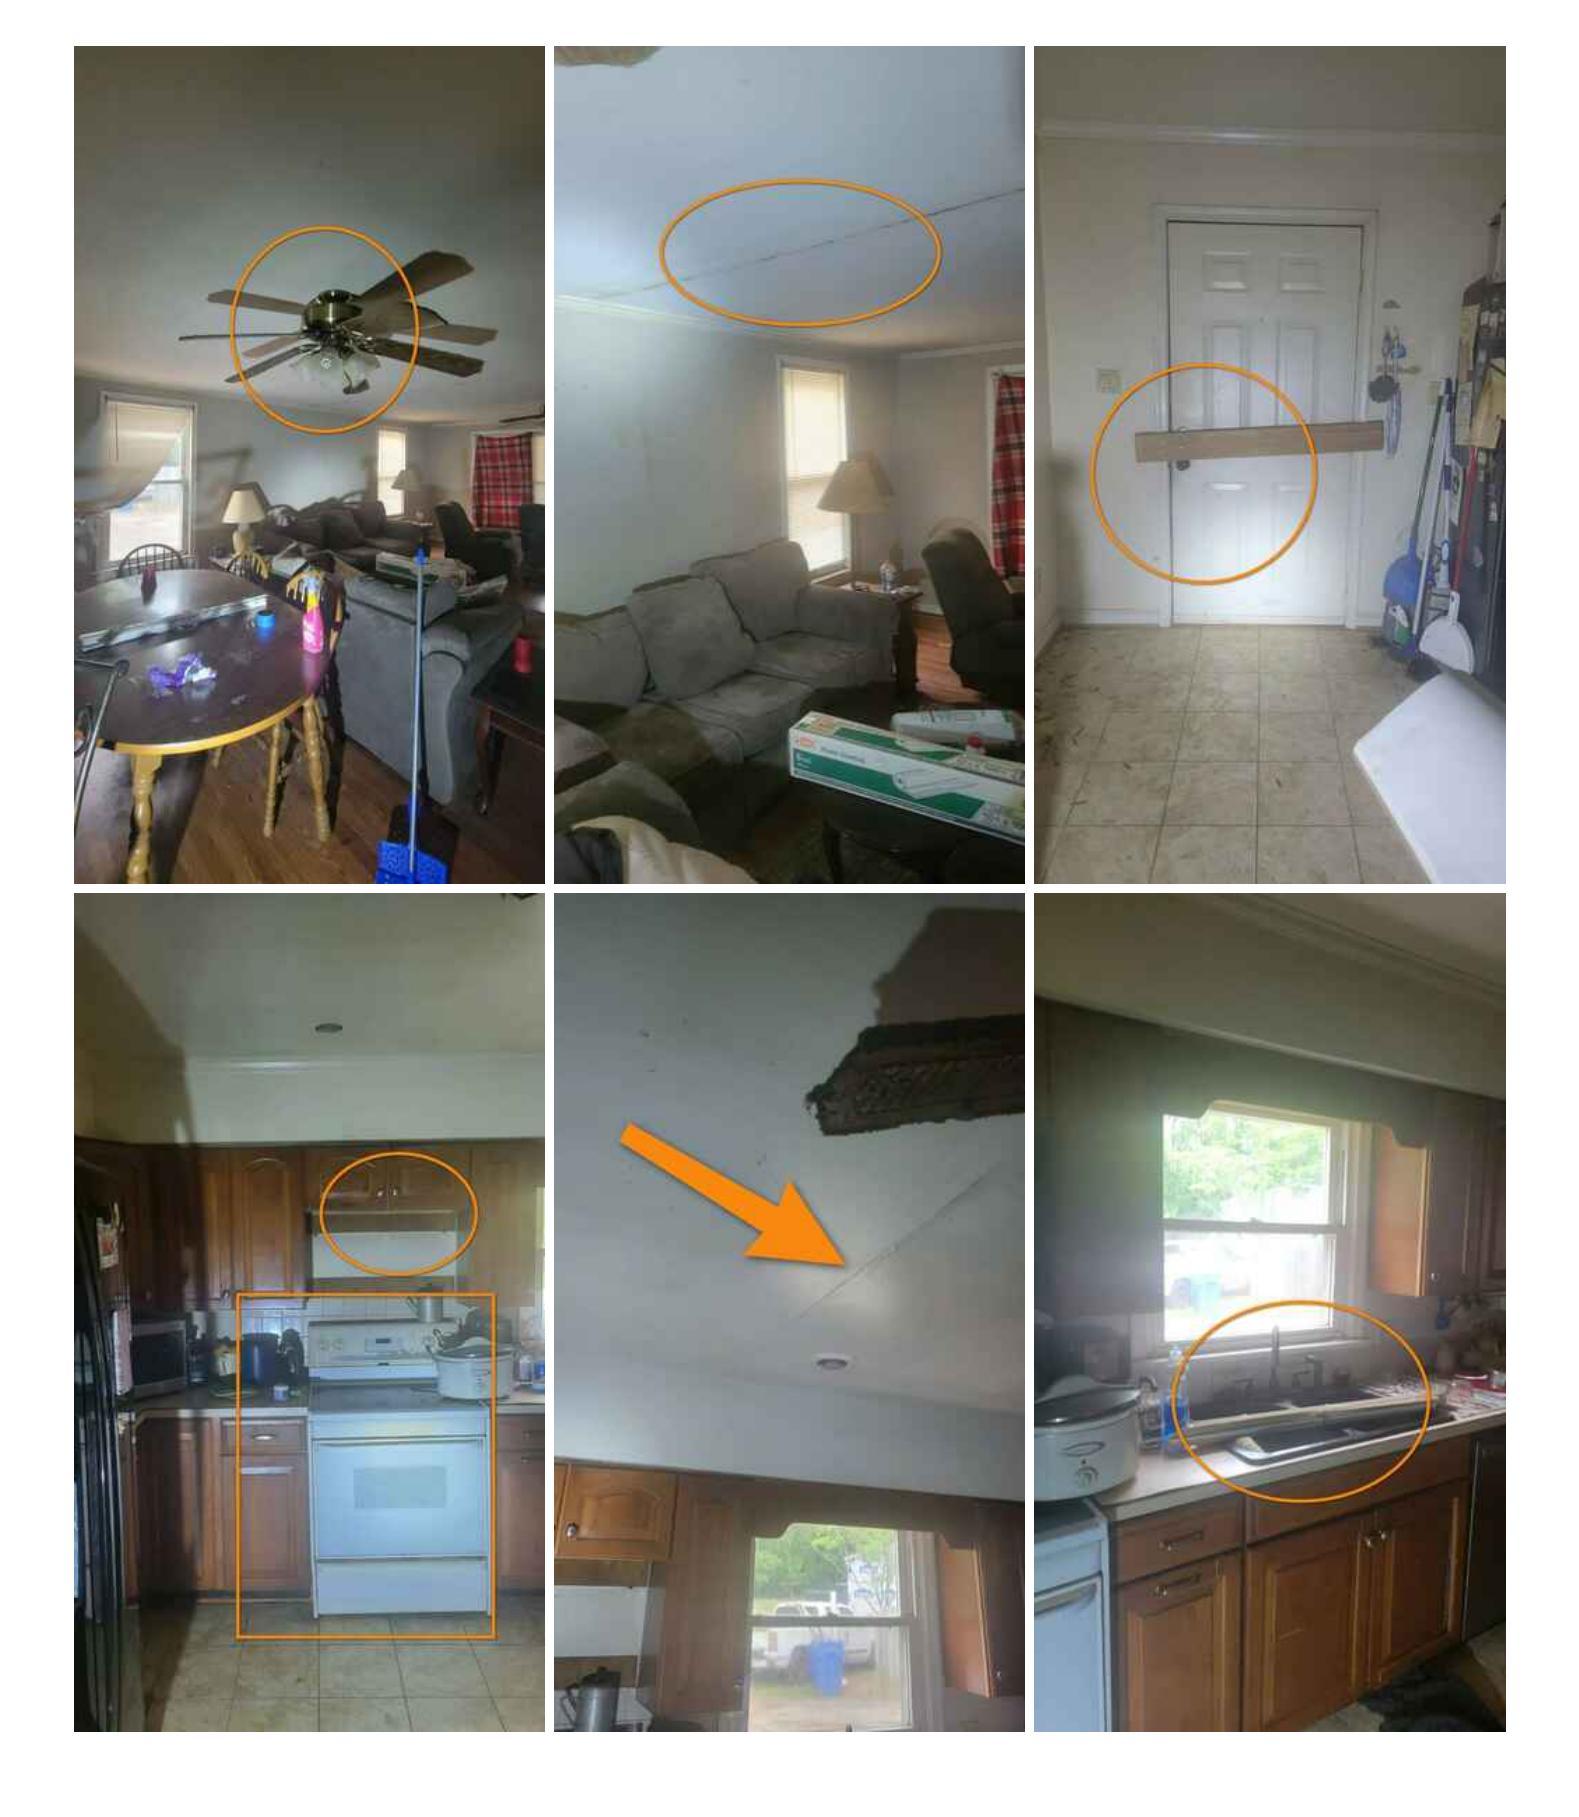
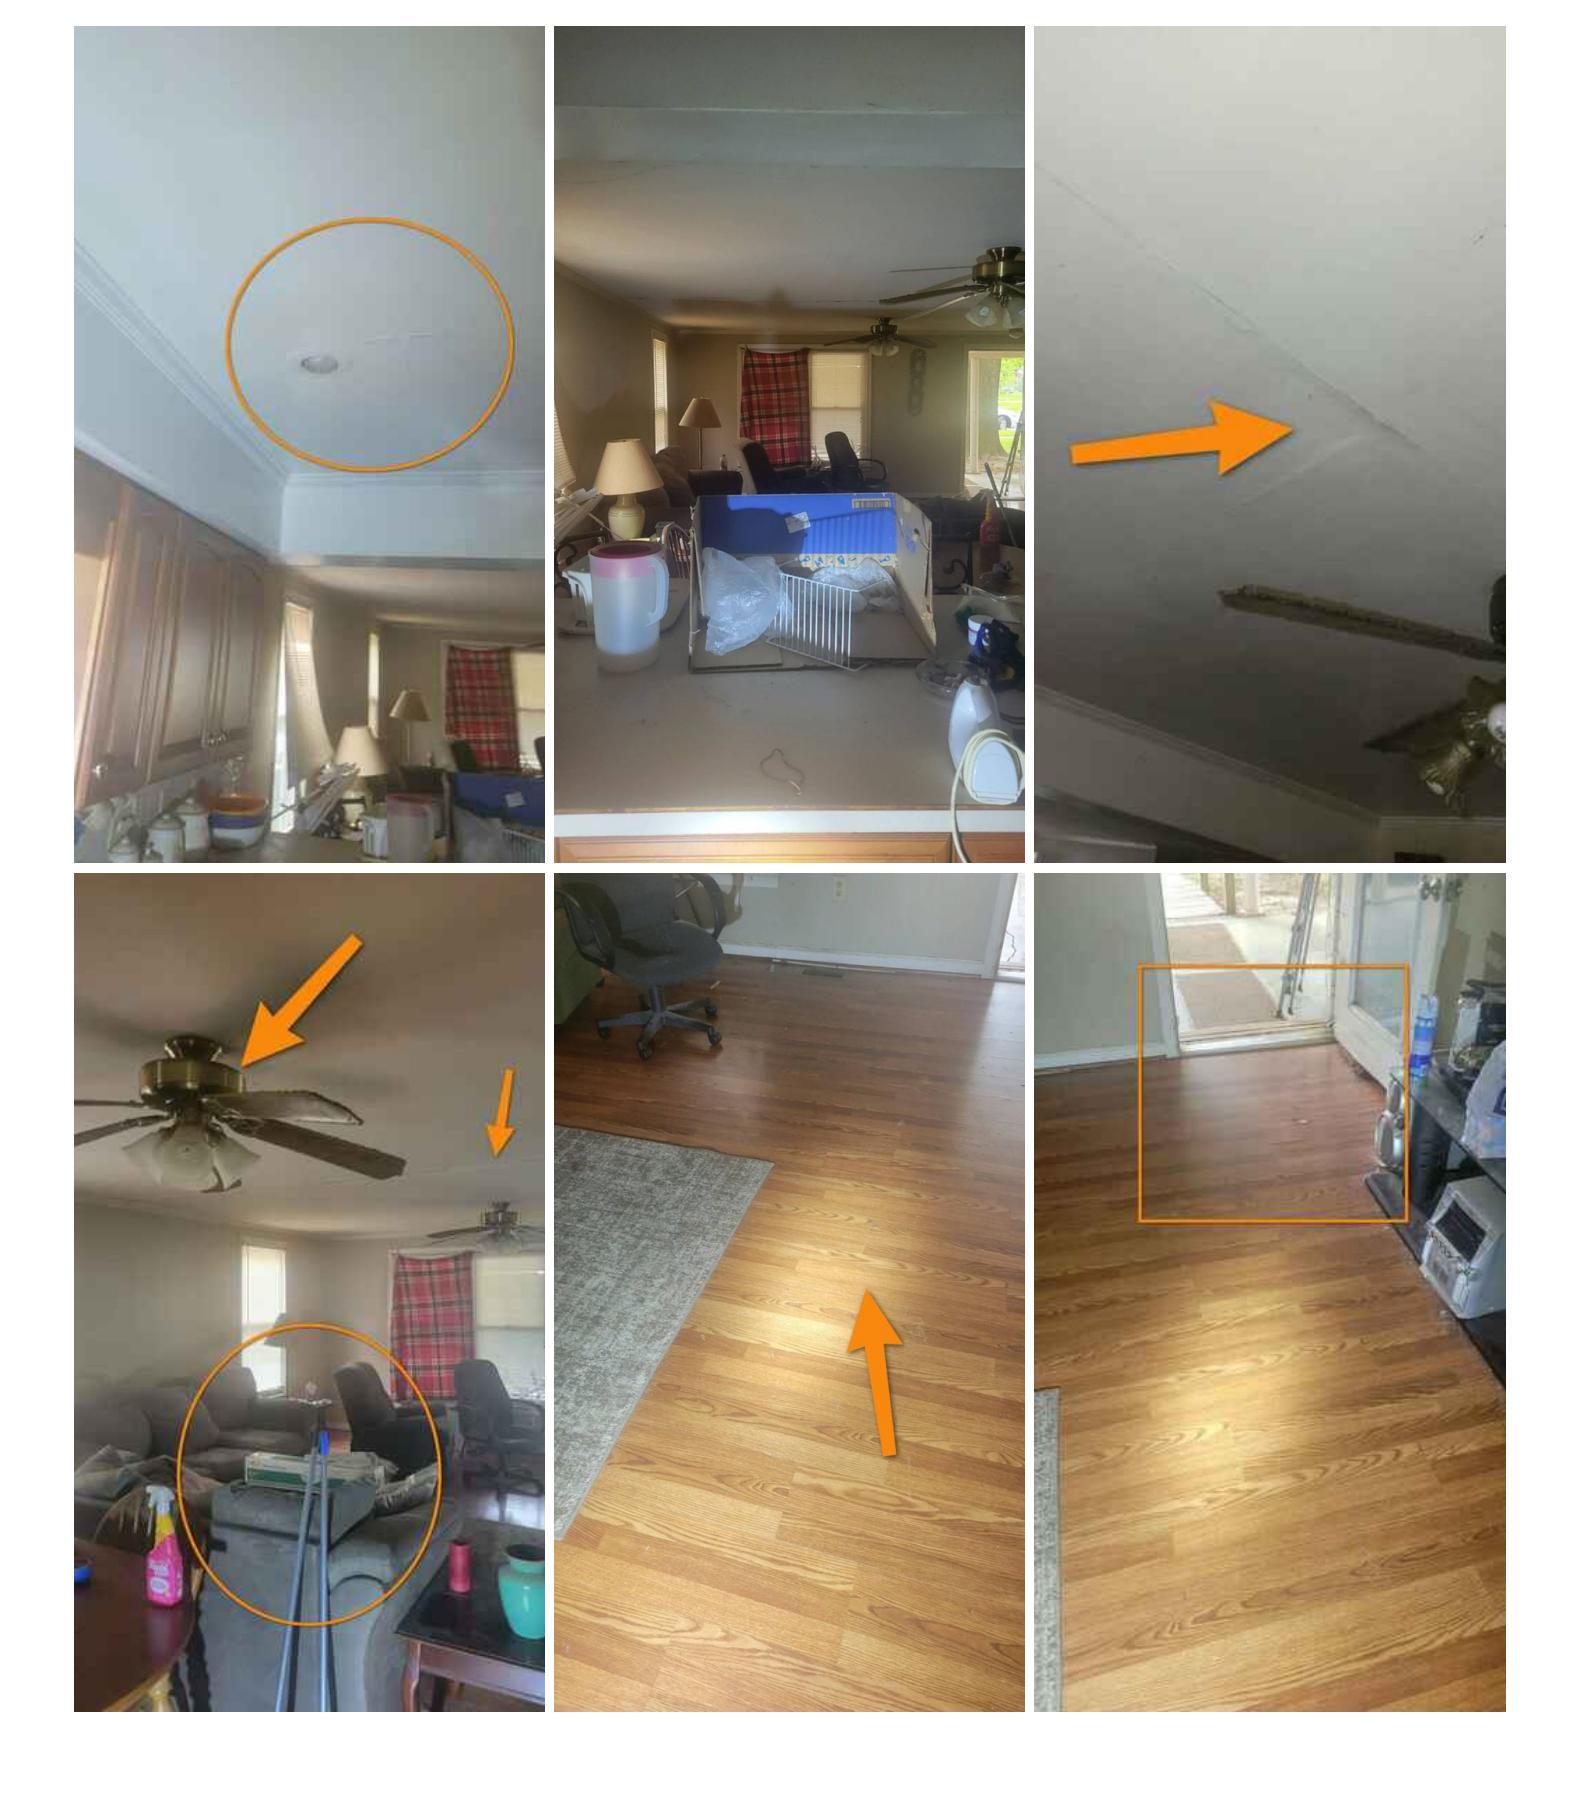
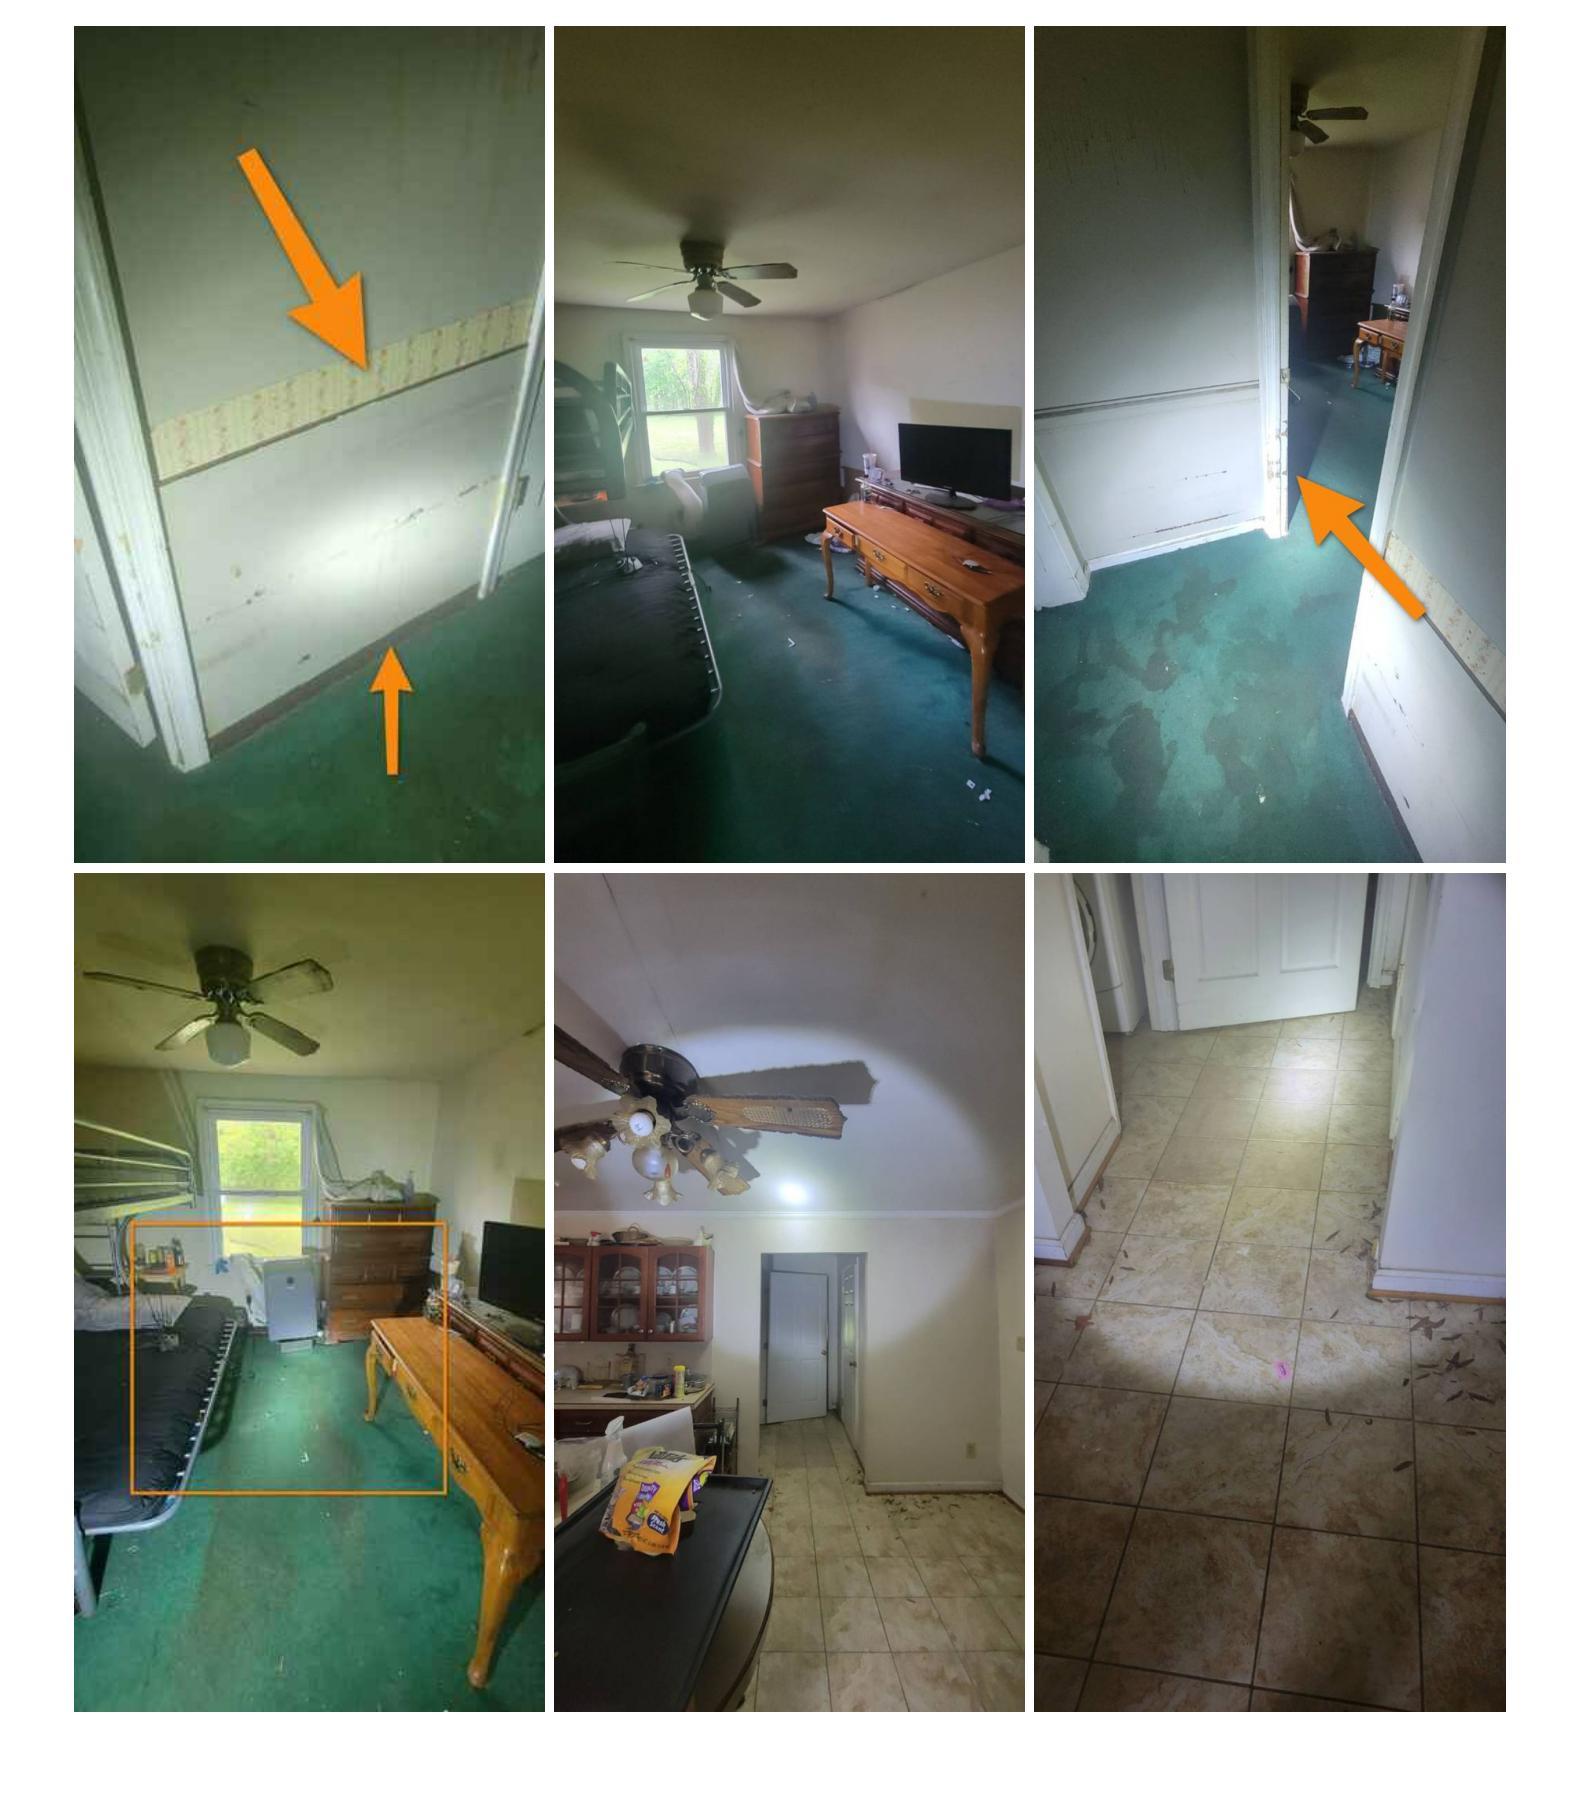
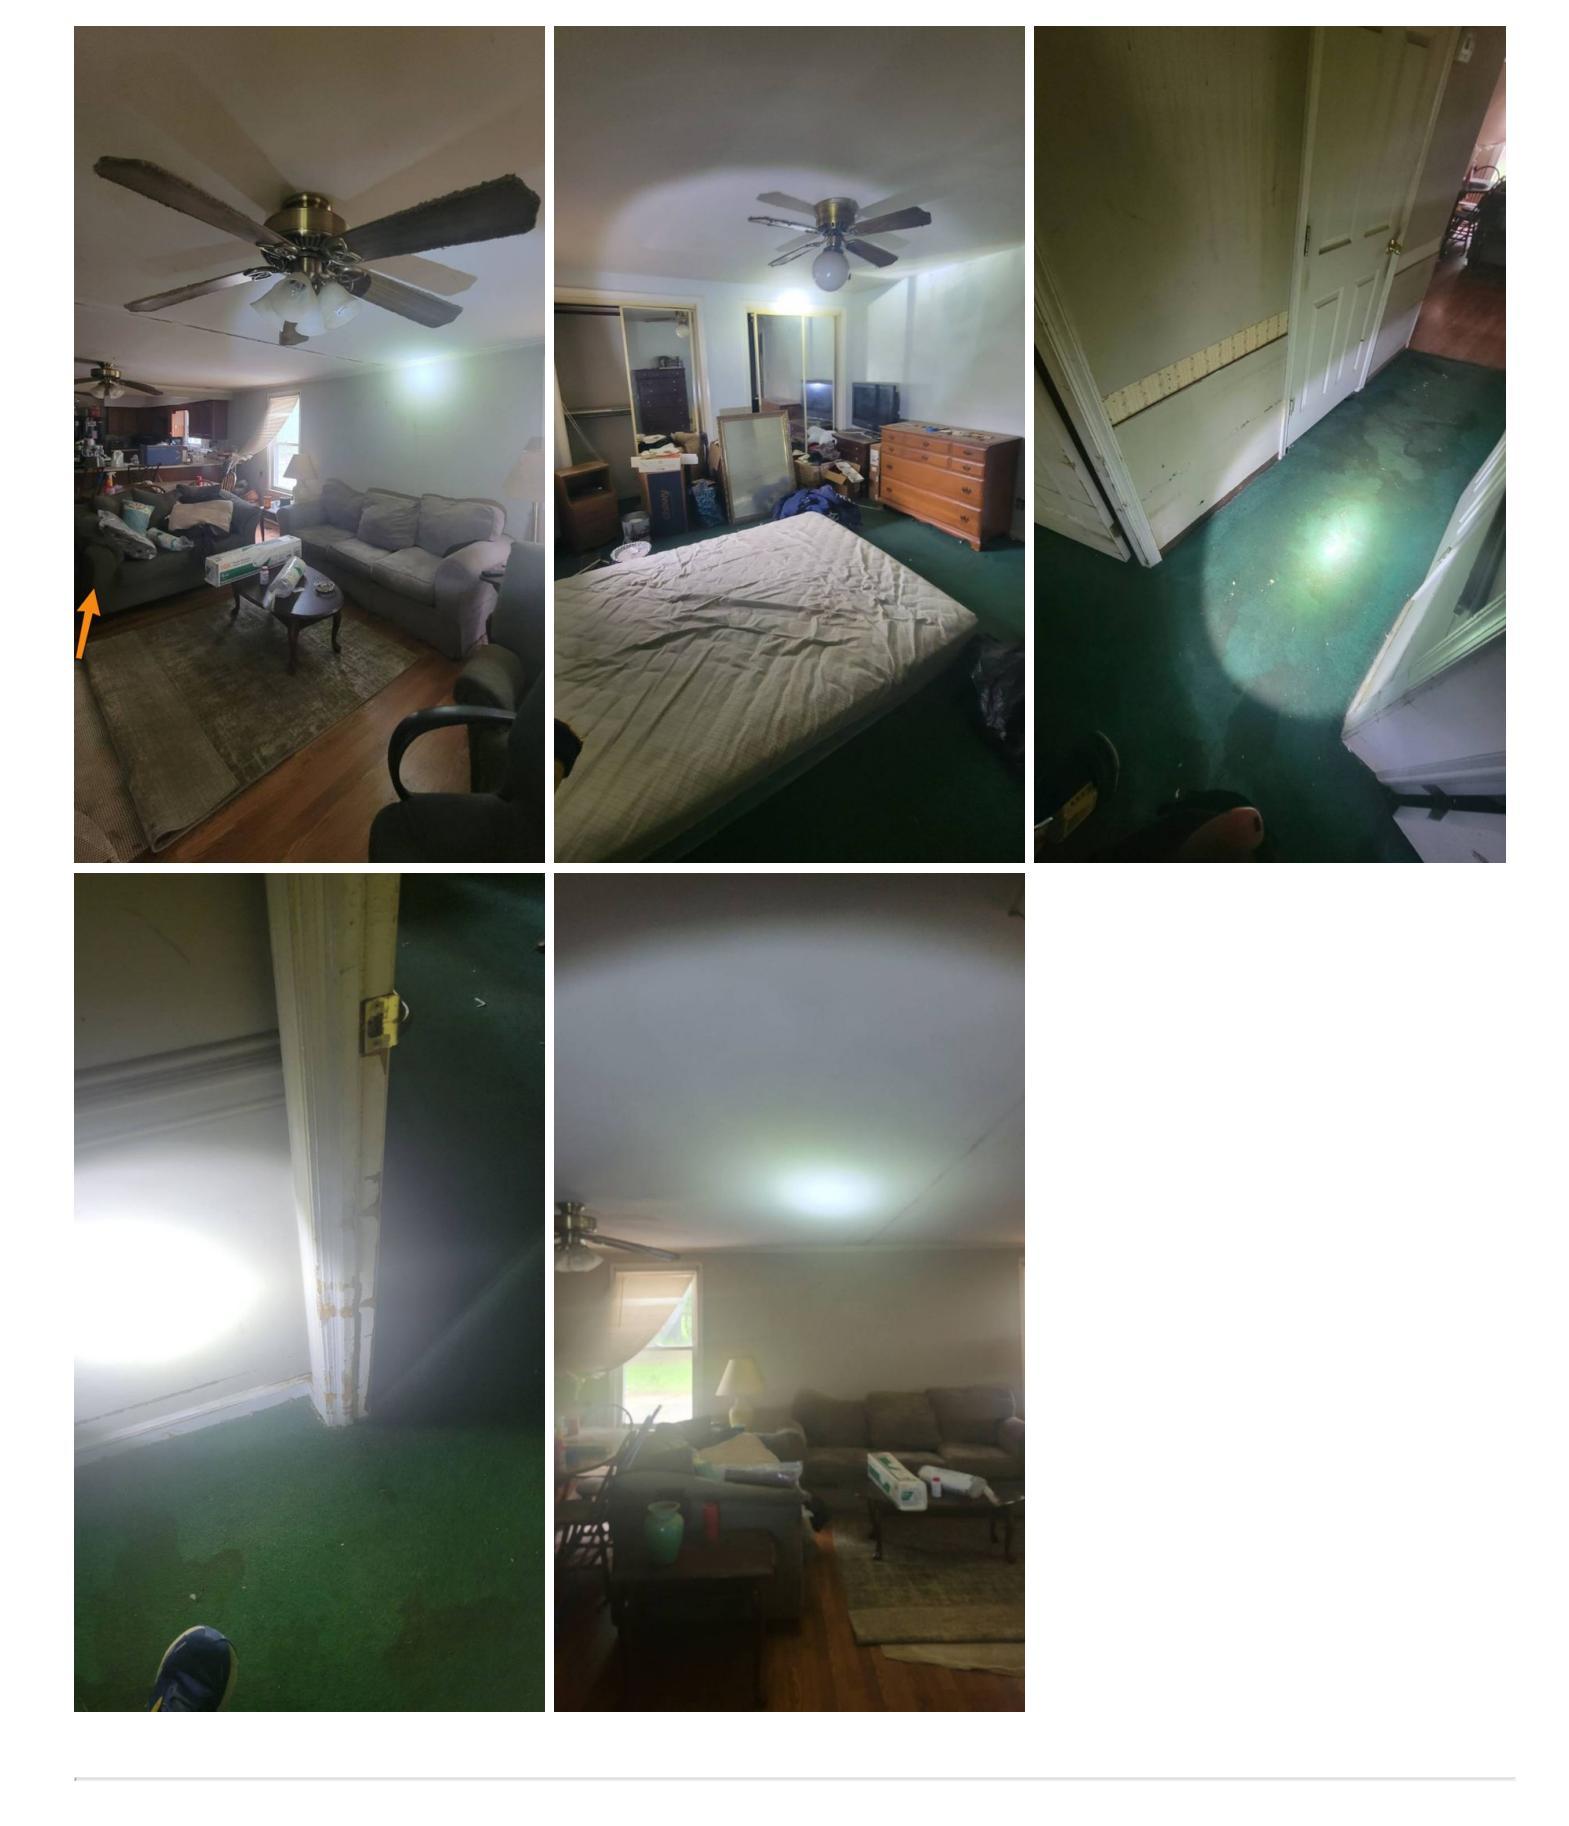
6.1.1 Interior doors, windows, floors, ceilings **INTERIOR DEFECTS: MULTIPLE ISSUES** INTERIOR

- 1. Multiple interior defects were noted during the inspection of the home, including:
- Cracks in the ceilings and walls, as well as settlement cracks attributed to wear in the crawl space (typical for the age of the home).
- Damaged flooring, uneven flooring, and worn light fixtures. •
- Damaged cabinets, aged and worn appliances, and a missing fan hood. •
- Damaged doors and door hardware, along with typical wear on cabinets and flooring. •
- Damaged or loose light fixtures, debris scattered throughout the home, and loose sink faucets. •
- General wear on windows, making them difficult to open and close, with loose window hardware. •
- Damage to walls and floor molding, as well as damaged ceiling fans. •

2. It is recommended to enlist the services of a qualified contractor to thoroughly evaluate and repair these areas of the home.

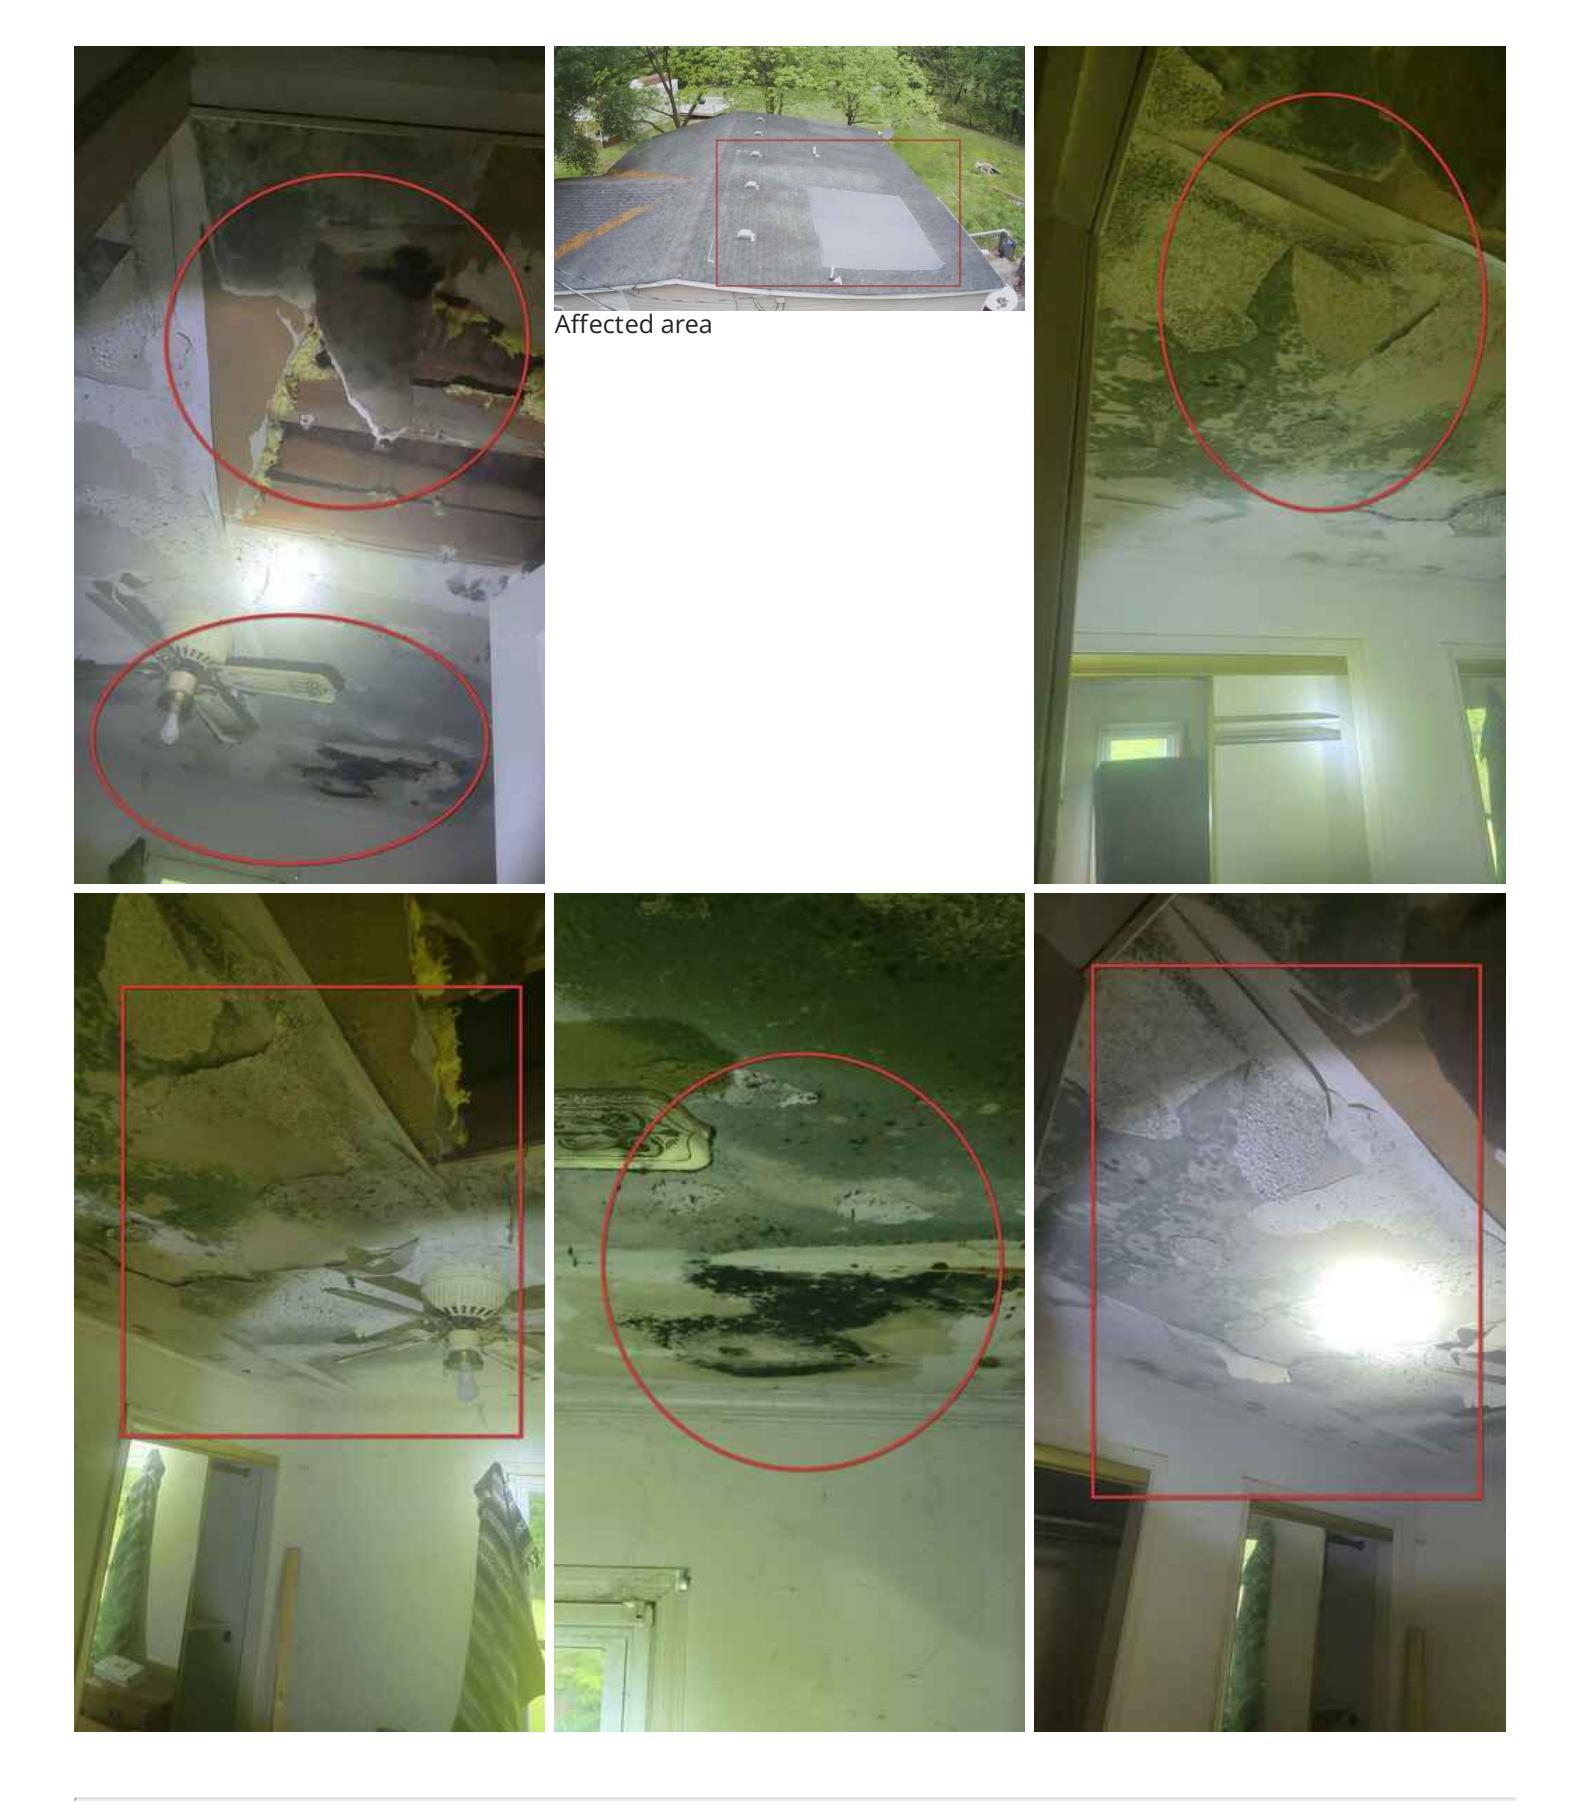
6.1.2 Interior doors, windows, floors, ceilings **CEILING DAMAGED BY WATER AND MOLD (CEILING FAILURE)** INTERIOR (REAR BEDROOM)

In the rear bedroom, the ceiling has collapsed due to water ingress from the damaged roof, necessitating the placement of a tarp over the affected area. Extensive mold growth is evident, affecting not only the ceiling but also the drywall, ceiling framing, wall framing and roof sheathing. Given the nature of mold, its spread to the adjacent bathroom ceiling is also observed. It is recommended to promptly evaluate and repair these areas to mitigate further damage.

• Begin by addressing the root cause of the water damage, which is likely the poor condition of the roof. Repair or replace the damaged roof to prevent further water ingress.

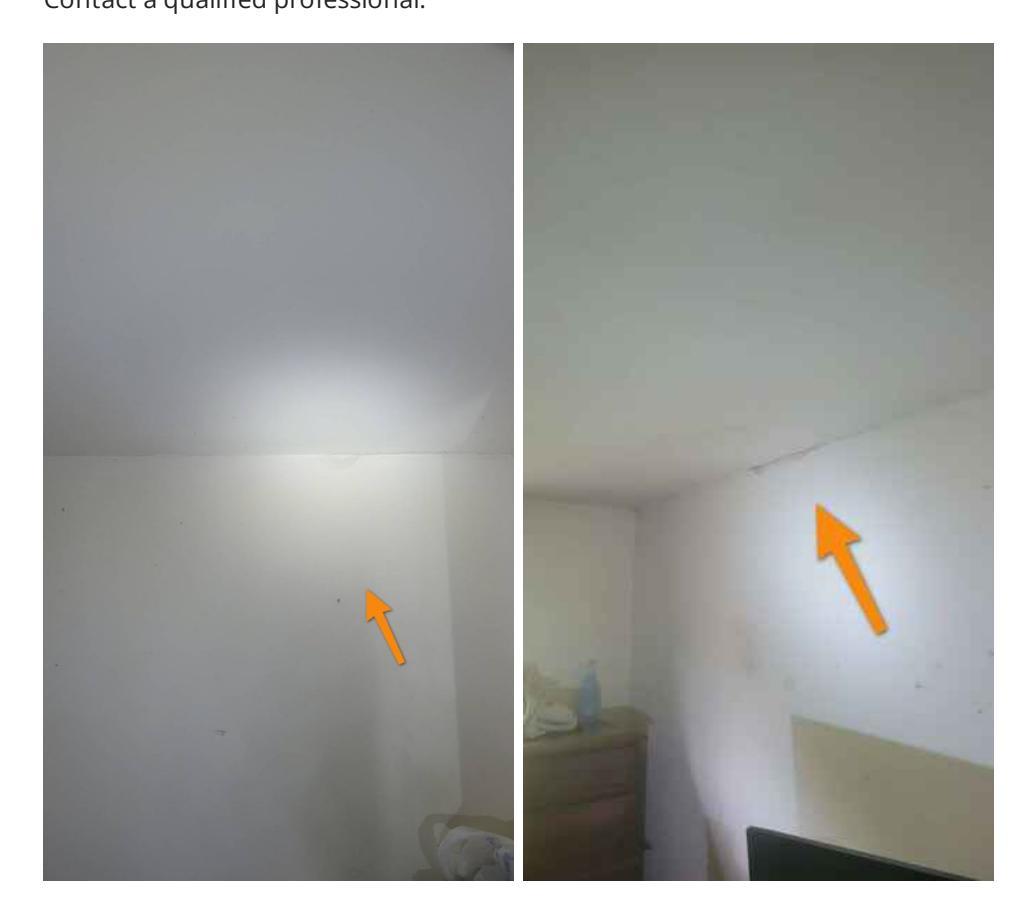
6.1.3 Interior doors, windows, floors, ceilings **ROOF LEAKS IN MULTIPLE AREAS OF THE HOME** INTERIOR BEDROOMS

Recommendation Contact a gualified professional.

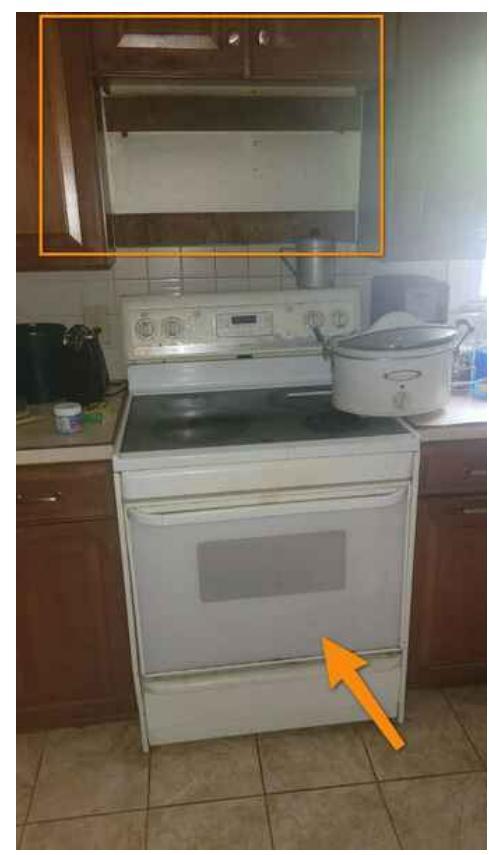
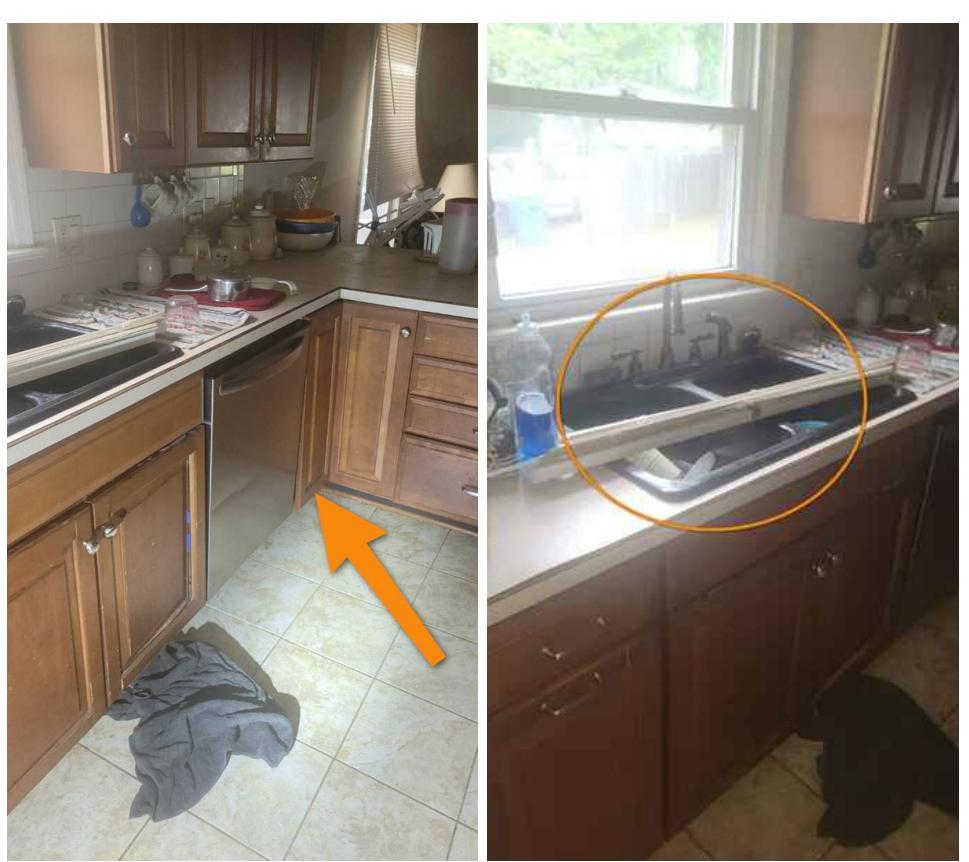
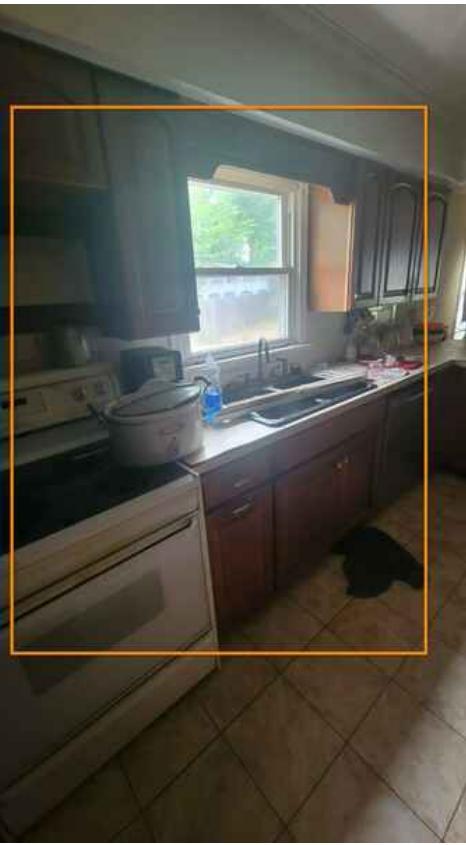
6.2.1 Counter tops & Cabinets and kitchen appliances **KITCHEN: MULTIPLE DEFECTS**

In the kitchen, various issues have been noted, such as worn or damaged appliances, the absence of a stove hood/fan/light, and indications of wear on the dishwasher. Additionally, there is no anti-tip device installed, which is crucial for preventing the stove from tipping over if someone accidentally steps on the oven door. Typical wear on the cabinets is observed. Furthermore, the sink faucets are loose. It's essential to highlight that the utilities were turned off in the home, raising the probability of encountering plumbing issues like clogs and leaks during remediation due to the property's poor condition.

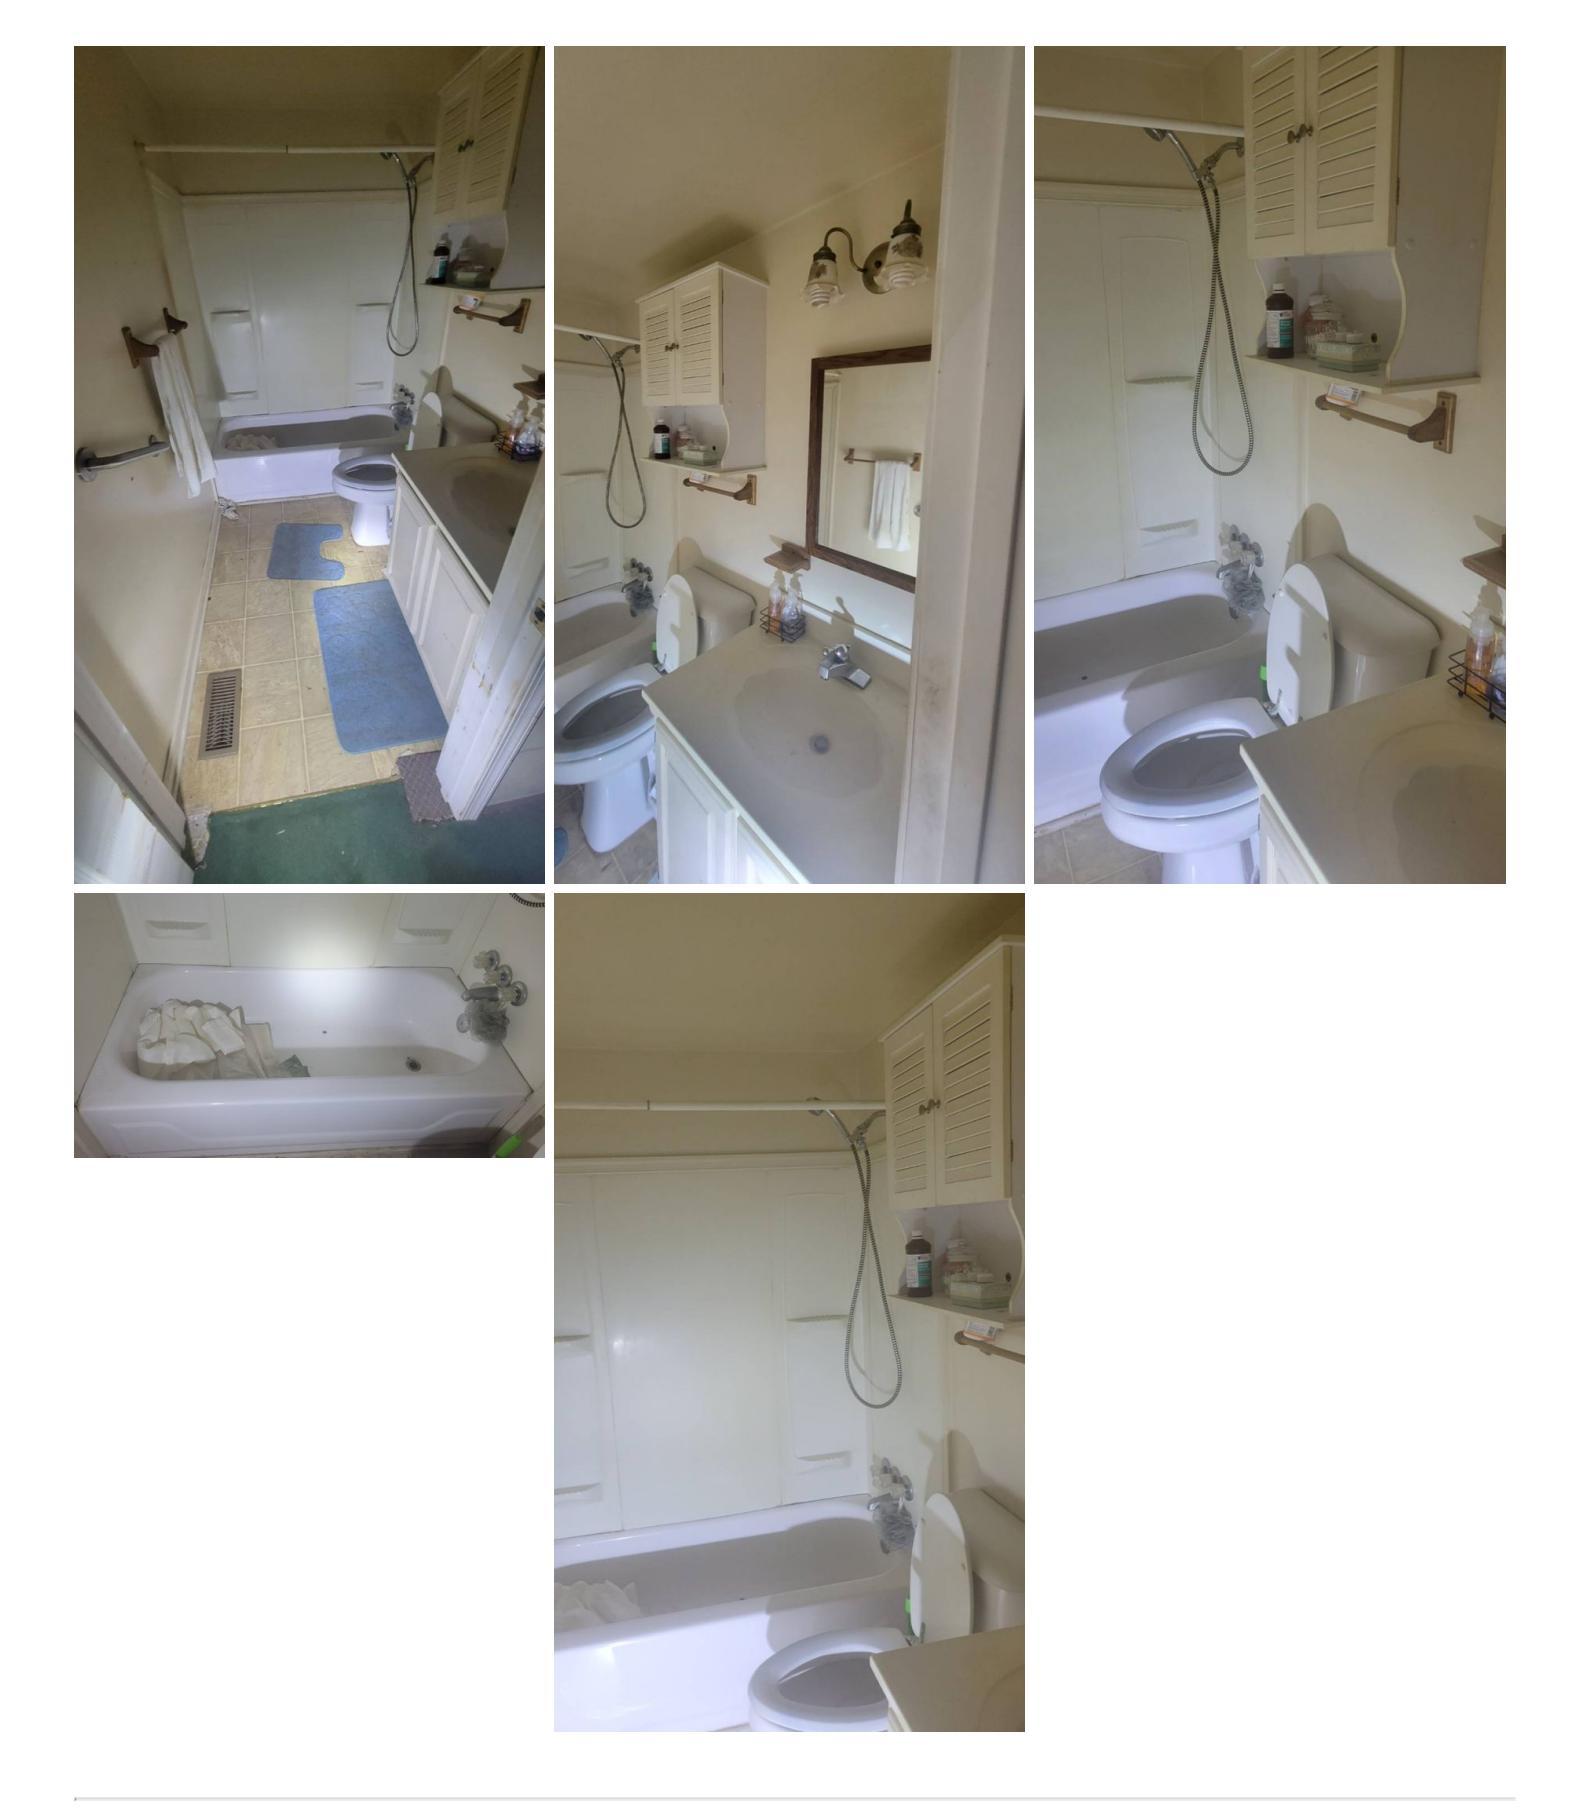
7.4.1 Bathrooms MULTIPLE DEFECTS: BATHROOM (COMMENT 1)

Multiple defects observed in the bathroom include damaged flooring, a damaged vanity, poor painting, loose or damaged sink faucets, a loose toilet base, and issues with the bathroom fan. Remediation of the bathroom is recommended. Additionally, upgrading the GFCI receptacles and light fixtures is advised. Given the property's condition, plumbing issues can be anticipated. Therefore, it is recommended to engage a plumber to evaluate, upgrade, or remediate the space.
