SAMPLE REPORT FOR TRAINING (SUMMARY/DEFECTS ONLY)

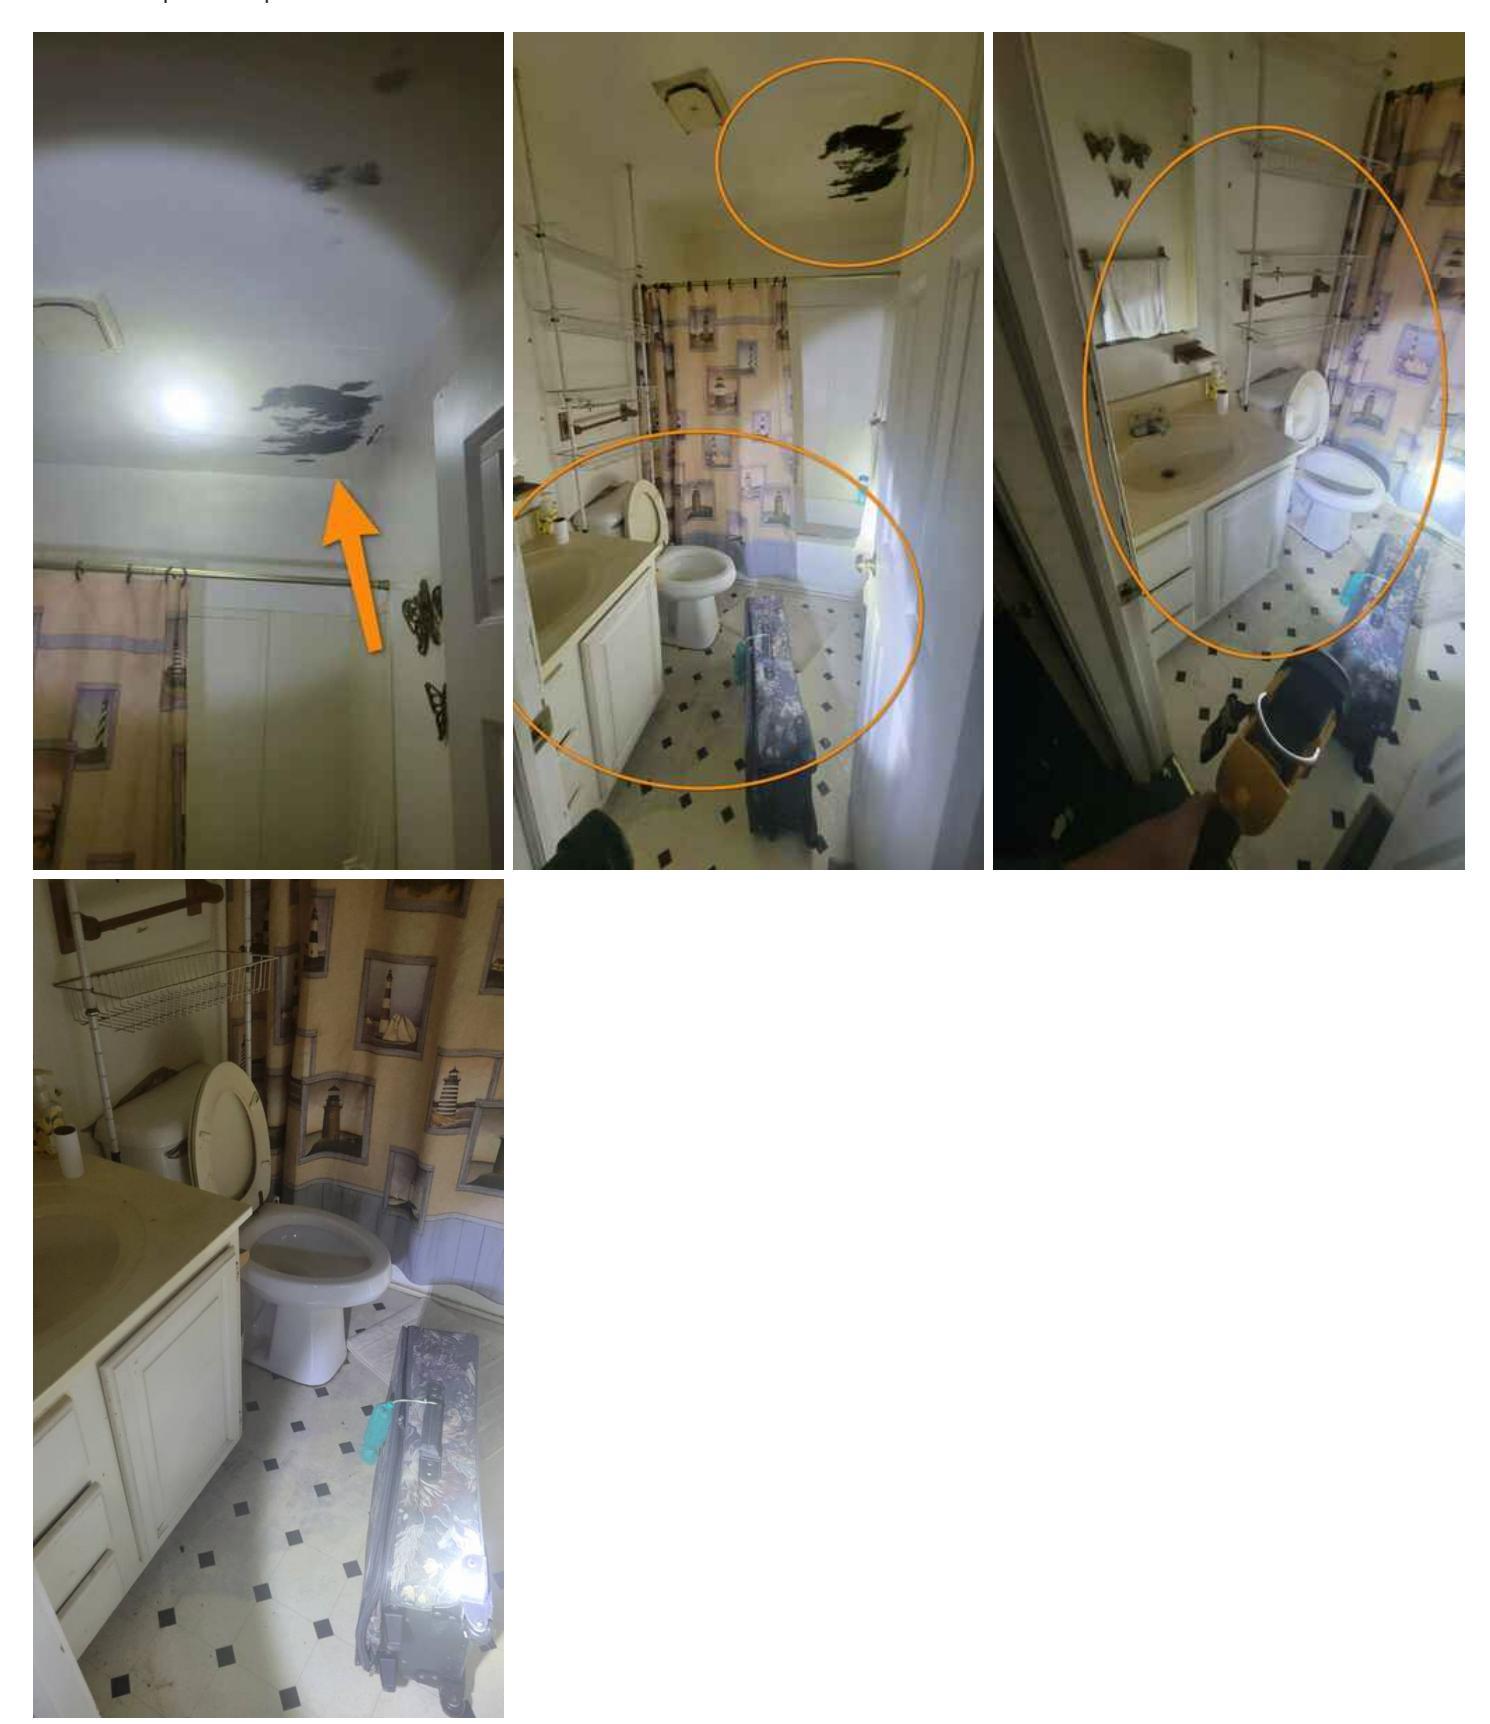
7.4.2 Bathrooms **MULTIPLE DEFECTS: BATHROOM (COMMENT 2)** BATHROOM SHARED (NEAR COLLAPSED CEILING)

Multiple defects are evident in the shared bathroom, which is adjacent to the collapsed ceiling area. Mold originating from the bedroom with the collapsed ceiling has infiltrated the bathroom ceiling and walls. Additionally, issues include a loose or damaged vanity, aged and loose toilet, loose or damaged tub and sink faucets, damaged flooring, and an aged fan with observed issues. Considering the overall condition of the property, a comprehensive remediation by a qualified contractor is strongly recommended.

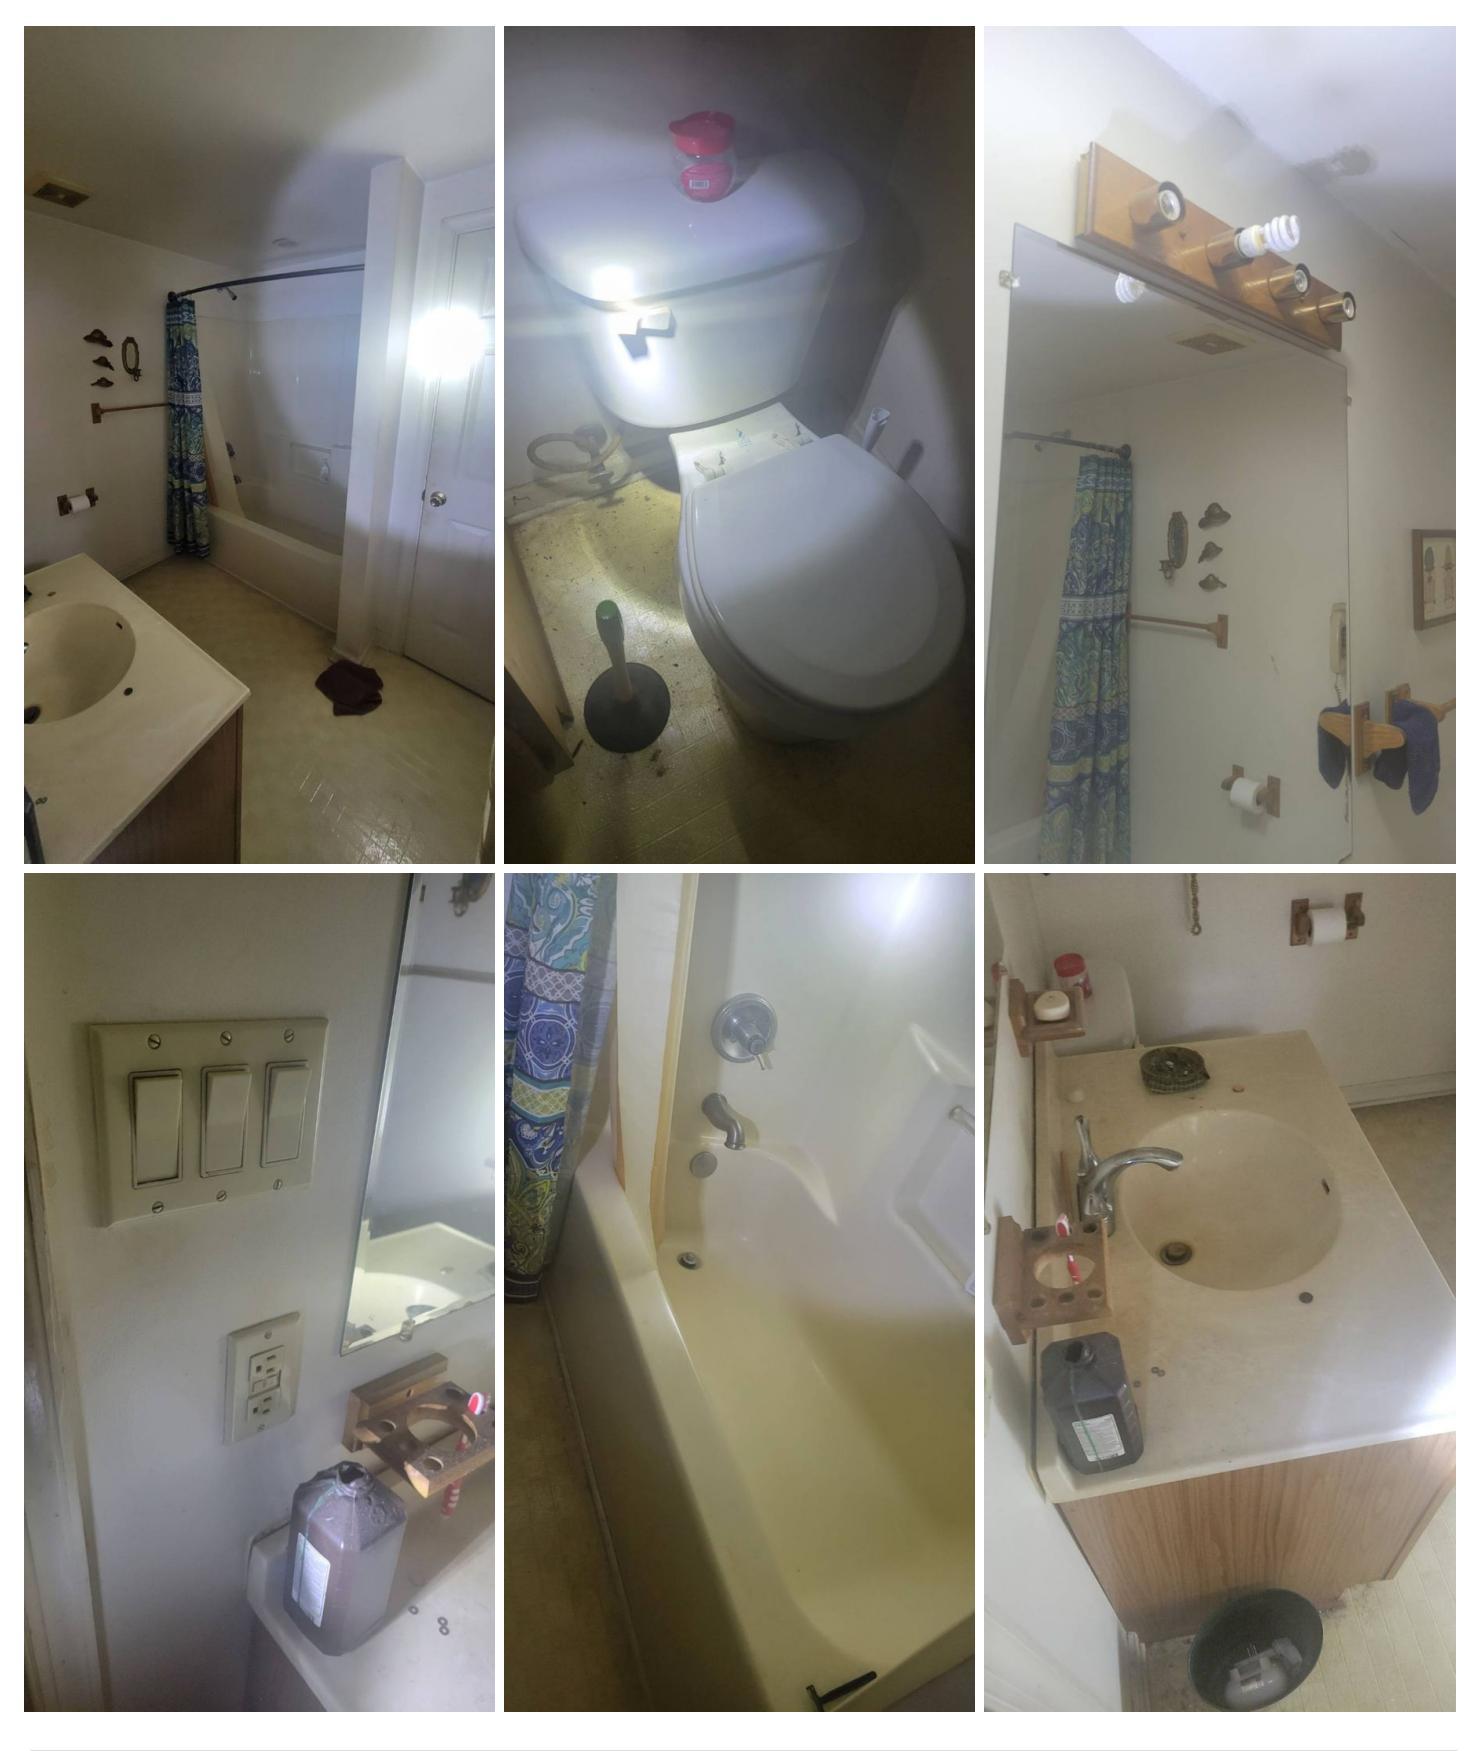
7.4.3 Bathrooms LOOSE TOILET BASE (COMMON DEFECT)

The bathroom exhibits multiple defects, including damaged flooring, a damaged vanity, subpar painting, loose or damaged sink faucets, a loose toilet base, and issues with the bathroom fan. Remediation of the bathroom is recommended. Additionally, upgrading the GFCI receptacles and light fixtures is advised. Considering the property's condition, plumbing issues are foreseeable. Therefore, engaging a plumber to evaluate, upgrade, or remediate the space is recommended.

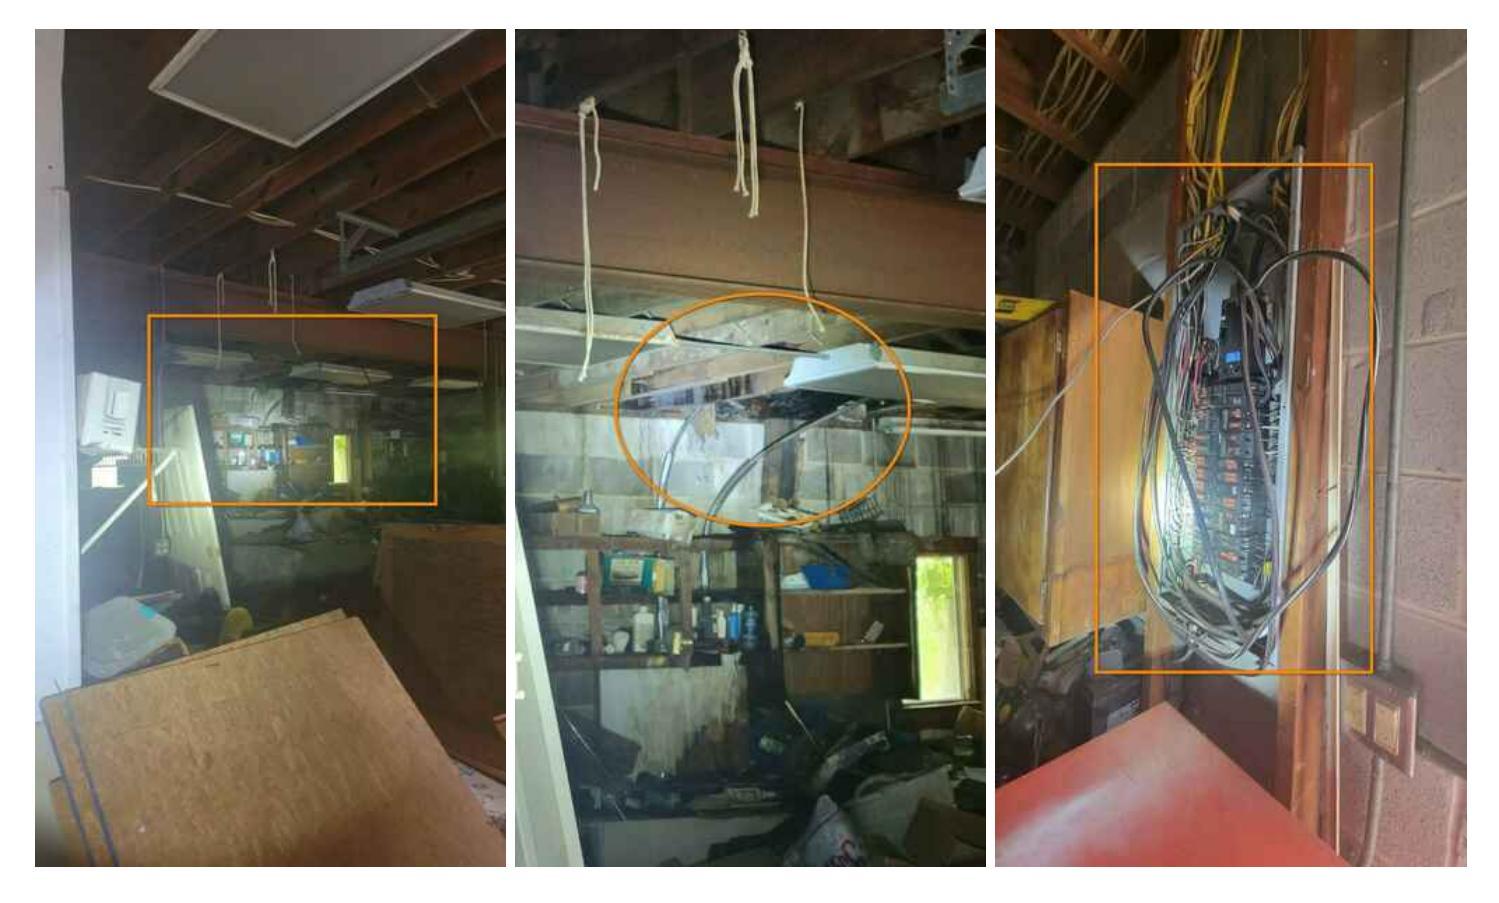
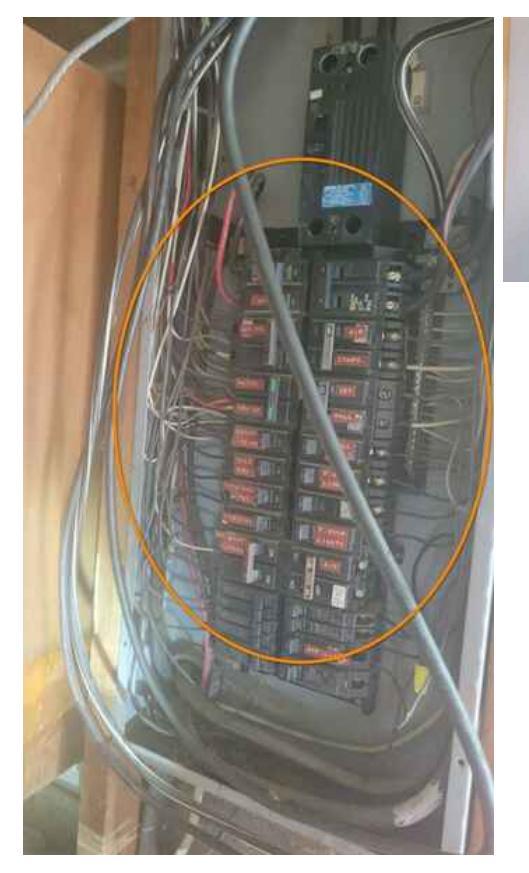
9.1.4 Ceiling, floor, walls and fire walls, garage door, windows and entrance doors **DEFECTS FOR GARAGE SIDE OF REAR BUILDING**

The presence of numerous seller items in this area limits viewing capabilities. Additionally, the area serves as storage for the water heater, which is at the end of its service life. General cosmetic defects are also evident in this space.
