SUMMARY PDF HOME
INSPECTION REPORT
FOR TRAINING
PURPOSES (DEFECTS
ONLY)

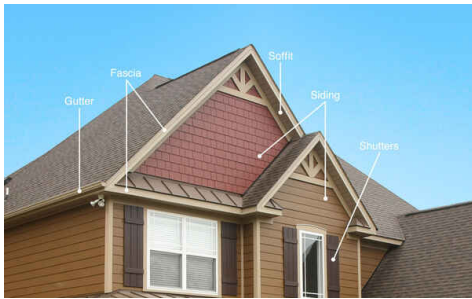
FASCIA/TRIM OR SOFFIT LOOSE OR SEPARATED (TYPICAL WEAR)

- 1. Fascia/trim or soffit loose or separated at the time of inspection. Recommend evaluation and repair by a qualified contractor.

Recommendation
Contact a qualified roofing professional.

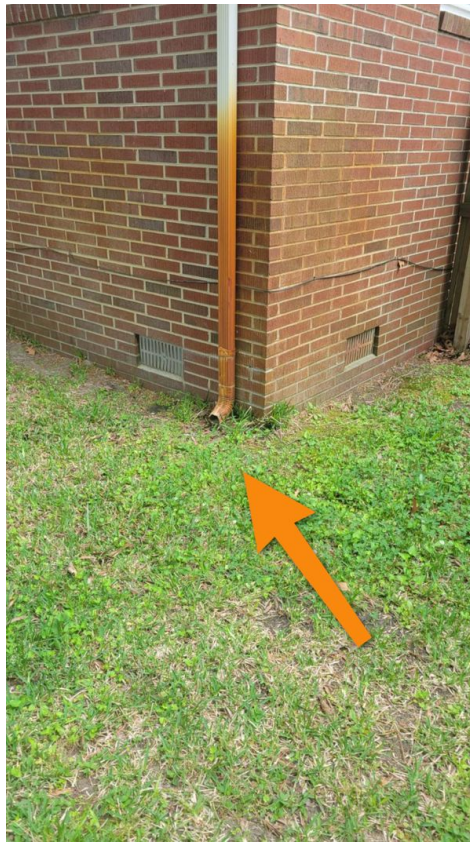
DOWN SPOUTS DRAIN NEAR HOUSE (MINOR DEFECT)

Down spouts drain near the home's foundation, this can cause water to seep near or under the home. Down spout extensions should be installed.

Contact a qualified professional.

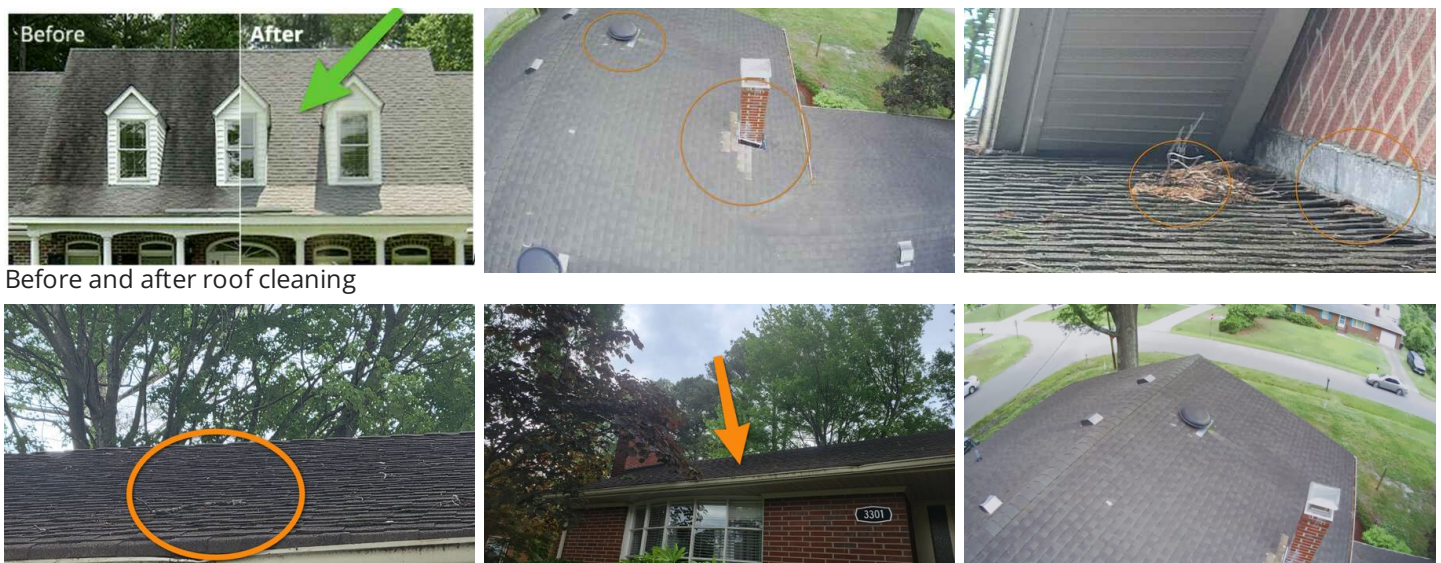
THE ROOF IS NEAR THE END OF ITS SERVICE LIFE/ROOFING EVALUATION

The roof displays discoloration, likely due to moisture, rust, or soot, requiring assessment and repair by a qualified contractor. **The roof is near the end of its service life**, worsened by overhanging trees fostering roof algae. Wear is evident around vents and sidewall flashing. Patched areas around the chimney (flue for boiler) indicate past leaks. While maintenance can extend the roof's life, planning for a full replacement is recommended for long-term structural integrity if financially viable.

Contact a qualified roofing professional.

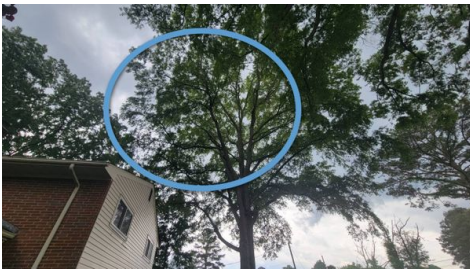
1. Tree overhang observed at the time of inspection recommend to trim trees back. Trees decrease the service life of the roof and can cause damage to the structure.
2. Debris on gutter or roof observed at the time of inspection. Recommend a qualified contractor to evaluate and remedy.

Recommendation
Contact a qualified professional.

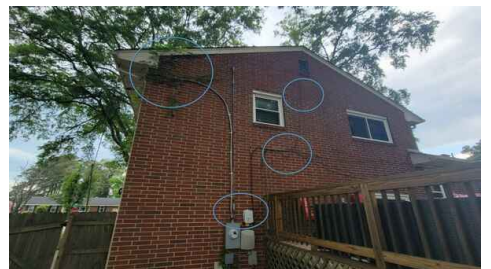
VINES ON EXTERIOR/PRESSURE WASH HOUSE/UNSIGHTLY COMMUNICATIONS WIRING OBSERVED

Vines have encroached upon the rear of the house, necessitating their removal. It is advisable to schedule a pressure washing service to restore the exterior surfaces. Additionally, the communication wiring installed around the exterior lacks proper installation, warranting evaluation and repair for optimal functionality and aesthetic appeal.

Contact a qualified professional.

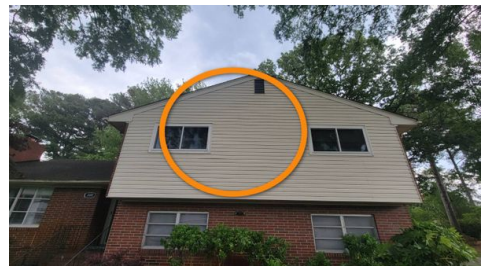
SIDING WARPING/BUCKLING/LOOSE (MINOR DEFECT)

Vinyl siding was warping/buckling or loose in one or more areas. This is often as a result of nailing siding boards too tight to the home, preventing expansion/contraction and *typical wear*. Recommend a qualified siding contractor evaluate and repair.

Contact a qualified siding specialist.

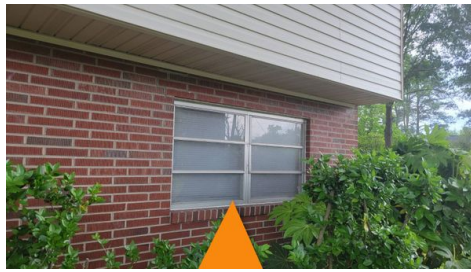
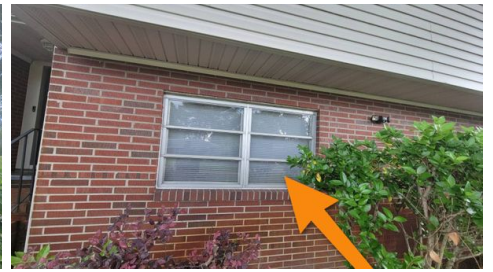
AGED WINDOWS

During the inspection, aged windows were noted. Over time, windows may lose their seal, become difficult to open or close, and decrease in efficiency. While several windows in the home have been replaced, this observation specifically concerns the three front windows adjacent to the front porch. It is advised to enlist a qualified contractor to assess and address these issues promptly. For windows with wood exterior framing, it is recommended to have these painted with exterior paint and sealed using exterior sealant in order to extend the service life of the windows.

Contact a qualified window repair/installation contractor.

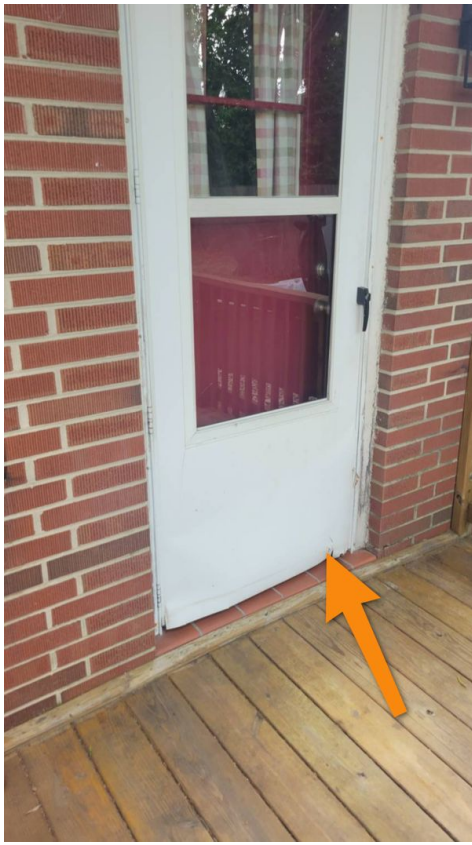
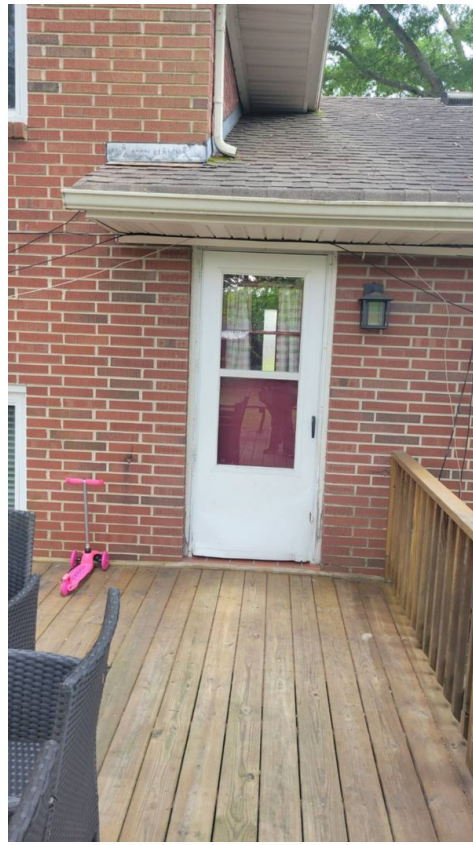
3.1.4 Siding, Flashing & Trim, exterior doors, eaves, soffit vents, windows and fascia
DAMAGED DOOR/DOOR TRIM OR DOOR SILL/LOOSE DOOR HARDWARE

One or more doors are damaged in one or more areas at the time of inspection. The door hardware is loose in multiple areas. Recommend a qualified contractor to evaluate and repair.

Contact a qualified door repair/installation contractor.

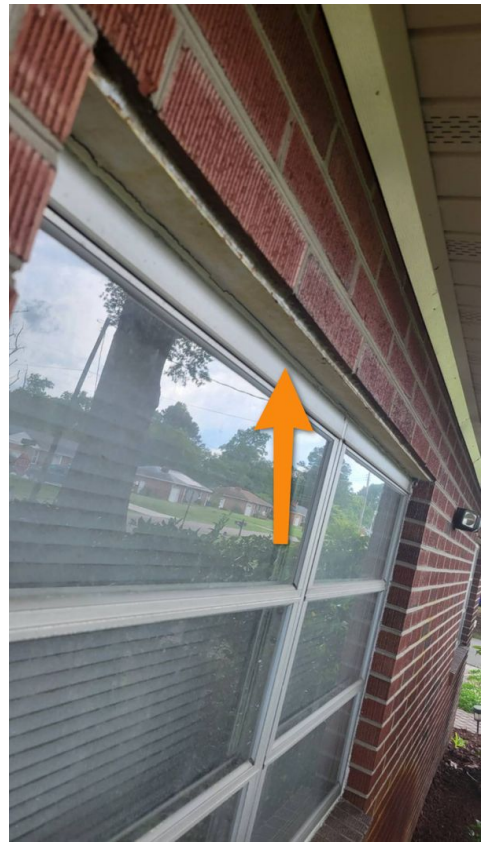
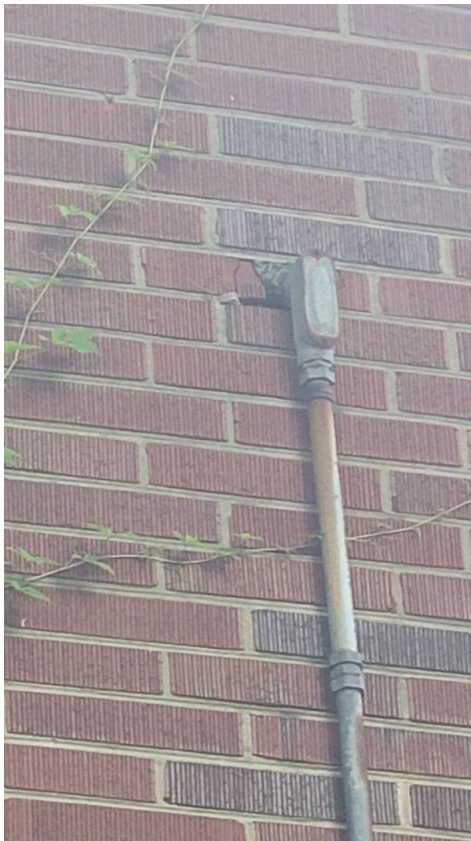
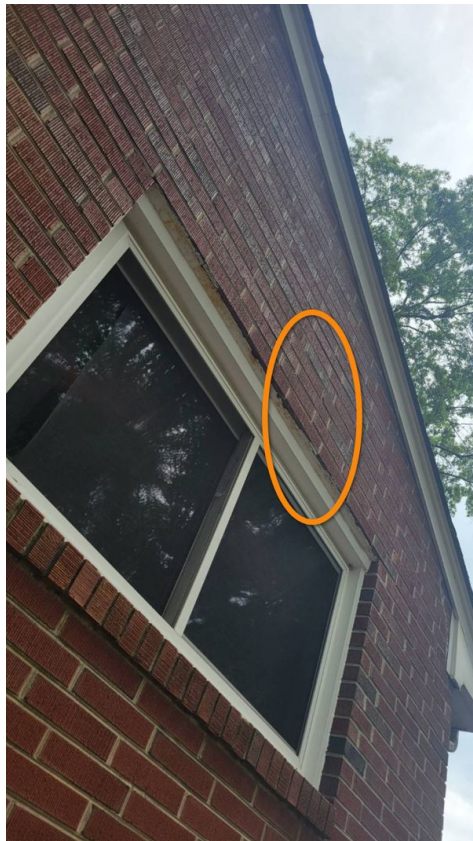
3.1.5 Siding, Flashing & Trim, exterior doors, eaves, soffit vents, windows and fascia **RUSTED LENTIL (WINDOW/DOOR OR GARAGE)**

During the inspection, a rusted window/door or garage lintel was observed. Rusted lintels have the potential to expand, exerting pressure on the surrounding structure and leading to step cracks. Typically, these are common issues found in older homes that utilized this type of lintel. To remedy this, the rusted lintel needs to be addressed promptly. This often involves removing the rust, reinforcing or replacing the affected lintel, and repairing any resulting structural damage. It is recommended to monitor any existing cracks and promptly address any signs of expansion or worsening. Additionally, seeking evaluation and repair by a qualified professional is advisable to ensure the structural integrity of the property.

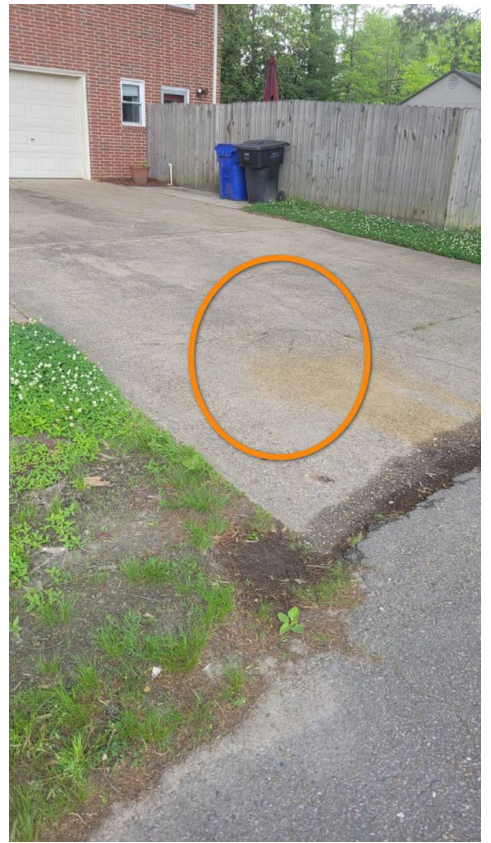
DRIVEWAY CRACKING (COMMON)

Driveway cracks observed, which may indicate movement in the soil. Recommend monitor and/or have concrete contractor patch/seal.

Contact a qualified concrete contractor.

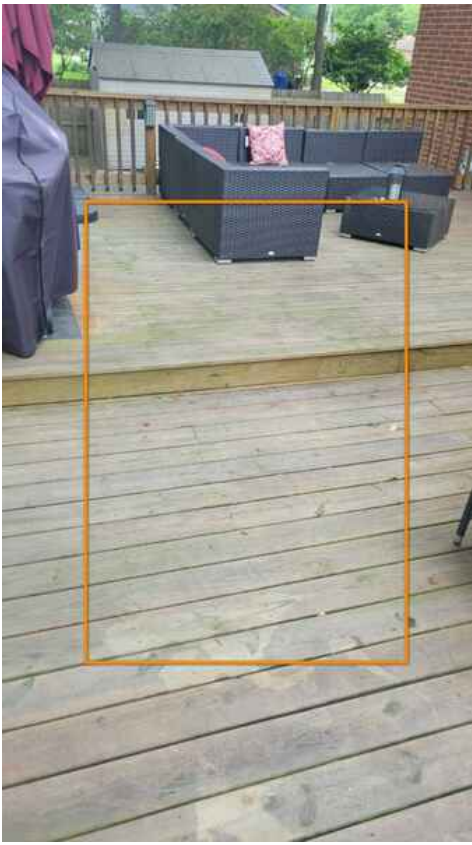
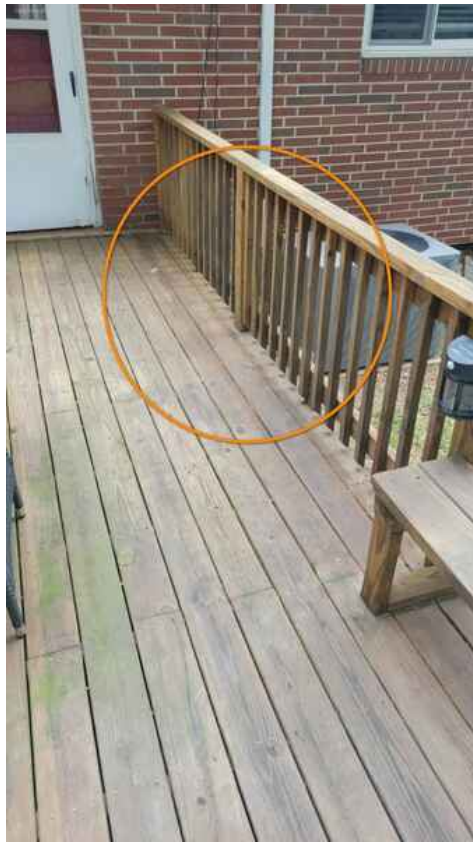
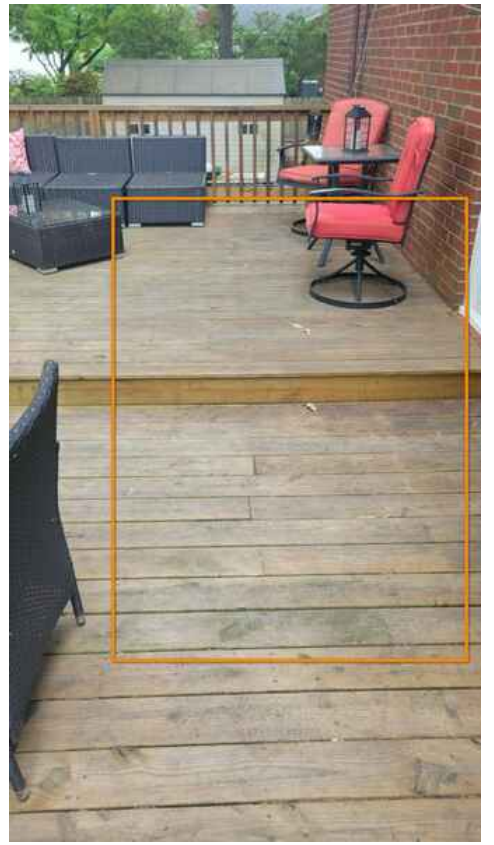
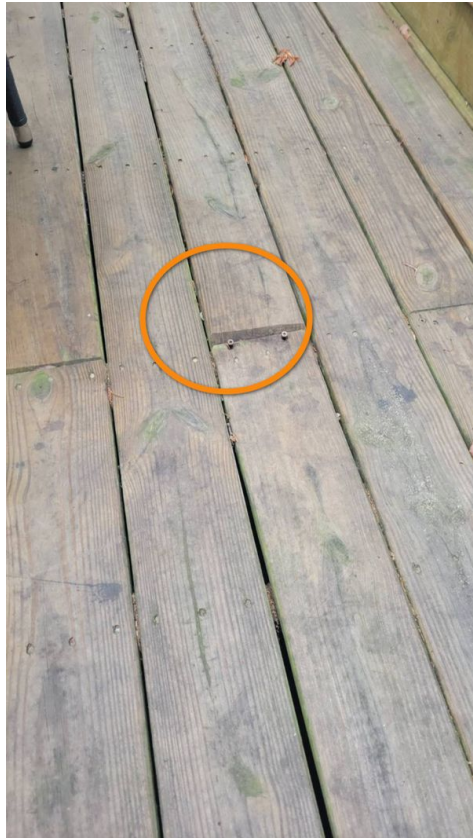
3.3.2 Decks, Balconies, Porches & Steps **MISSING HAND RAIL ON REAR DECK**

1. Missing handrail observed at the time of inspection. Recommend a qualified contractor to evaluate and repair.

Recommendation
Contact a qualified deck contractor.

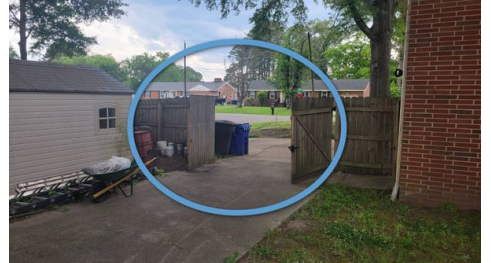
3.4.1 Exterior fence **DAMAGED FENCE/GATE ADJUSTMENT NEEDED**

The fence/gate is damaged and requires adjustment. It is recommended to engage a qualified contractor for evaluation and necessary repairs. Gate kits are available for installation to rectify any sagging issues with the gate.

Recommendation
Contact a qualified fencing contractor

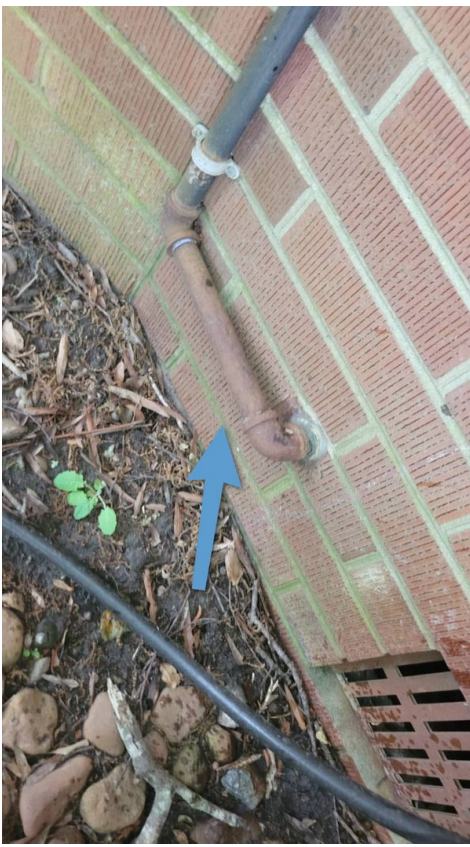
3.5.1 Gas **RUSTED GAS LINE (TYPICAL)**

Rusted gas line (typical) observed. This is an observation only. These lines can rust in the crawl space due to high humidity levels.

Recommendation
Contact your local utility company

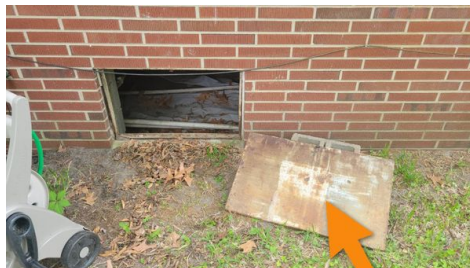
FUNGUS/MOLD LIKE SUBSTANCE (COMMON WOOD FUNGUS)

Contact a qualified professional.

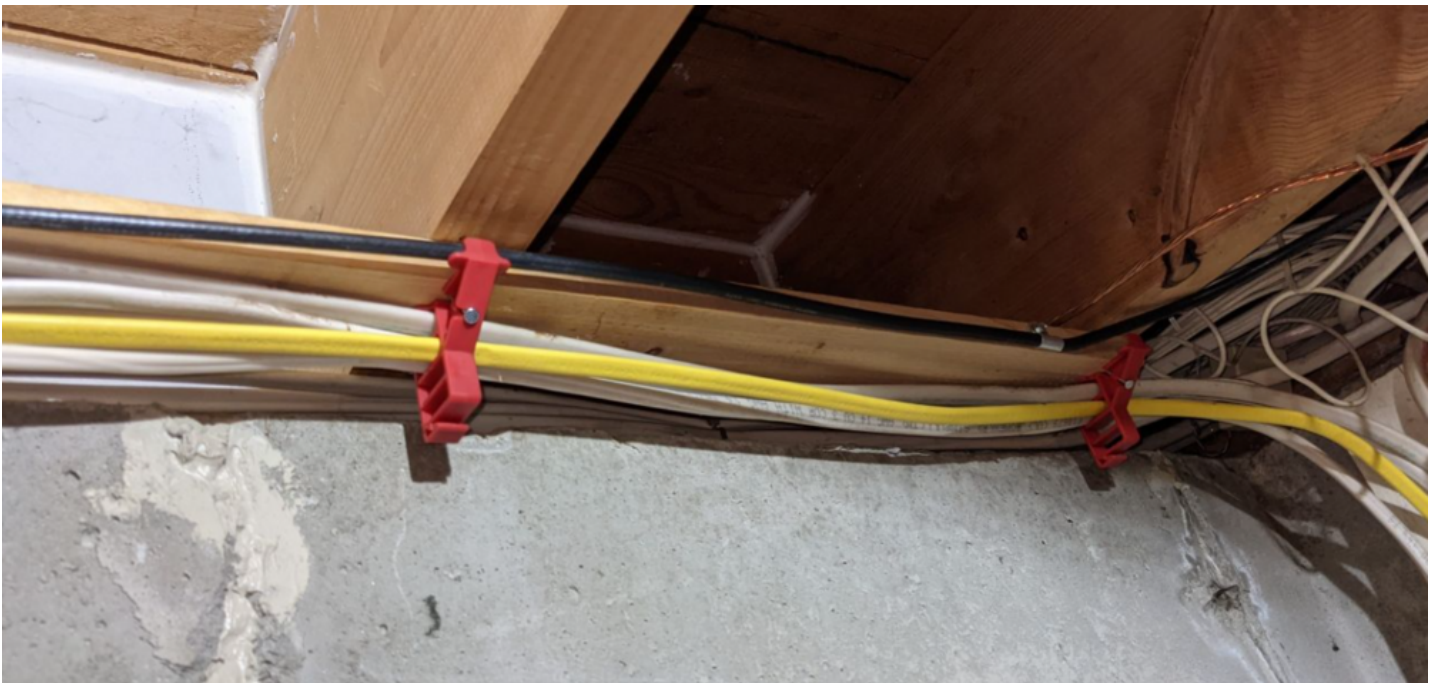
EXAMPLE ONLY: PROPERLY SECURED WIRES IN CRAWL SPACE FOR COMPARISON

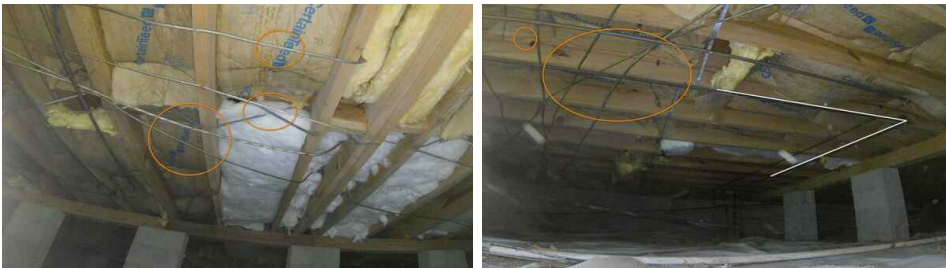
CRAWL SPACE

The presence of electrical wires atop gas lines in the crawlspace is not optimal, and furthermore, the wires are not properly secured. The layout of the home necessitated the routing of wires from the rear to the front, but they should have been grouped together and securely fastened, particularly given the older installation. It's acknowledged that older construction practices often did not adhere strictly to codes and protocols. While addressing this issue may require significant effort, it is crucial to identify and document it as a defect for future reference and corrective action.

Recommendation

Contact a qualified electrical contractor.

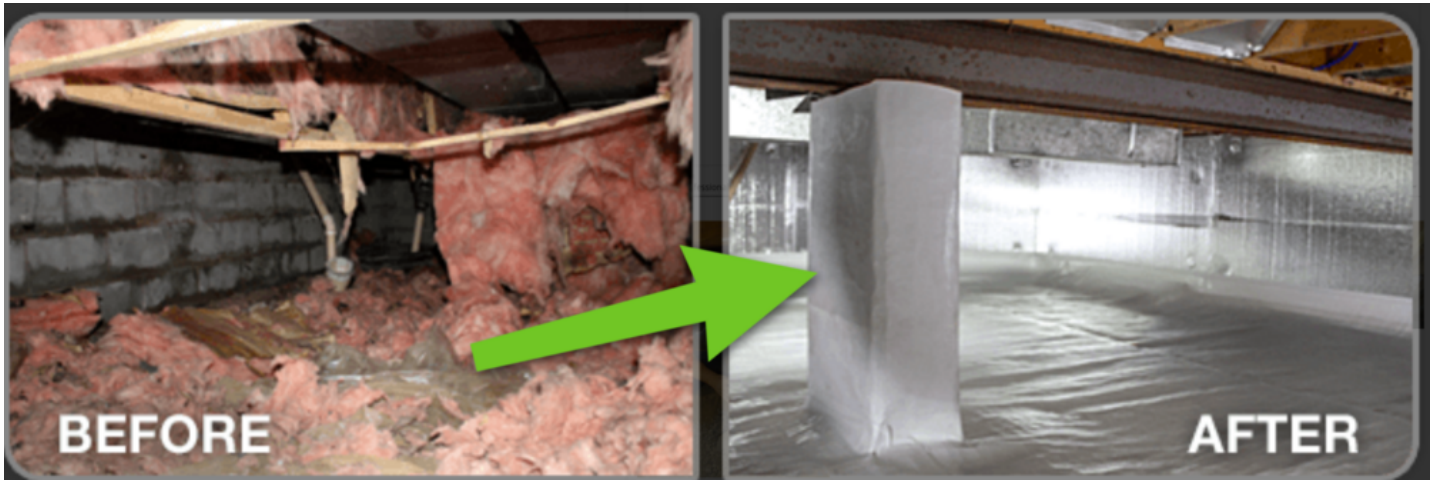
In the crawl space, there is observed hanging insulation. It appears that new insulation has been added beneath the home, likely due to the previous installation becoming displaced and damp (as moist insulation can retain moisture beneath the subfloor). The newly installed insulation appears slightly loose. However, in comparison to more severe conditions depicted in accompanying images, this issue is relatively minor. This observation is provided for documentation purposes only.

Contact a qualified professional.

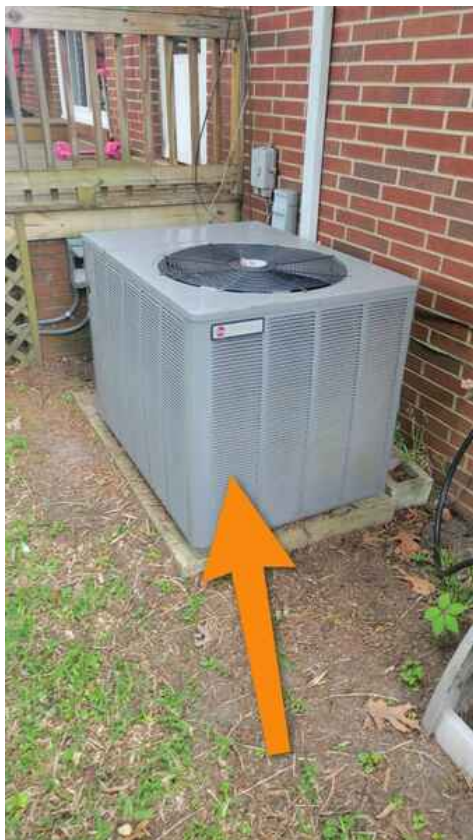
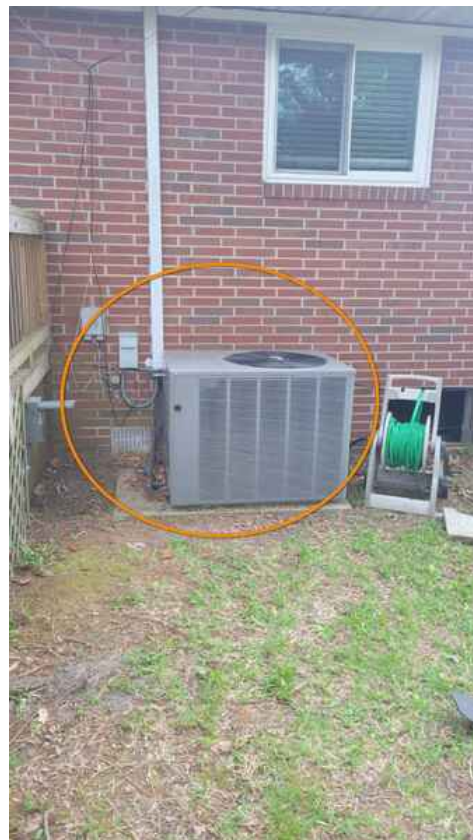
5.1.1 Heating and cooling equipment
UNITS NEAR THE END OF THEIR SERVICE LIFE (HVAC)
EXTERIOR AND INTERIOR

The condenser unit and furnace or air handler were both manufactured in 2013. In general, modern air conditioners can last between 15-20 years due to advancements in technology, whereas older models typically last around 12-15 years. However, the longevity and efficiency of your A/C system depend on several factors, including regular maintenance throughout its lifespan. Additionally, the service life of units can vary based on manufacturer specifications. Larger homes, particularly those with two or three stories, may require multiple units, with around four units being common. In earlier construction periods, undersized units were sometimes installed, especially in non-split-level systems.

It is advisable to have older units serviced by HVAC contractors as part of general maintenance, ideally on an annual basis. Considering the age of the units, it is recommended to schedule servicing and possibly explore obtaining a home warranty for added protection. It is also recommended to plan for the replacement of the units.

Contact a qualified heating and cooling contractor

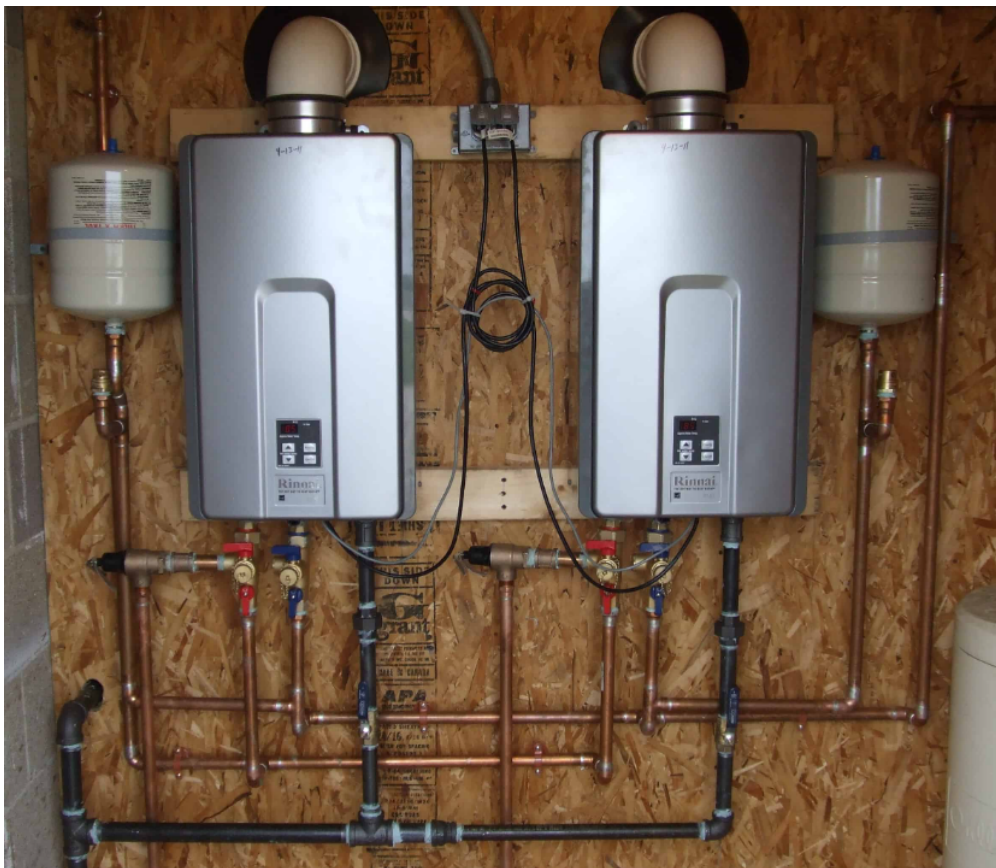
Image: There are also newer tankless boilers available. These boilers are more efficient and take up less space in the home.

EXAMPLE ONLY: TANKLESS BOILERS (NEWER MODELS)

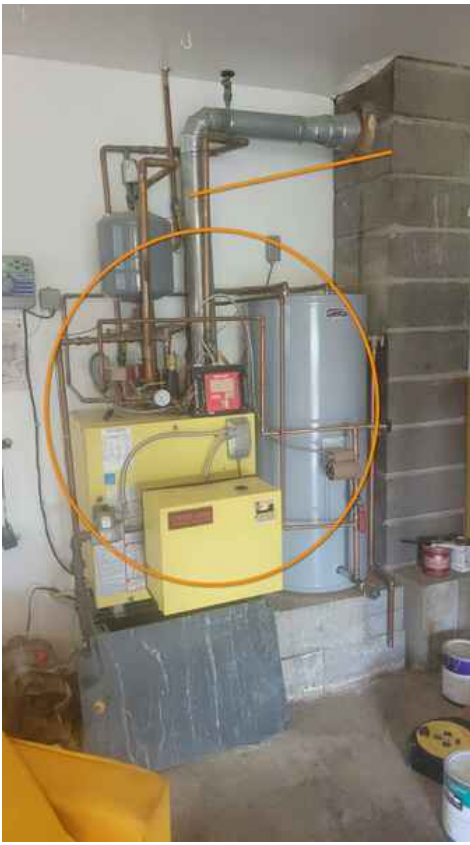
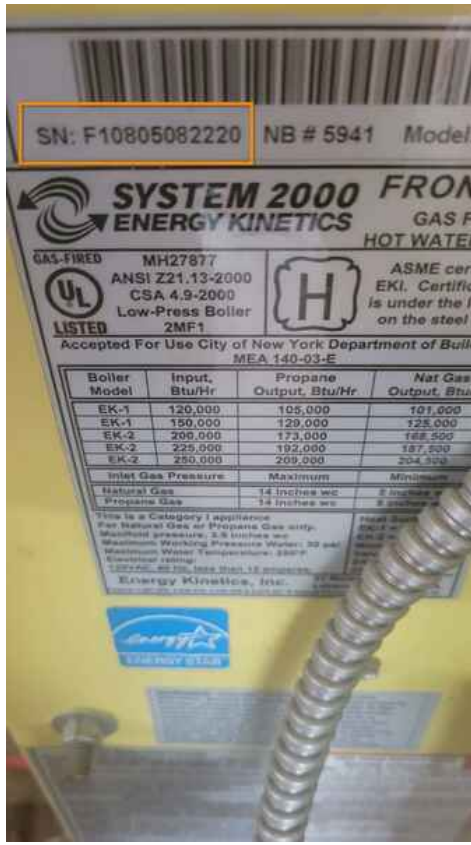
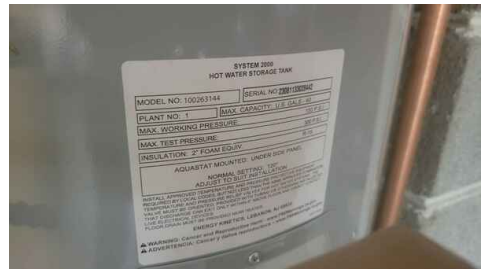
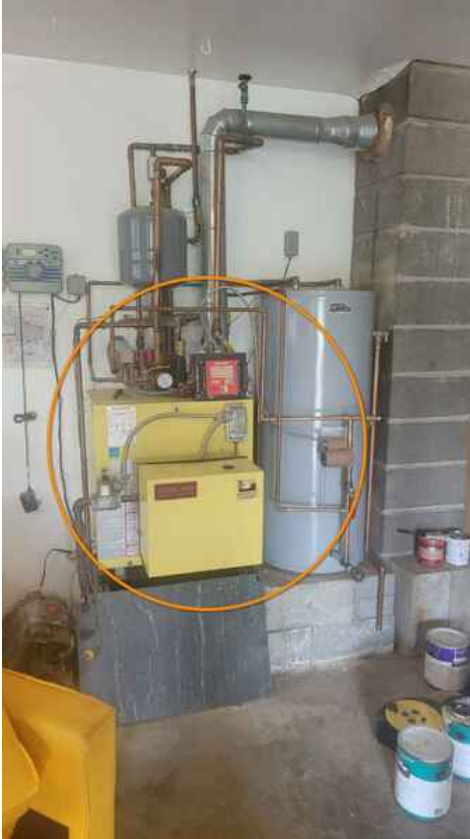
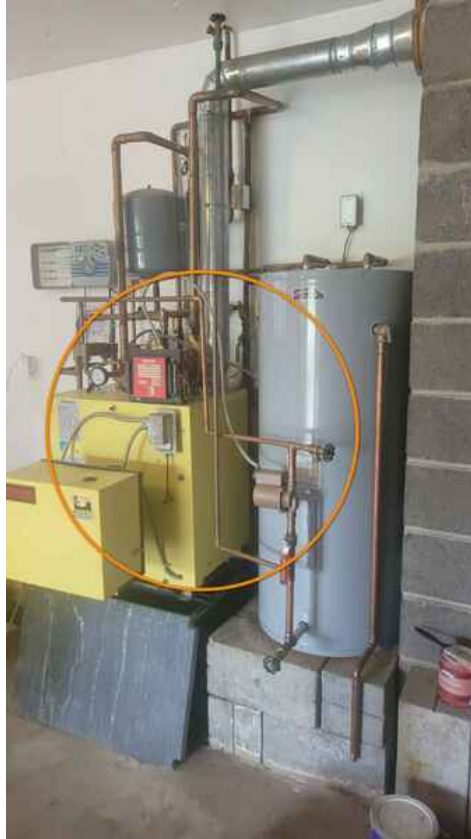
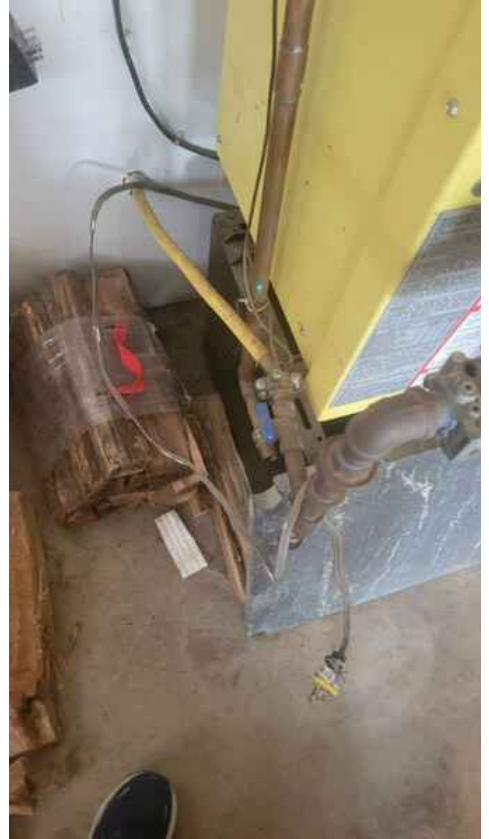
GARAGE

In the garage, there is a System 2000 Frontier boiler by Energy Kinetics, manufactured in 2008, along with a water heater of the same manufacture year. These units are interconnected to provide hot water for sinks, bathrooms, and hydronic floor vents (heat-only vents). It is recommended to have these units serviced promptly.

Recommendation
Contact a qualified heating and cooling contractor

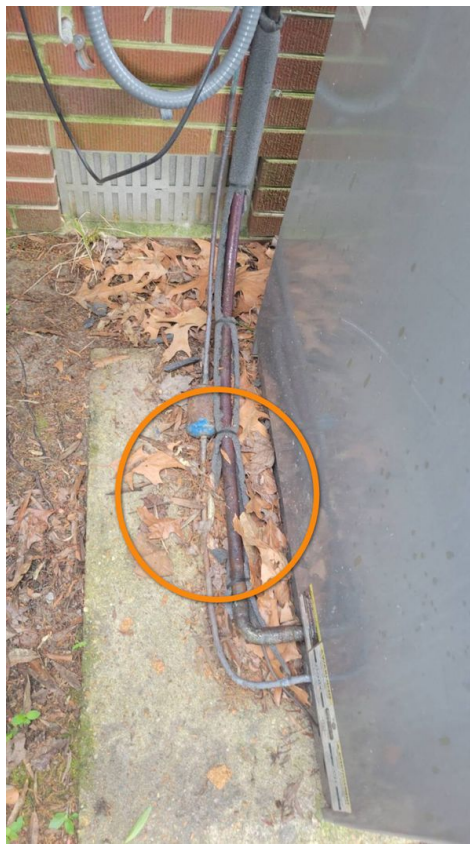
Refrigerant lines consist of two copper tubes connecting the outdoor air conditioner or heat pump to the indoor evaporator coil. The larger line usually carries cool gas and is insulated. While commonly known as the suction line, it may also be referred to as the return line or vapor line. It is recommended to maintain insulation on these lines and ensure that any penetrations are properly sealed.

Contact a qualified heating and cooling contractor

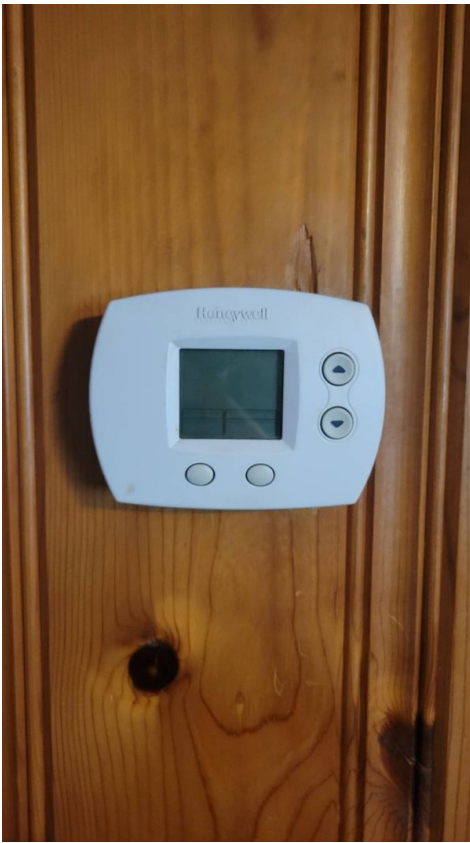
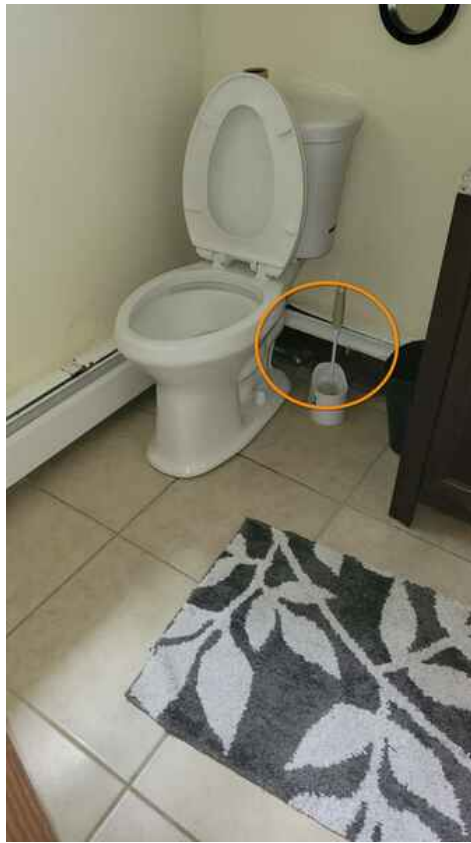
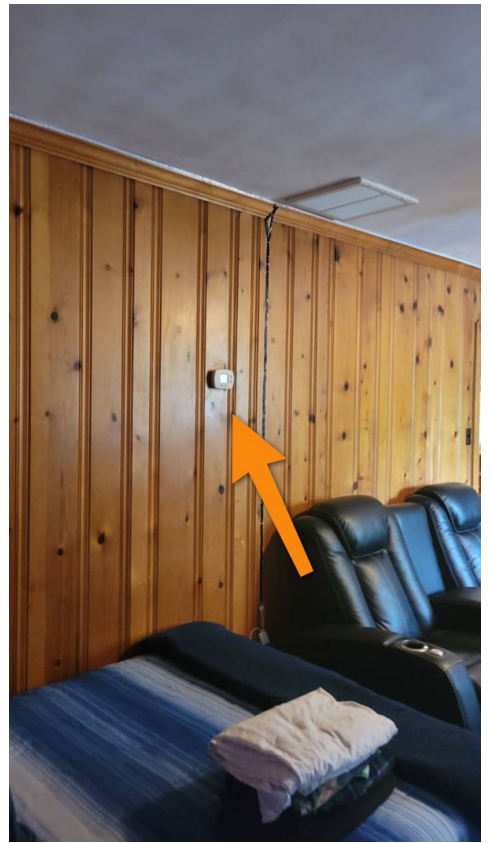
There are four thermostats in the home. It is recommended to replace the batteries in these thermostats. Additionally, consider upgrading to more modern thermostats for improved functionality and energy efficiency.

The home features heated floor vents, which are heated by the boiler. Many of these floor vents are not securely attached to the wall. It is crucial to properly secure these vents since they contain copper lines with extremely hot water flowing through them. One of the vents is damaged. It is recommended to address this issue when the boiler is serviced.

Contact a qualified heating and cooling contractor

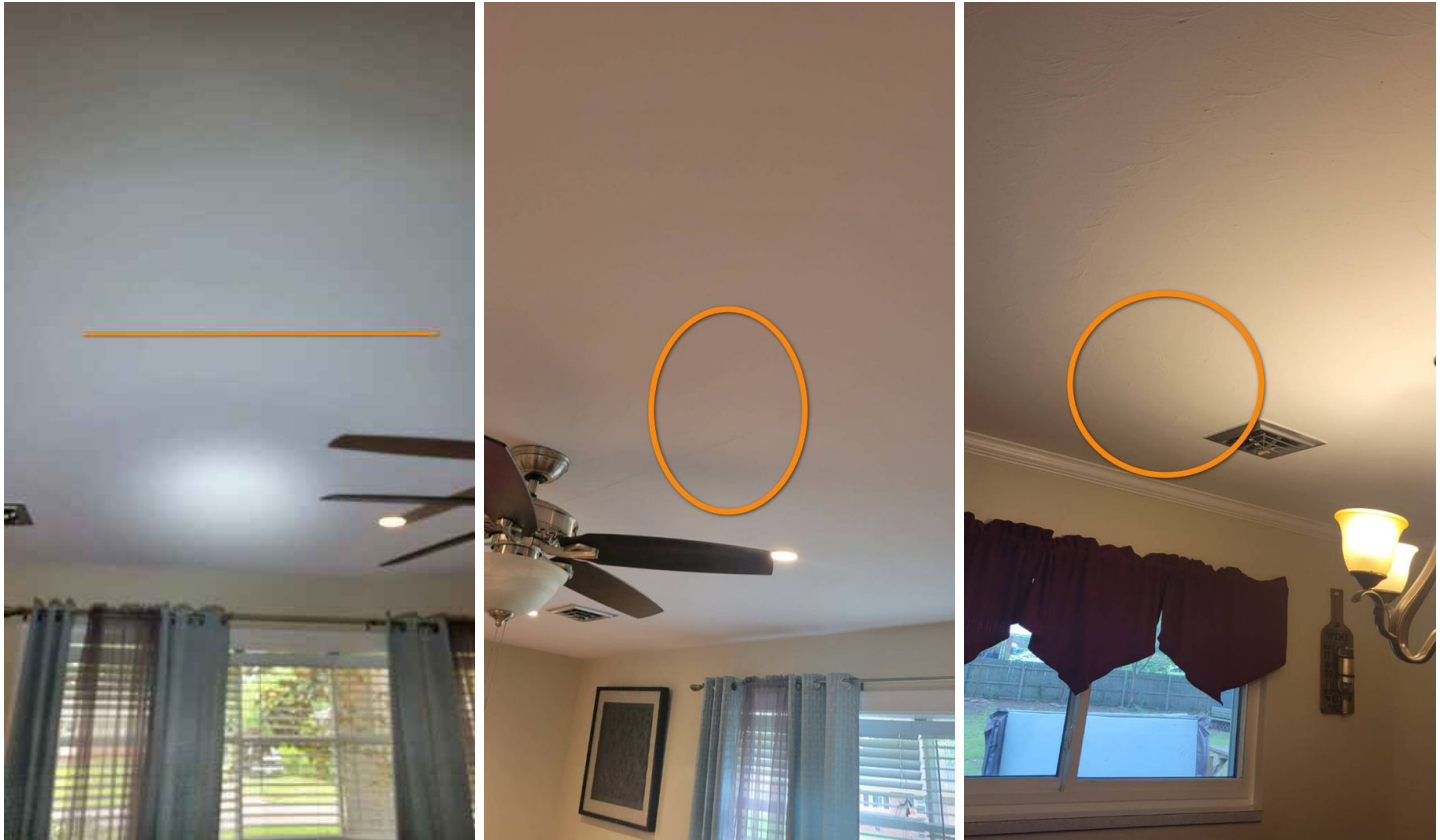
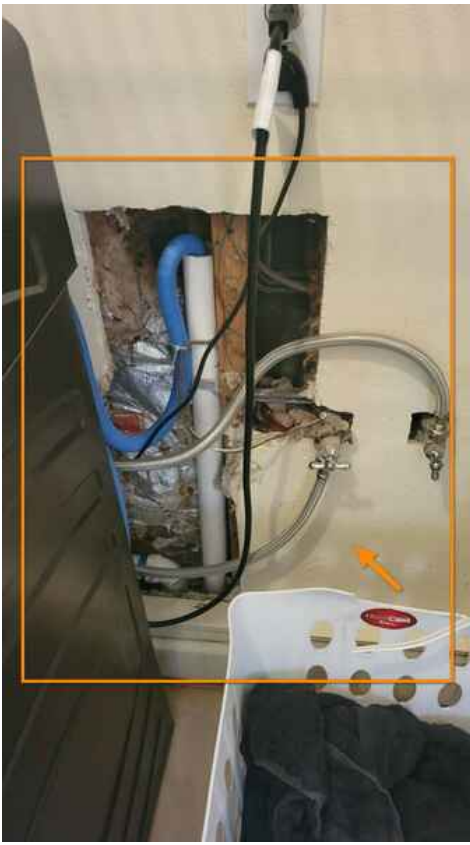
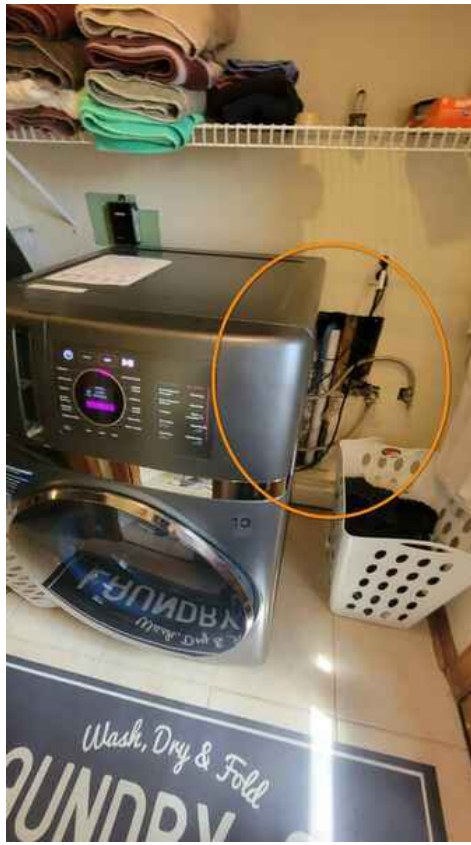
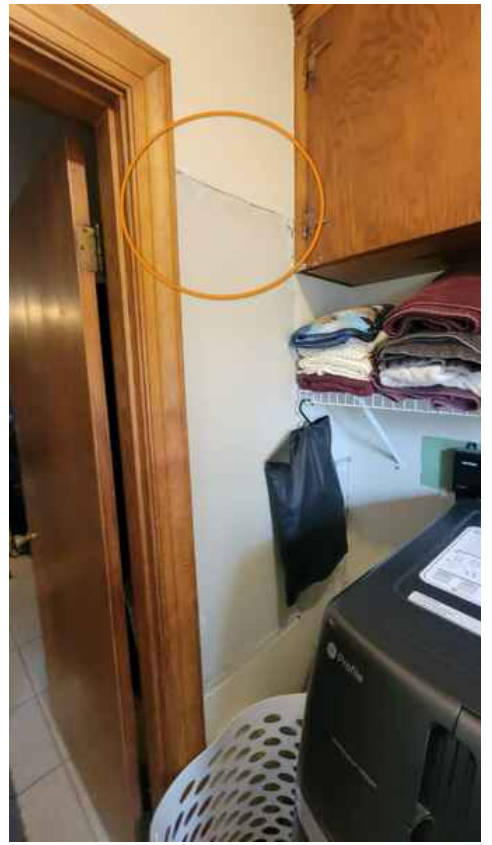
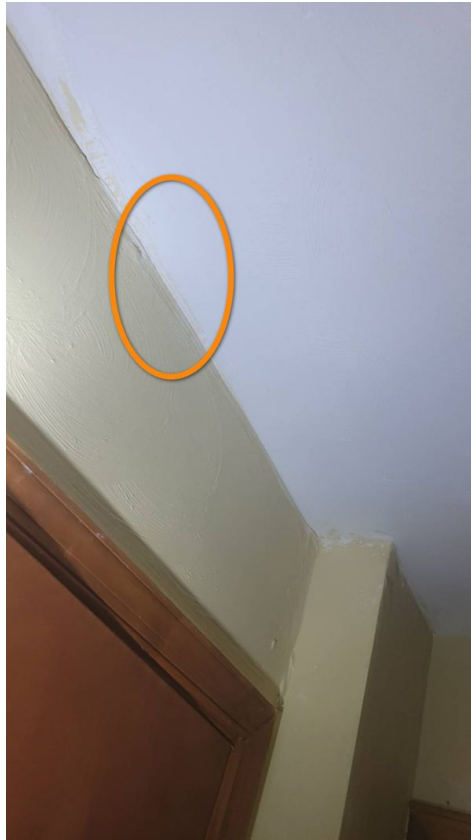
6.1.1 Interior doors, windows, floors, ceilings
TYPICAL CRACKS IN WALLS/CEILINGS AND NAIL POPS/GENERAL COSMETIC DAMAGE/SETTLEMENT CRACKS

1. Settlement cracks have been observed in the walls and/or ceilings. As a house ages, it is common for homeowners to experience some normal wear and tear, including minor settling. This may manifest as hairline cracks over doors, ceilings, and windows. Additionally, general cosmetic defects were noted during the inspection.

Recommendations include engaging a qualified contractor to evaluate and address these issues. Specifically, there are holes in the walls in one or more areas, with a notable large hole in the laundry room that remains unpatched. Furthermore, DIY painting has been done in one or more areas, indicating a need for professional intervention. It is advised to consult with both a drywall contractor and a paint contractor to assess and remediate these cosmetic defects effectively.

Recommendation
Contact a qualified professional.

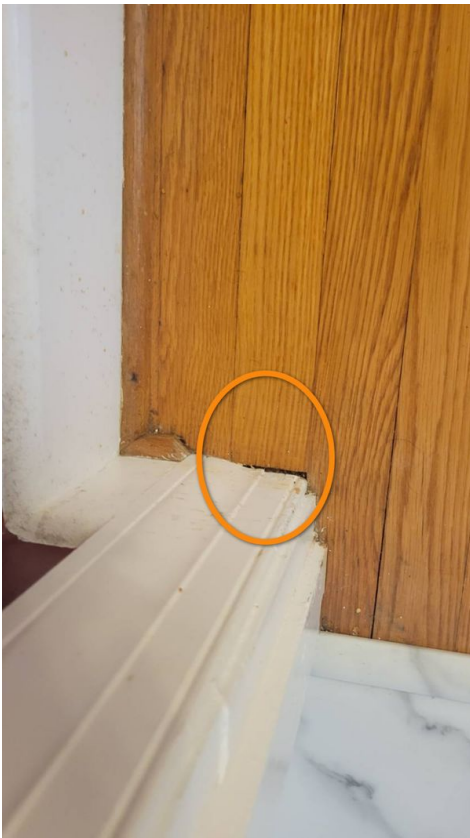
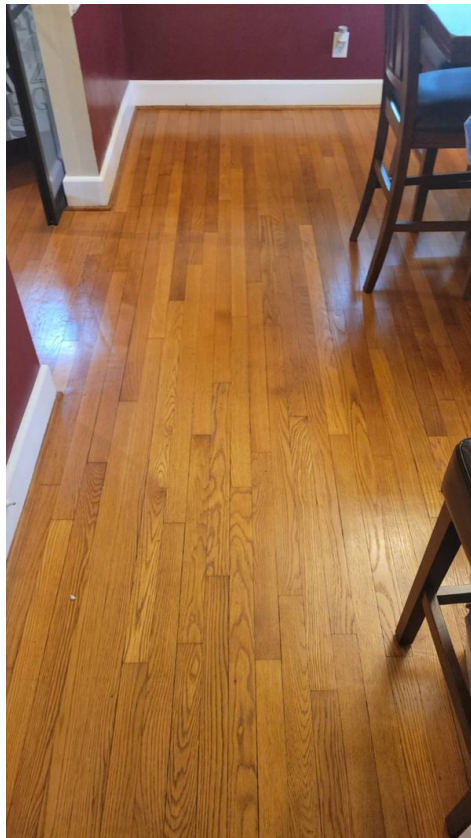
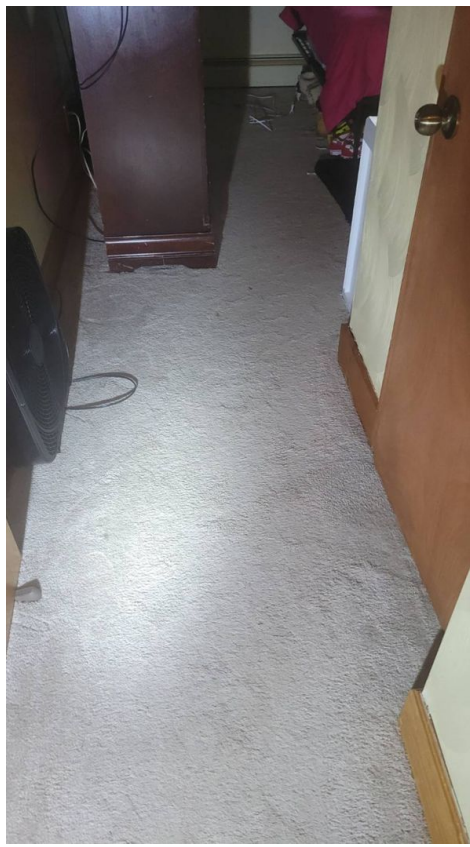
Floor gaps and worn carpet are present in one or more areas, which is common given the age of the home. The hardwood floors have undergone sanding and staining.

Contact a qualified flooring contractor

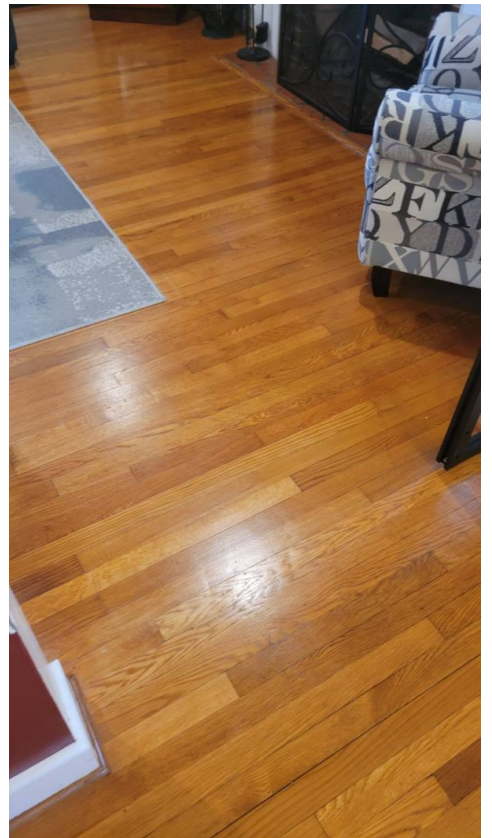
WORN FLOORS/CARPET (TYPICAL)

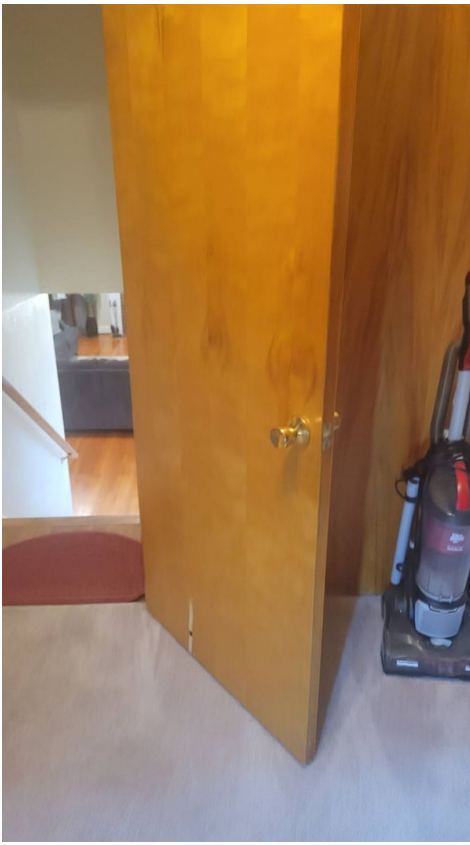
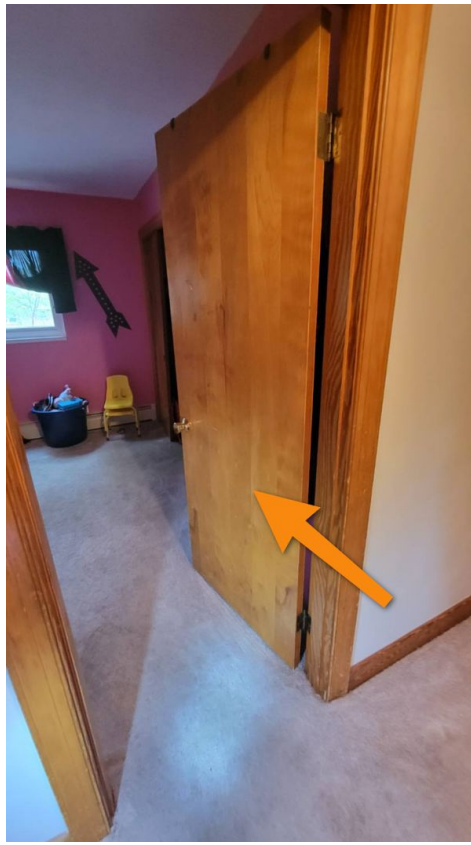
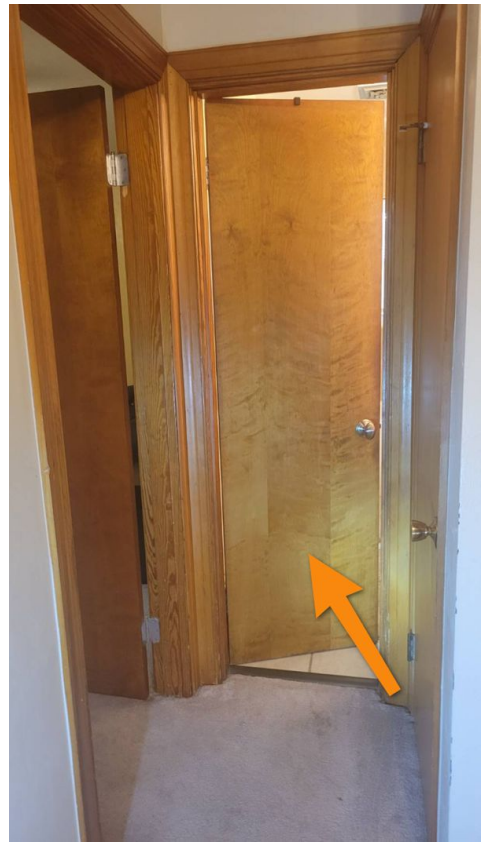
Several doors throughout the home display signs of wear and damage. Among them, some doors are sticking, while others have loose hardware. Additionally, there are instances where doors are missing altogether. Multiple doors do not have locks and have door hinges that do not match. It is recommended to have these issues evaluated and repaired promptly.

Contact a qualified door repair/installation contractor.
