SUMMARY PDF HOME
INSPECTION REPORT
FOR TRAINING
PURPOSES (DEFECTS
ONLY)

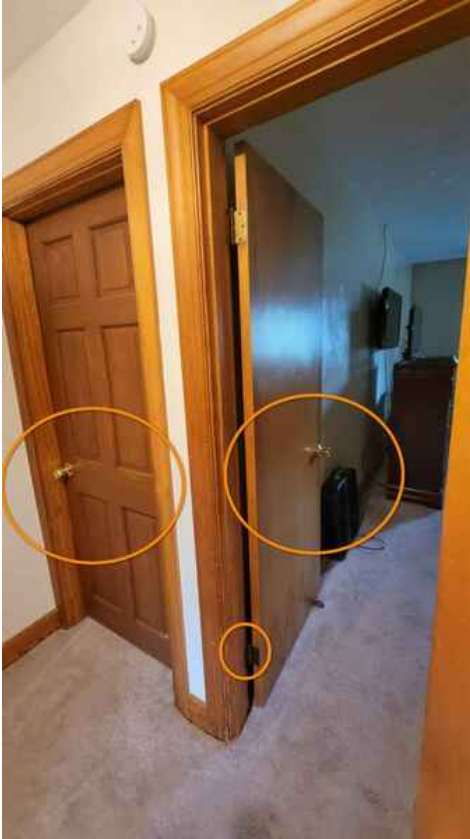
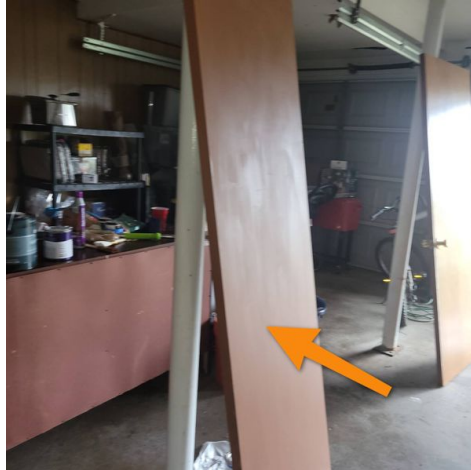
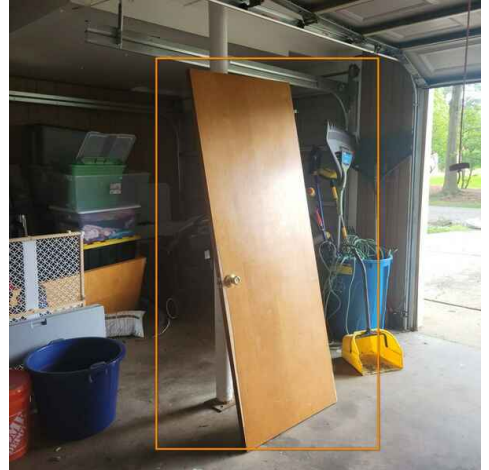
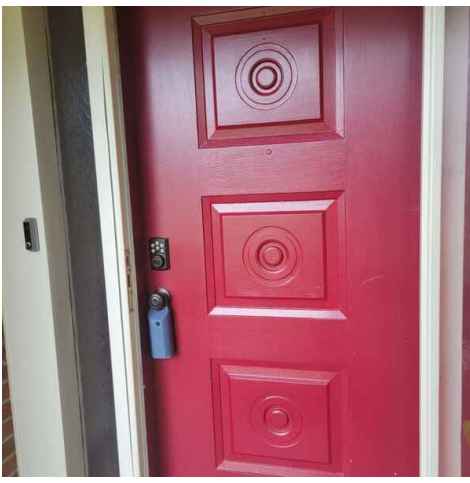
DOOR AND DOOR HARDWARE ISSUE

Contact a qualified door repair/installation contractor.

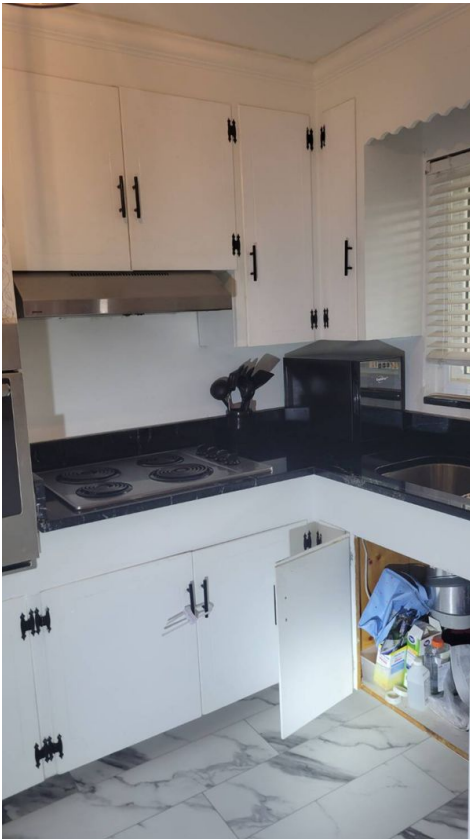
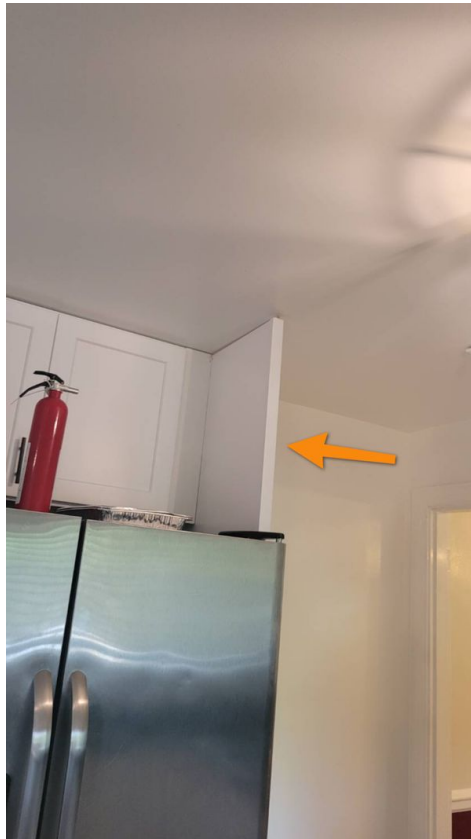
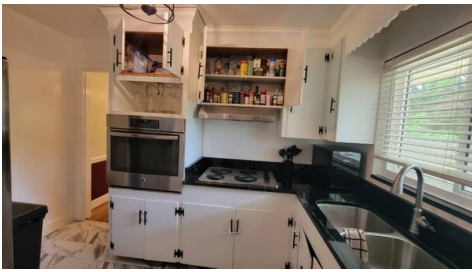
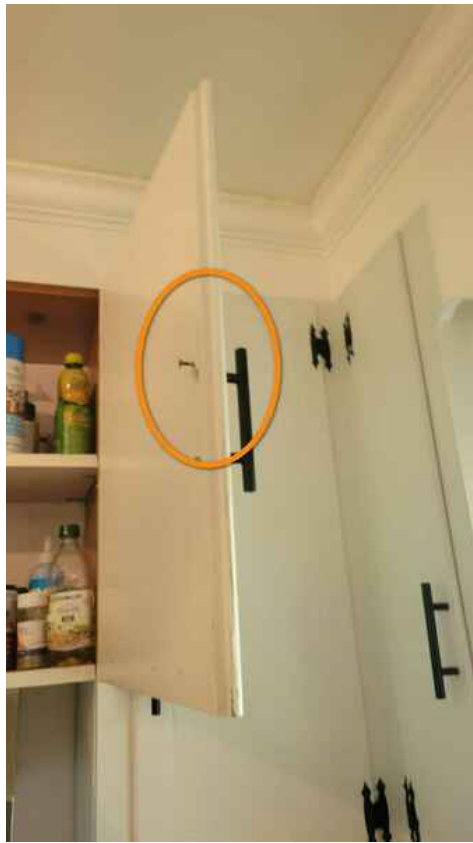
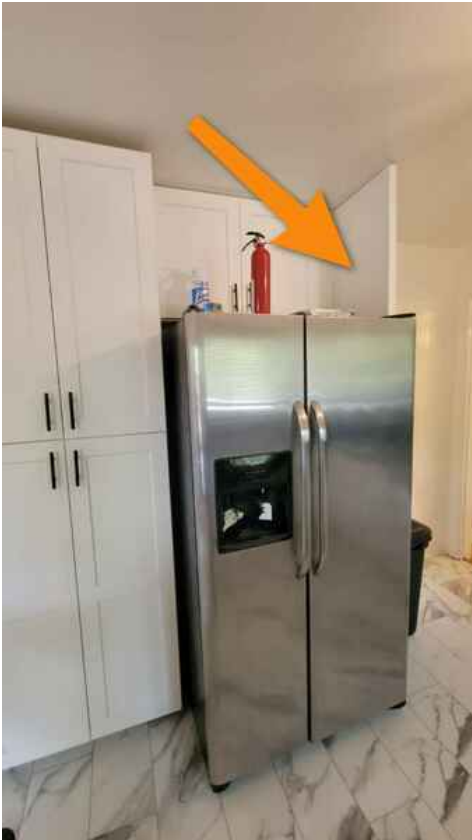
KITCHEN CABINET EVALUATION

Contact a qualified cabinet contractor.

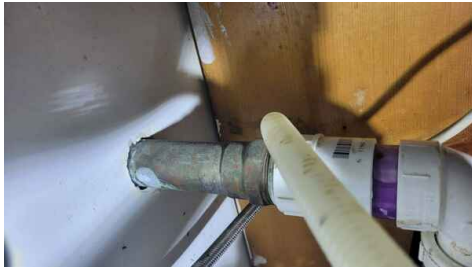
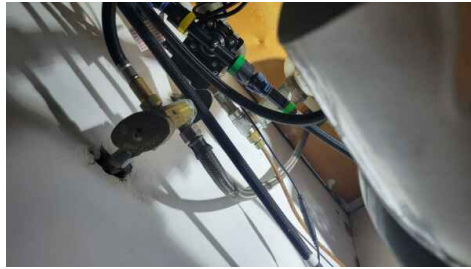
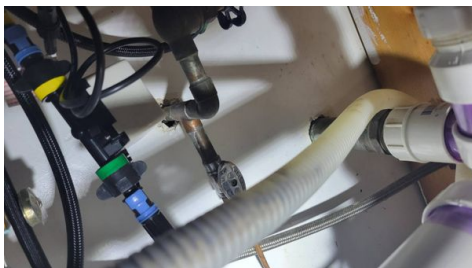
Oxidation on plumbing lines observed at the time of inspection. Recommend a qualified contractor to evaluate and remedy.

Contact a qualified plumbing contractor.

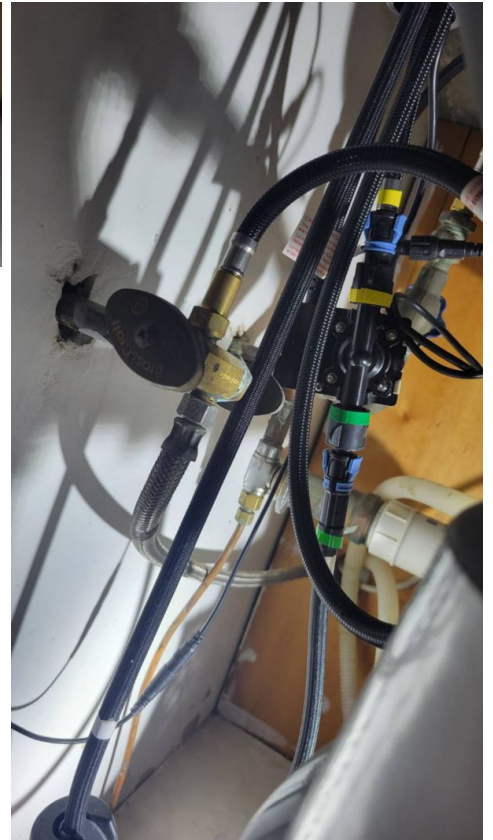
7.2.1 Water Supply, Distribution Systems, Fixtures, Drain, waste and vent systems
OXIDATION ON COPPER LINES
MULTIPLE

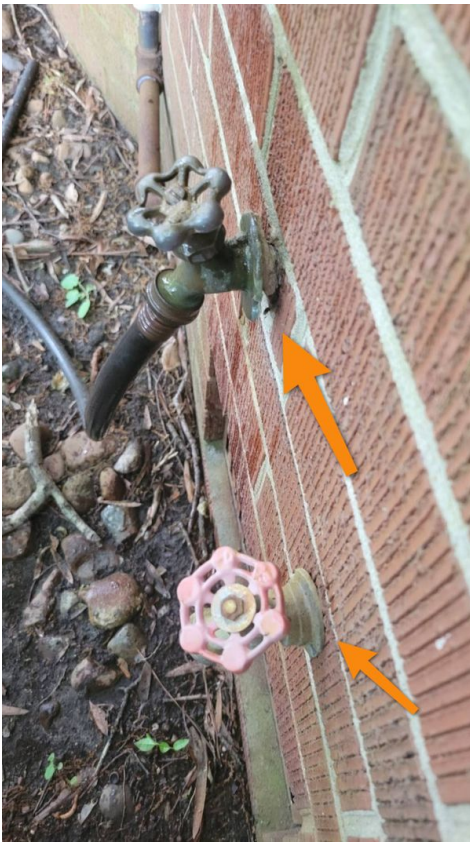
LOOSE HOSE BIB/HOSE BIBS NOT TURNED ON

Loose hose bibs were noted during the inspection. It is recommended to have a qualified contractor assess and repair them.

Contact a qualified plumbing contractor.

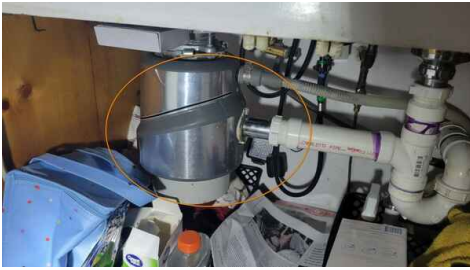
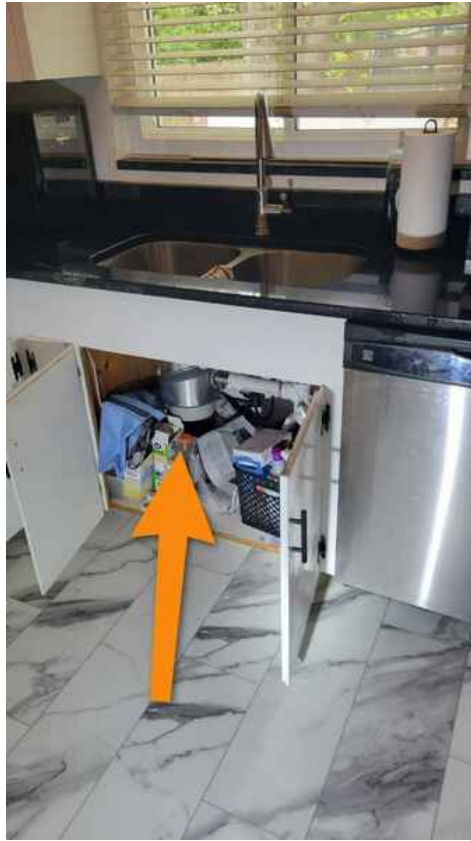
SERVICE GARBAGE DISPOSAL

Contact a qualified professional.

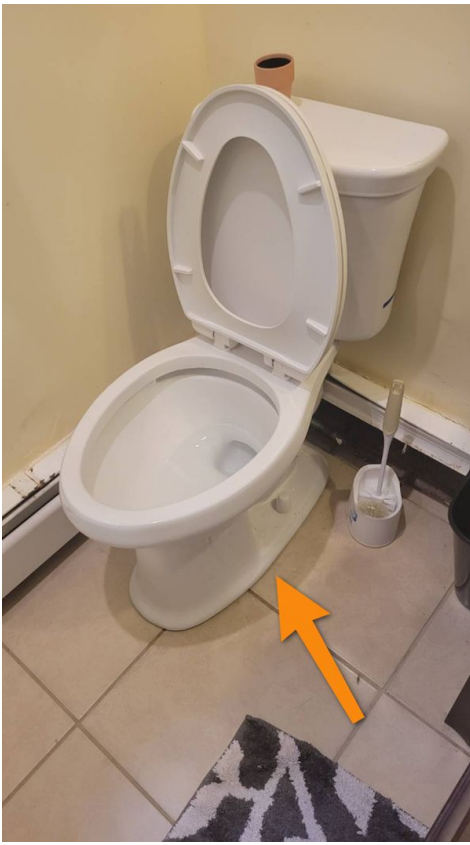
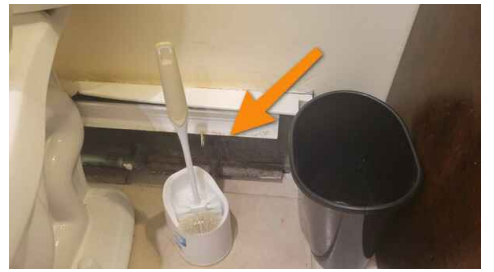
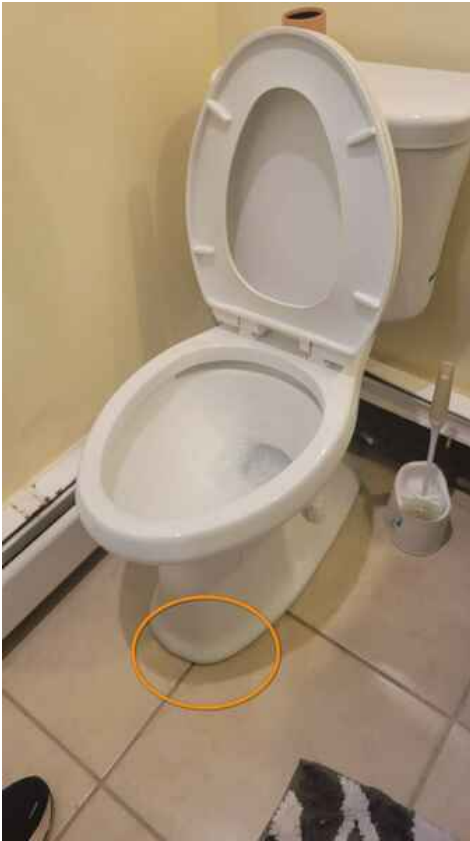
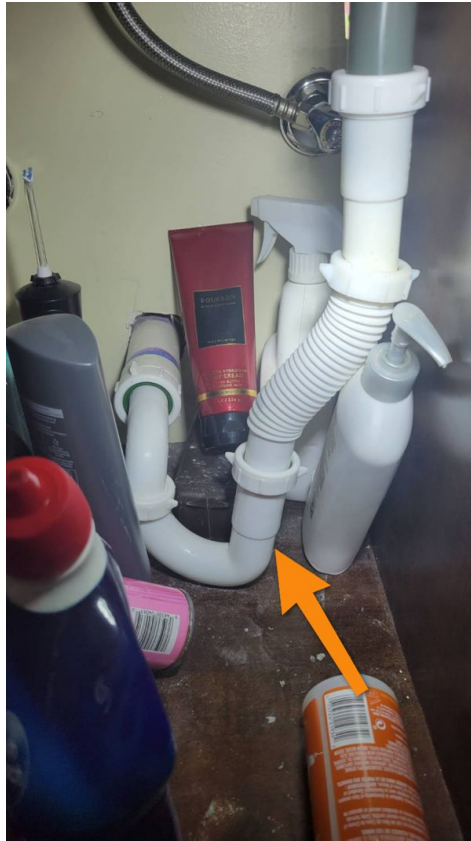
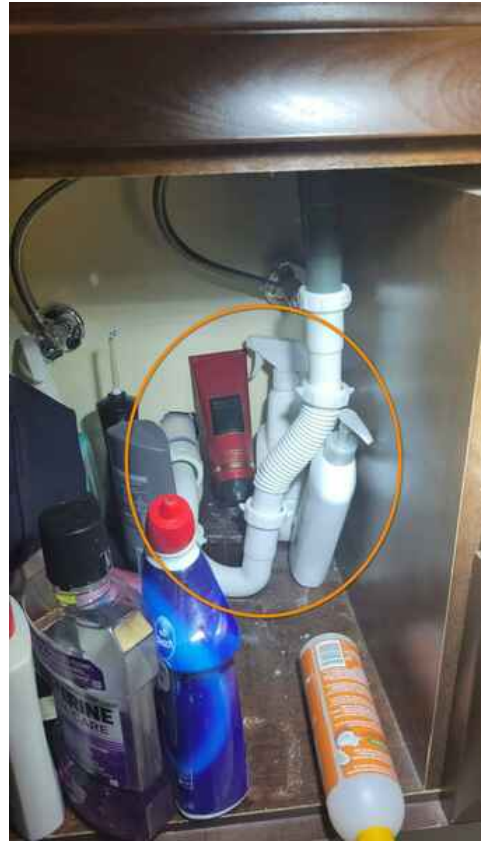
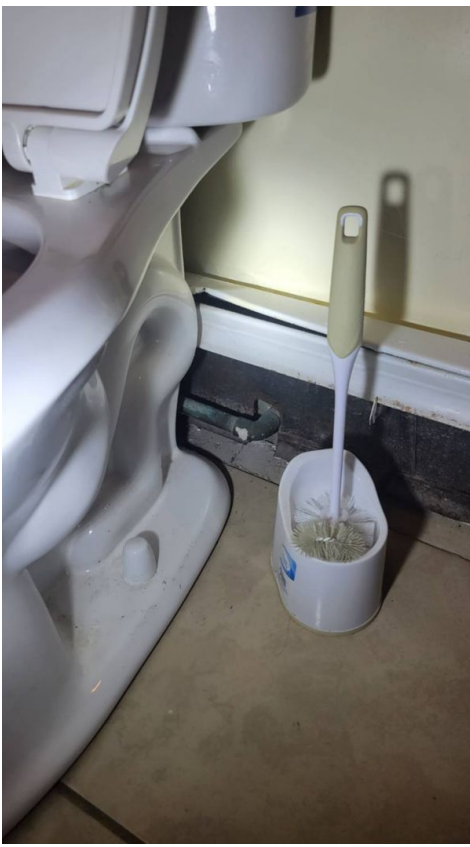
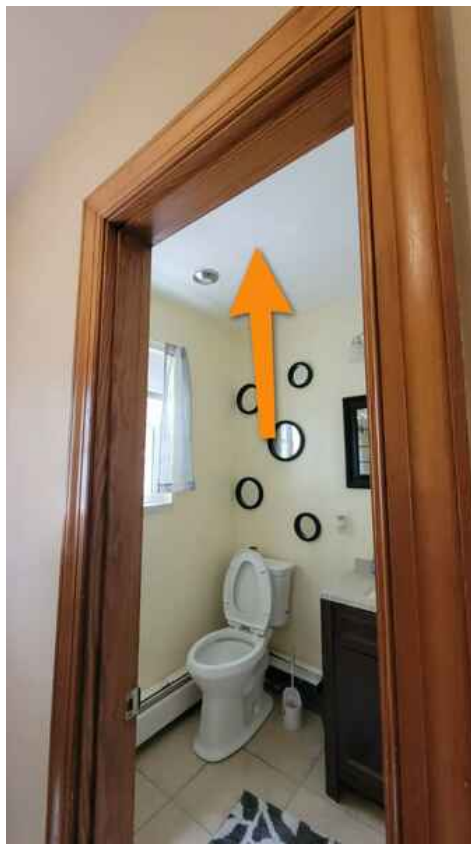
MULTIPLE DEFECTS: 1ST FLOOR BATHROOM (LOWER LEVEL)

Defects noted in the 1st floor bathroom (lower level) include a loose toilet base and damaged floor vents. The sink drain is also not properly secured and is loose, posing a risk of leaks. Additionally, there is no fan in the bathroom, but there is a window, as required by code. General cosmetic wear is observed on the vanity, walls, and floors.

Contact a qualified professional.

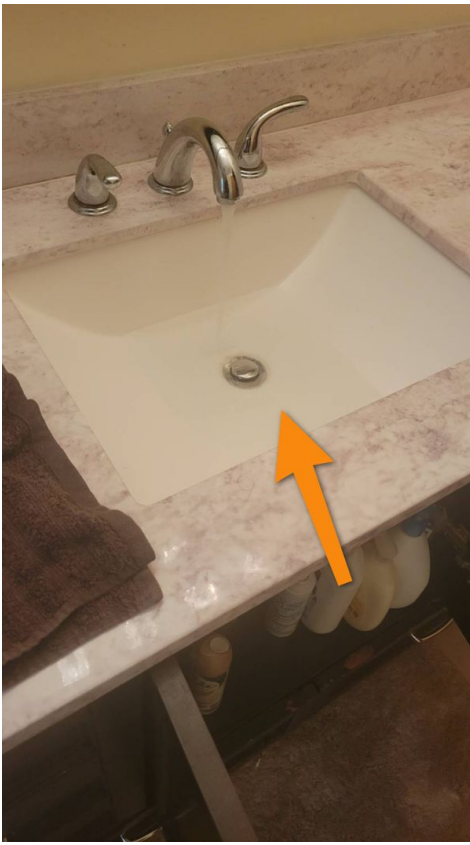
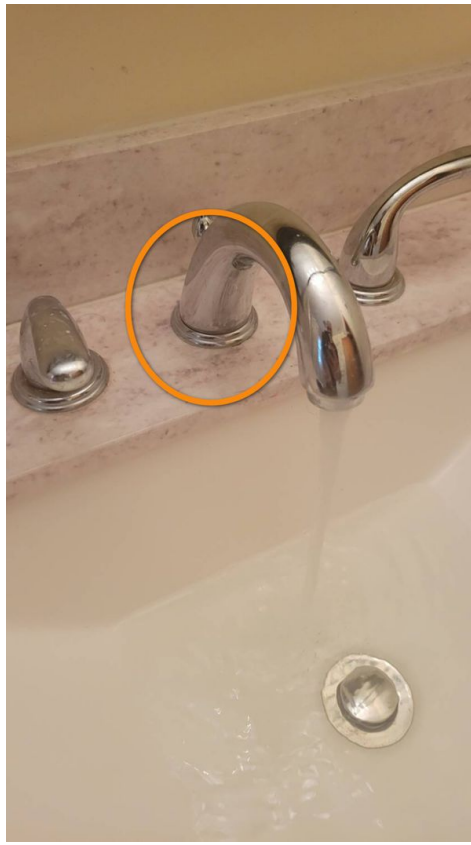
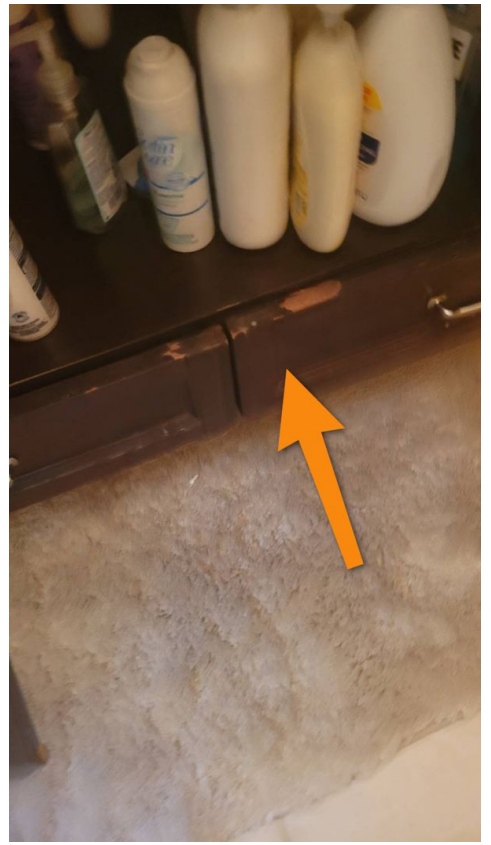
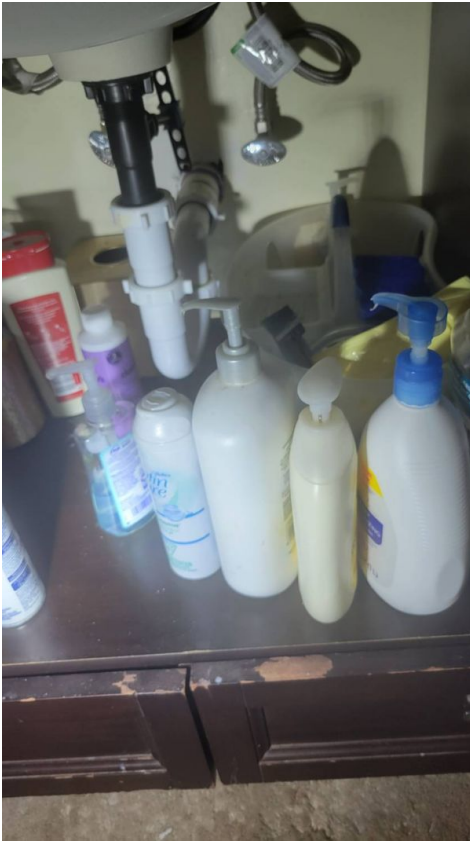
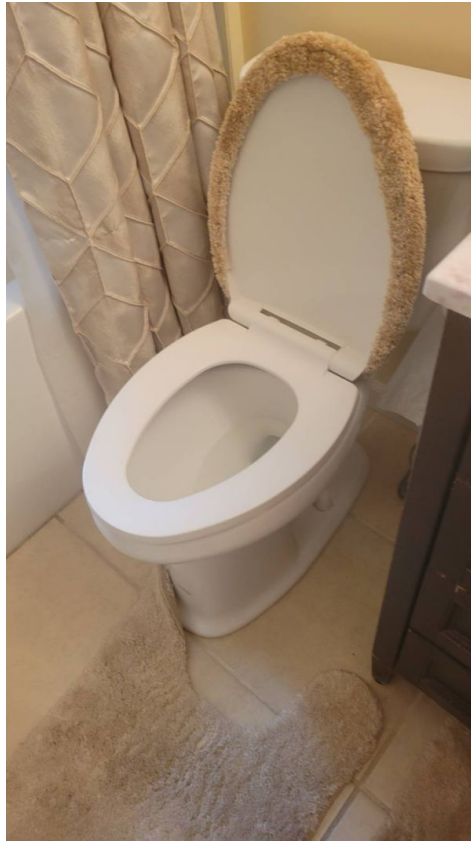
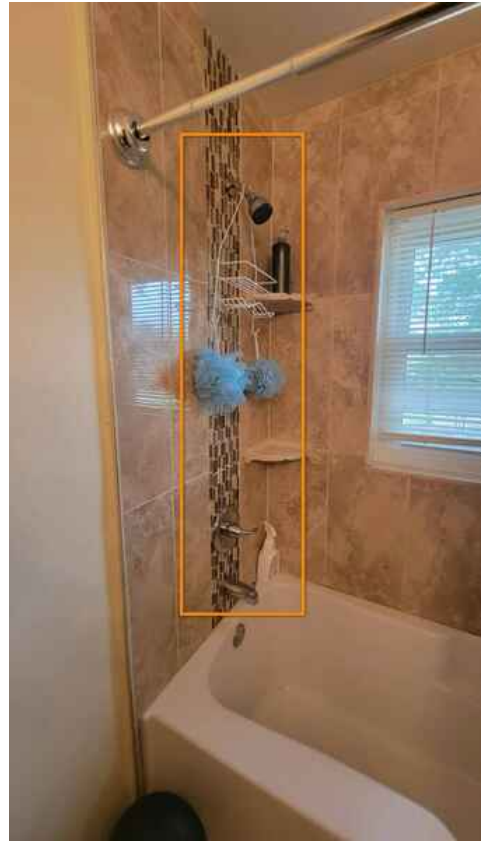
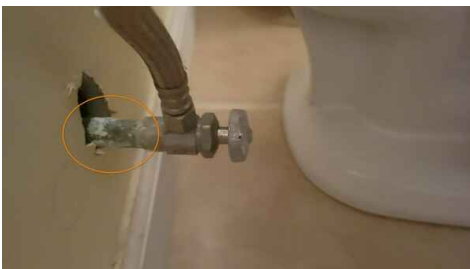
MULTIPLE DEFECTS: 2ND FLOOR SHARED BATHROOM

Defects noted in the 2nd floor shared bathroom include a damaged door, a slow drain in the sink, and an excessively loose sink faucet, which could result in leaks. Additionally, the vanity is damaged, and the toilet base is loose. General cosmetic damage is observed in this area. The shower and tub fixtures have not recently been replaced, these fixtures are slightly loose, and the shower valve is worn.

Contact a qualified plumbing contractor.

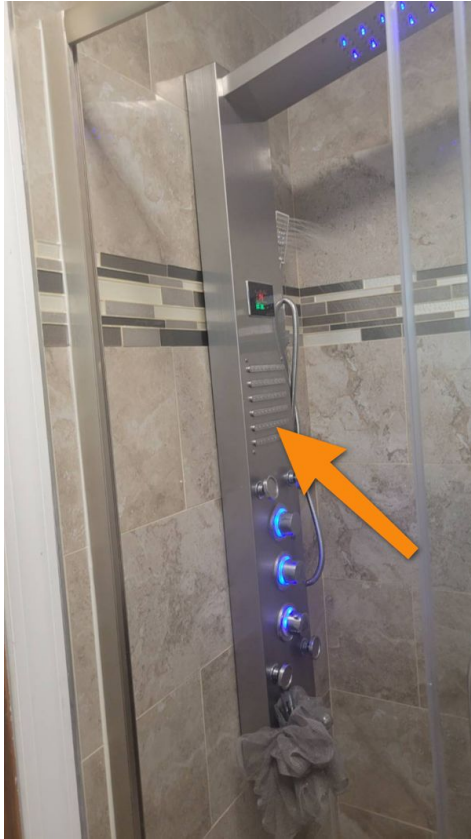
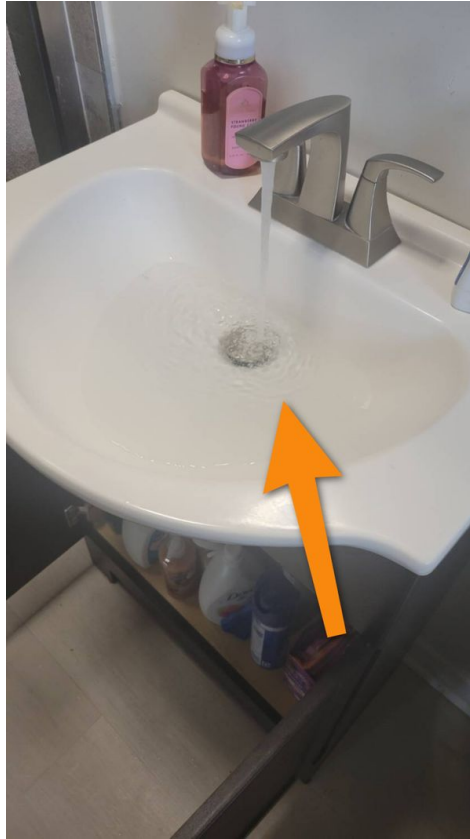
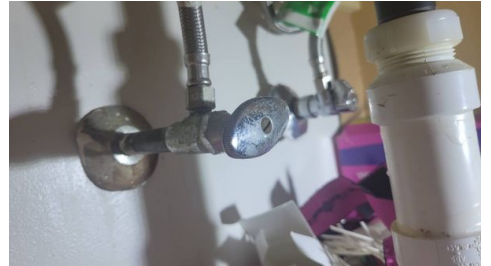
MULTIPLE DEFECTS: 2ND FLOOR MASTER BATHROOM

In the 2nd floor master bathroom, the shower unit on the shower stall wall is loose, and a slow sink drain is observed. Typical wear on the copper plumbing lines is noted. It is recommended to install a liner in the vanity.

Contact a qualified professional.

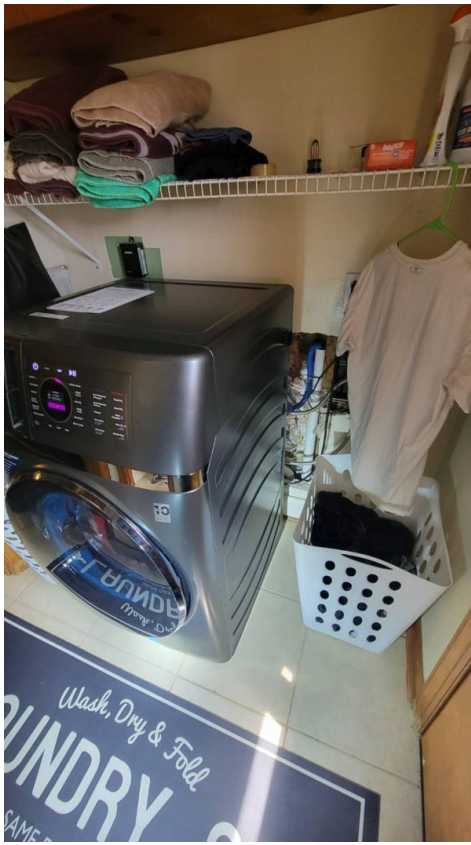
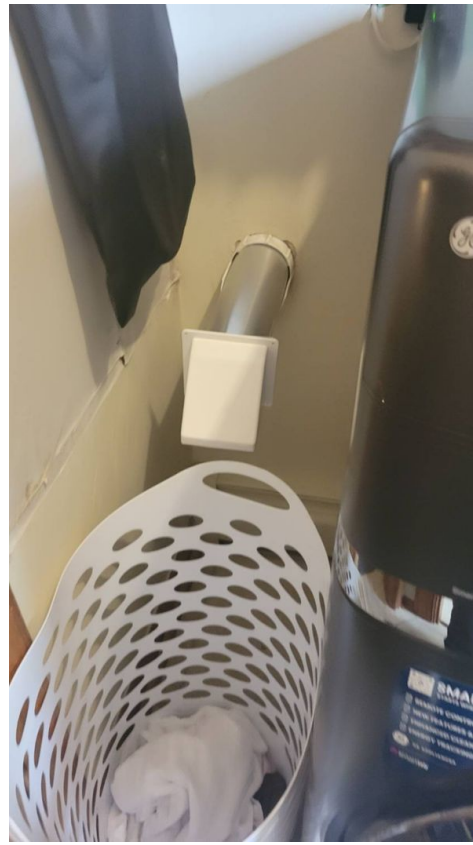
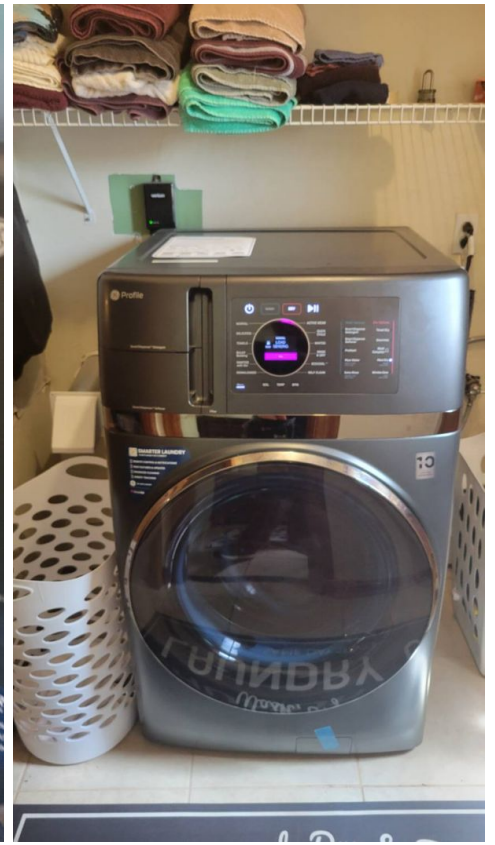
WASHER/DRYER COMMENT

On the 1st floor (lower level), there is a washer/dryer combination unit. A backward dryer vent is observed in the wall. Additionally, the wall behind the washer has been cut out to accommodate plumbing lines, which should be patched. Ensure that your washer and dryer fit properly in this area. Modifications may be necessary to correctly connect your units due to the layout here.

Contact a qualified professional.

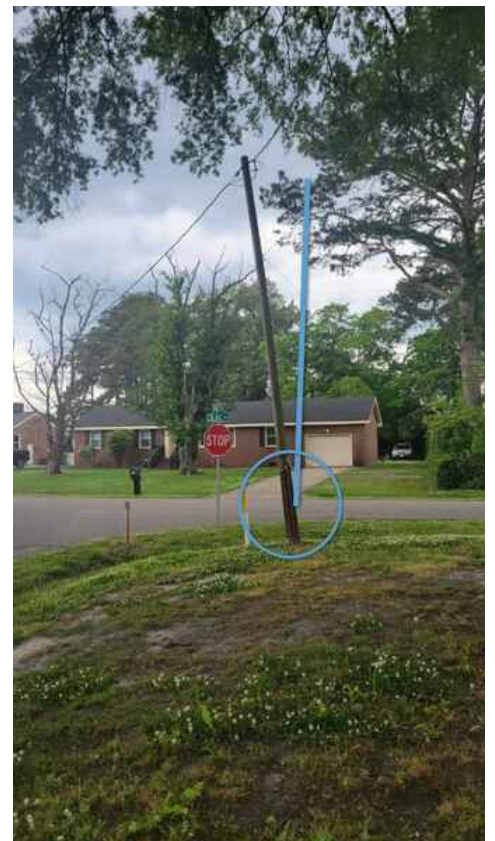
8.1.1 Service Entrance Conductors **LEANING UTILITY POLE**

The utility pole in the front yard is leaning and off-center. A brace has been added to support the pole. This is an observation only, and you may contact the utility company to inquire about a replacement pole; however, the brace serves as a temporary repair solution.

Contact your local utility company

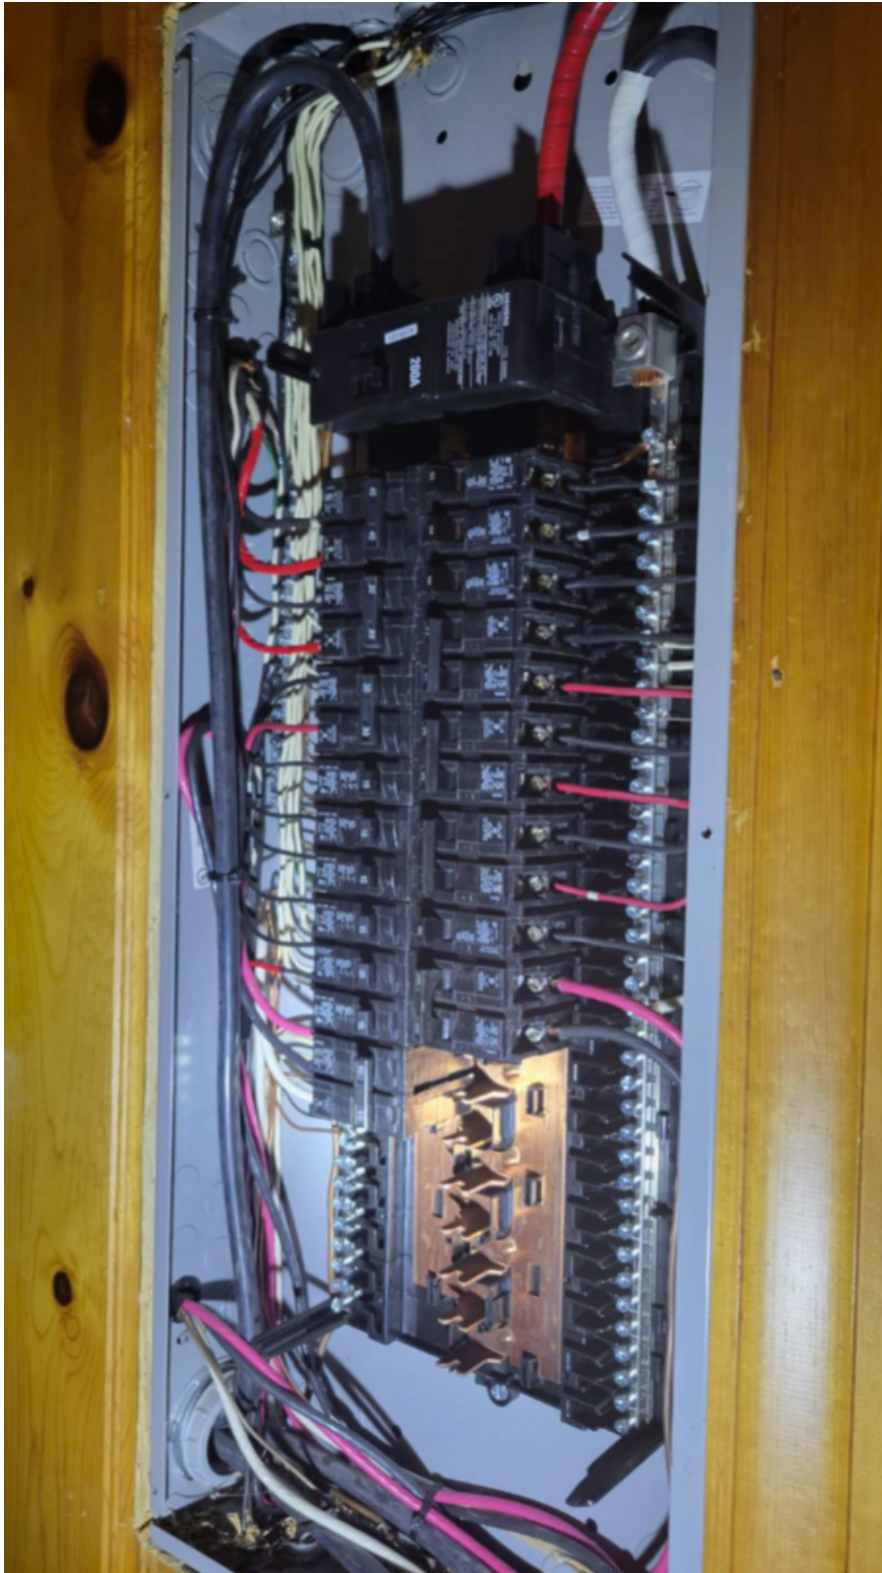
LOOSE OUTLETS OR RECEPTACLES/LOOSE SWITCHES OR MISSING HARDWARE

Loose outlets or receptacles were observed during the inspection. It is recommended to have a qualified contractor evaluate and repair them. Excessively loose outlets can result in wires becoming loose behind the wall. Multiple switches and light fixtures are loose or missing hardware.

While the main electrical panel has been upgraded, many of the receptacles in the home have not been. Some receptacles are excessively loose, which could potentially cause electrical issues. It is advisable to have these receptacles evaluated and repaired as needed.

Contact a qualified electrical contractor.

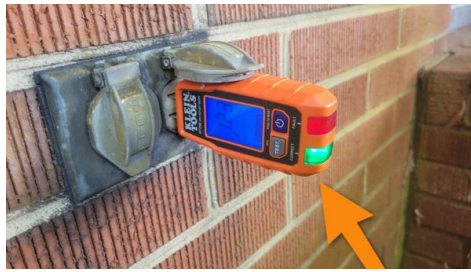
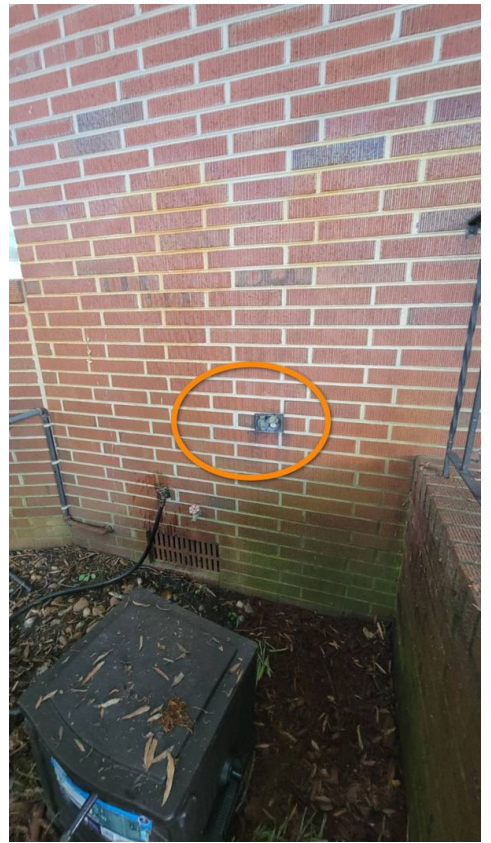
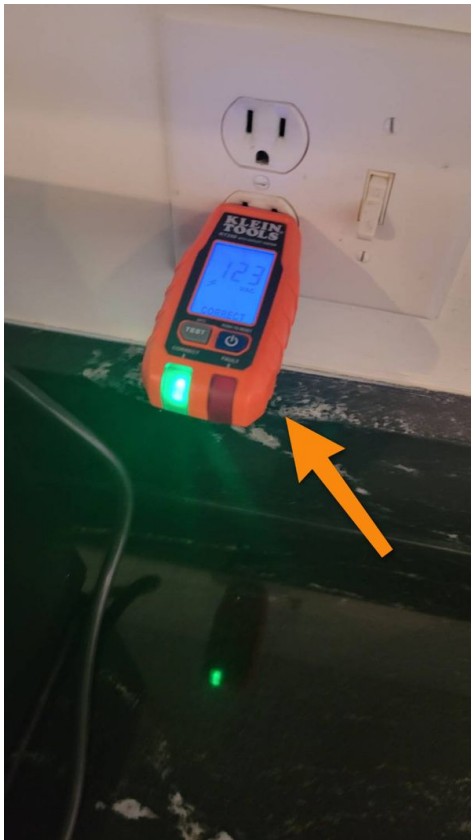
8.3.2 Switches & Receptacles
NO GFCIS OR OUTDATED GFCIS
ALL AREAS WITH IN 6 FEET OF WATER

A ground fault circuit interrupter (GFCI) serves to prevent electrocution by cutting off power if it senses a person's body receiving a shock. They are typically installed in areas where electrical circuits might come into contact with water accidentally. While GFCIs are present in the bathrooms, they are lacking in the kitchen and on the exterior of the home. Upgrading is recommended.

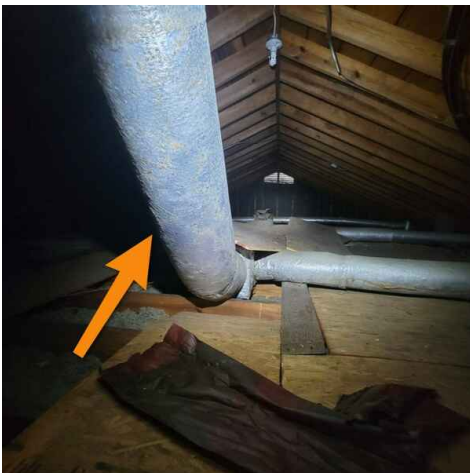
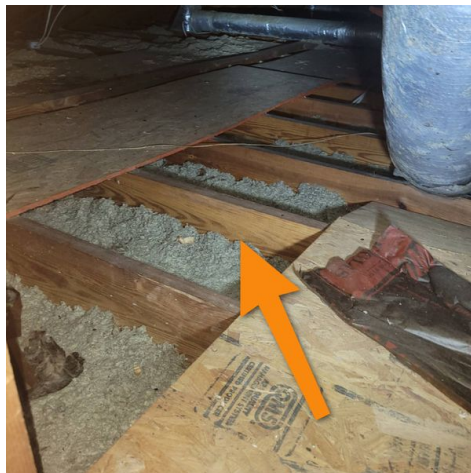
LOOSE OR MISSING ATTIC WALKWAY/MASTER BATHROOM FAN DOES NOT TERMINATE OUTSIDE OF THE ROOF

2nd floor bathroom vent does not exit the roof

Contact a qualified professional.

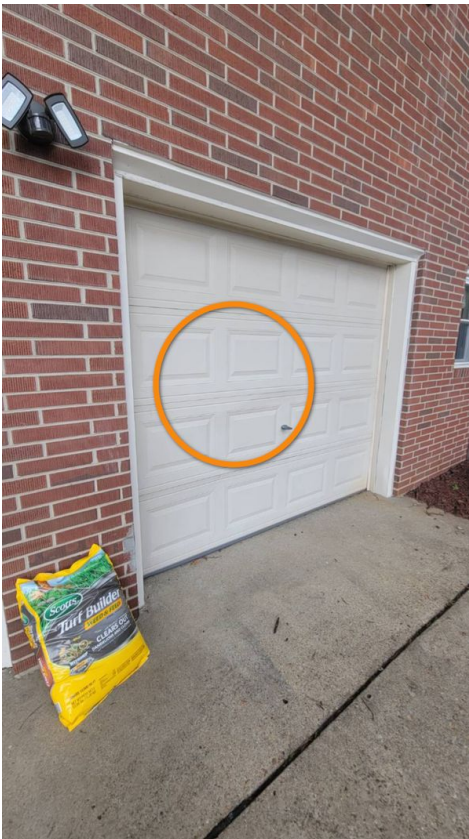
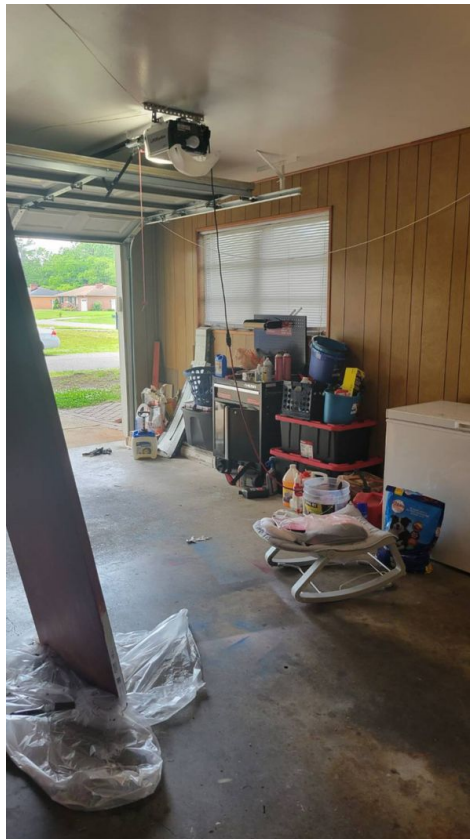
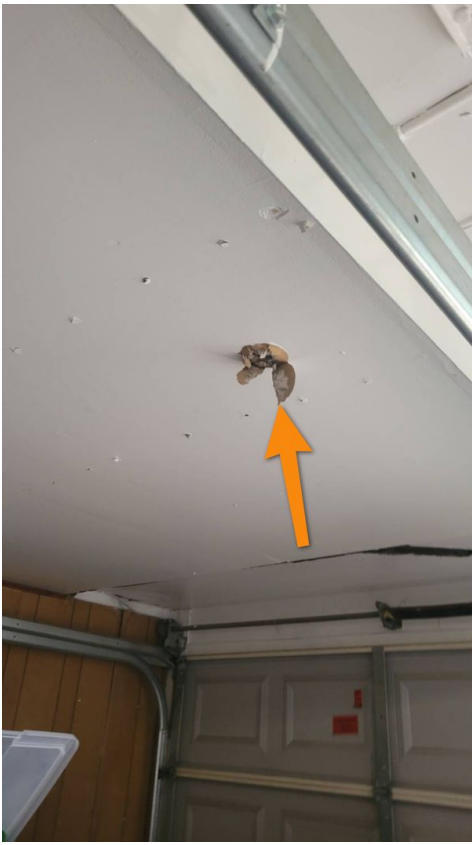
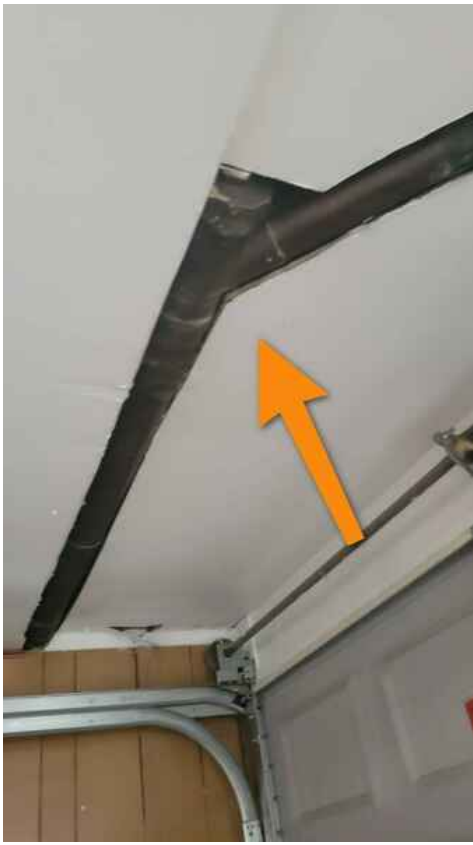
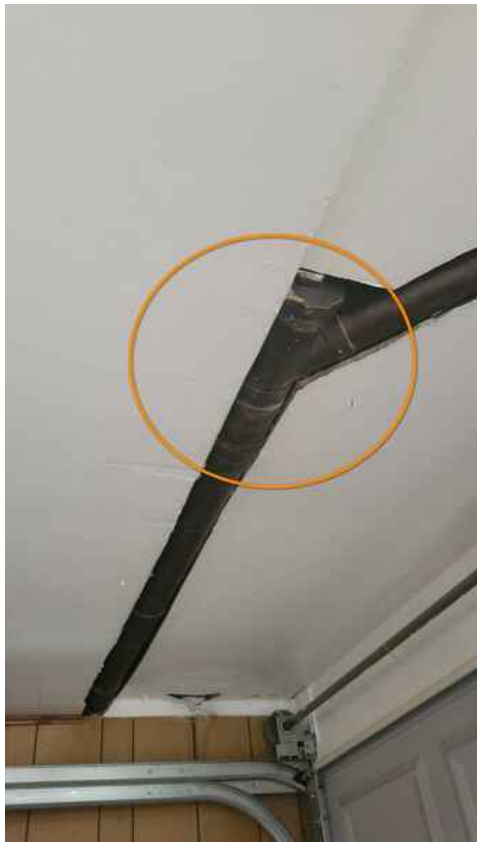
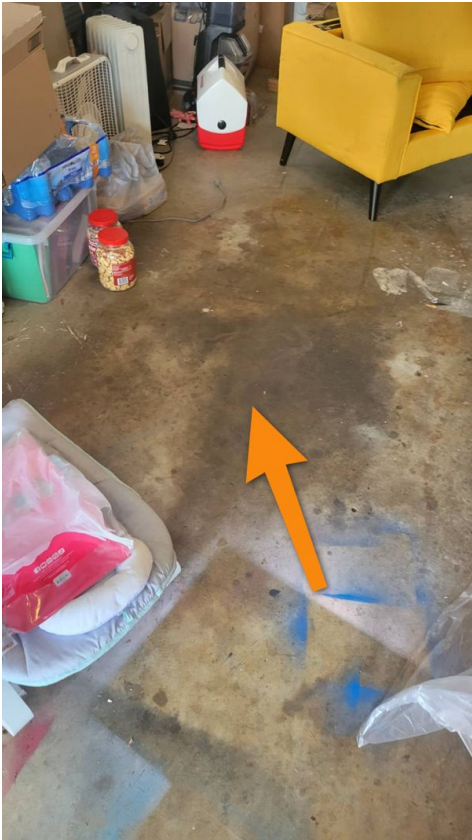
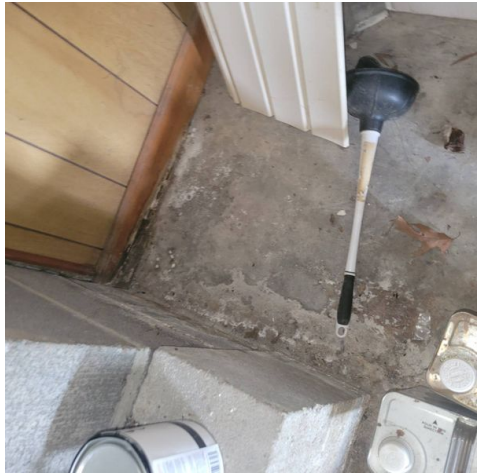
GENERAL GARAGE SUMMARY OF DEFECTS

General garage summary of defects:

Garage Overview: The garage door exhibits dents, and only one garage door motor is installed despite there being two doors. Stains and cracks are visible on the slab, and there are holes in the ceiling and walls requiring patching. The main drain line for the home is located in the garage ceiling, necessitating a cutout for access. Minor moisture is present around the slab, along with general cosmetic defects.

Recommendation

Contact a qualified professional.

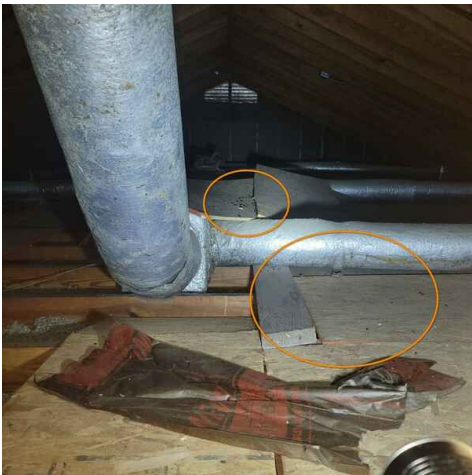
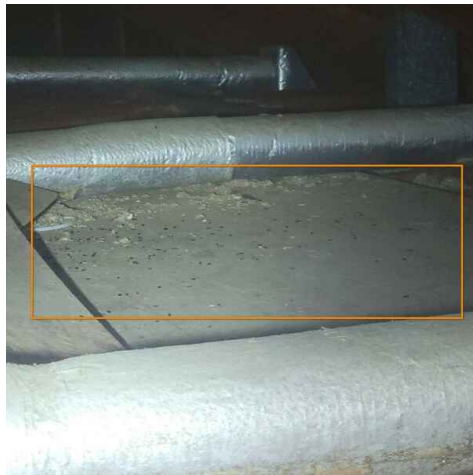
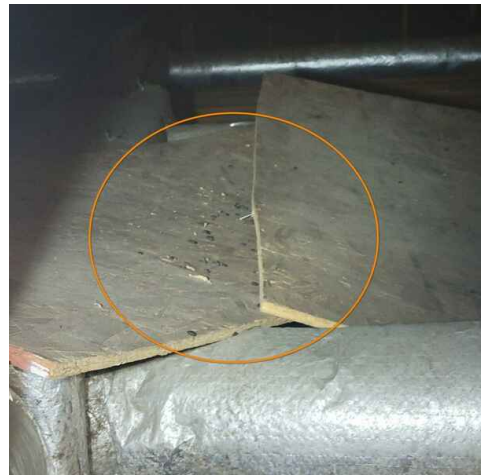
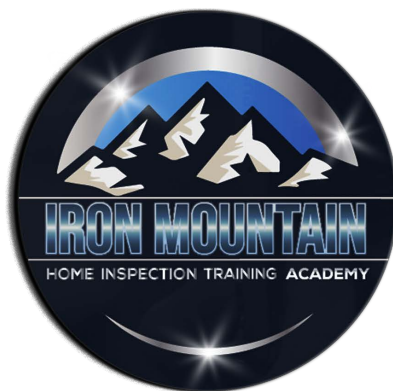
12.1.1 Findings of insects or pest **RODENT DROPPINGS**

Rodent droppings observed at the time of inspection. Recommend a qualified contractor to evaluate and remedy.

Recommendation

Contact a qualified pest control specialist.
