SAMPLE REPORT FOR TRAINING (SUMMARY/DEFECTS ONLY)

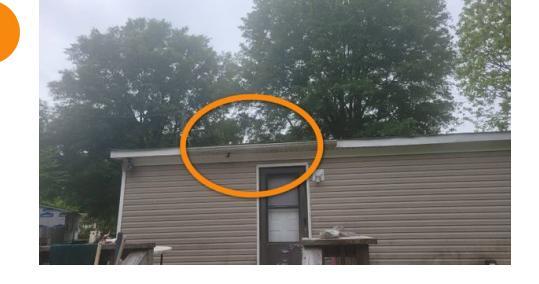
Absence of Gutters Throughout Property; Recommendation for Installation to Divert Water Away from Structures.

Recommendation Contact a qualified gutter contractor

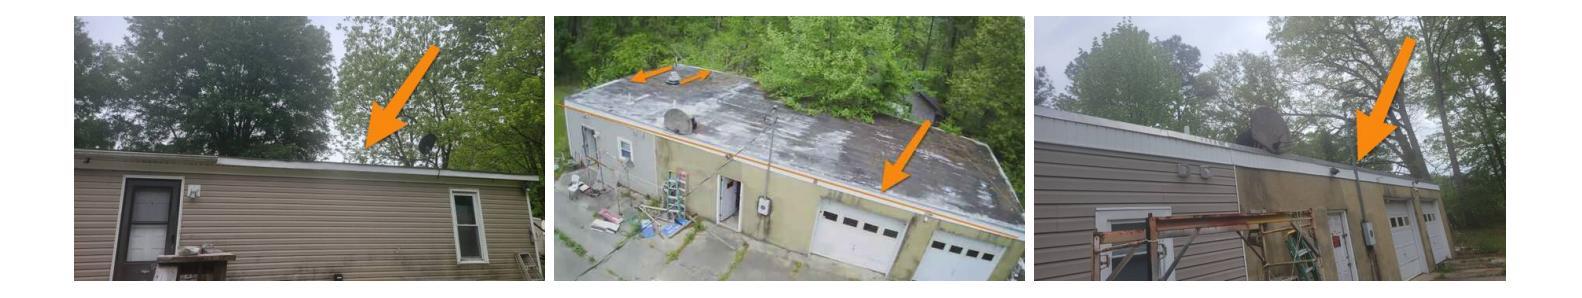
3.1.1 Siding, Flashing & Trim, exterior doors, eaves, soffit vents, windows and fascia PROPERTY EXTERIOR ASSESSMENT AND RECOMMENDATIONS FOR SIDING MAINTENANCE AND DEBRIS MANAGEMENT

- 1. The siding on the main home exhibits signs of deterioration including looseness, staining, and cracks in multiple areas.
- 2. The rear building features a mix of vinyl siding, concrete, and a material resembling stucco.
- 3. Debris is scattered across the yard, detracting from the property's appearance and cleanliness.

- Secure and pressure wash the siding on both structures to restore their appearance and integrity.
- Arrange for the removal of debris from the yard to enhance aesthetics and safety.
- Consider refinishing the material on the rear building to improve its condition and visual appeal.
- Engage a siding contractor to conduct a thorough evaluation and perform necessary repairs for both structures.

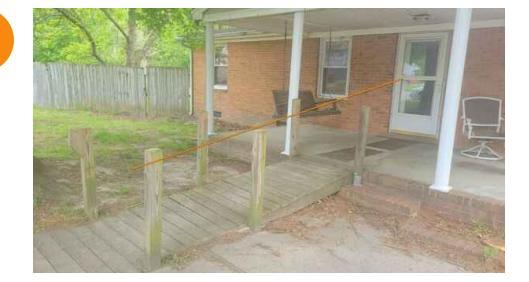
3.3.2 Decks, Balconies, Porches & Steps DECK - DECK IN POOR CONDITION (CLOSE TO FAILURE) EXTERIOR (REAR)

Assessment of Rear Deck:

The rear deck is in a state of disrepair, with the majority of the deck boards exhibiting rot. Additionally, a section of the handrails is missing, and multiple types of materials have been utilized in its construction. The deck shows signs of deterioration, including holes, and is nearing failure. It is strongly recommended to engage a deck contractor for a thorough evaluation and necessary repairs.

Recommendation Contact a qualified deck contractor.

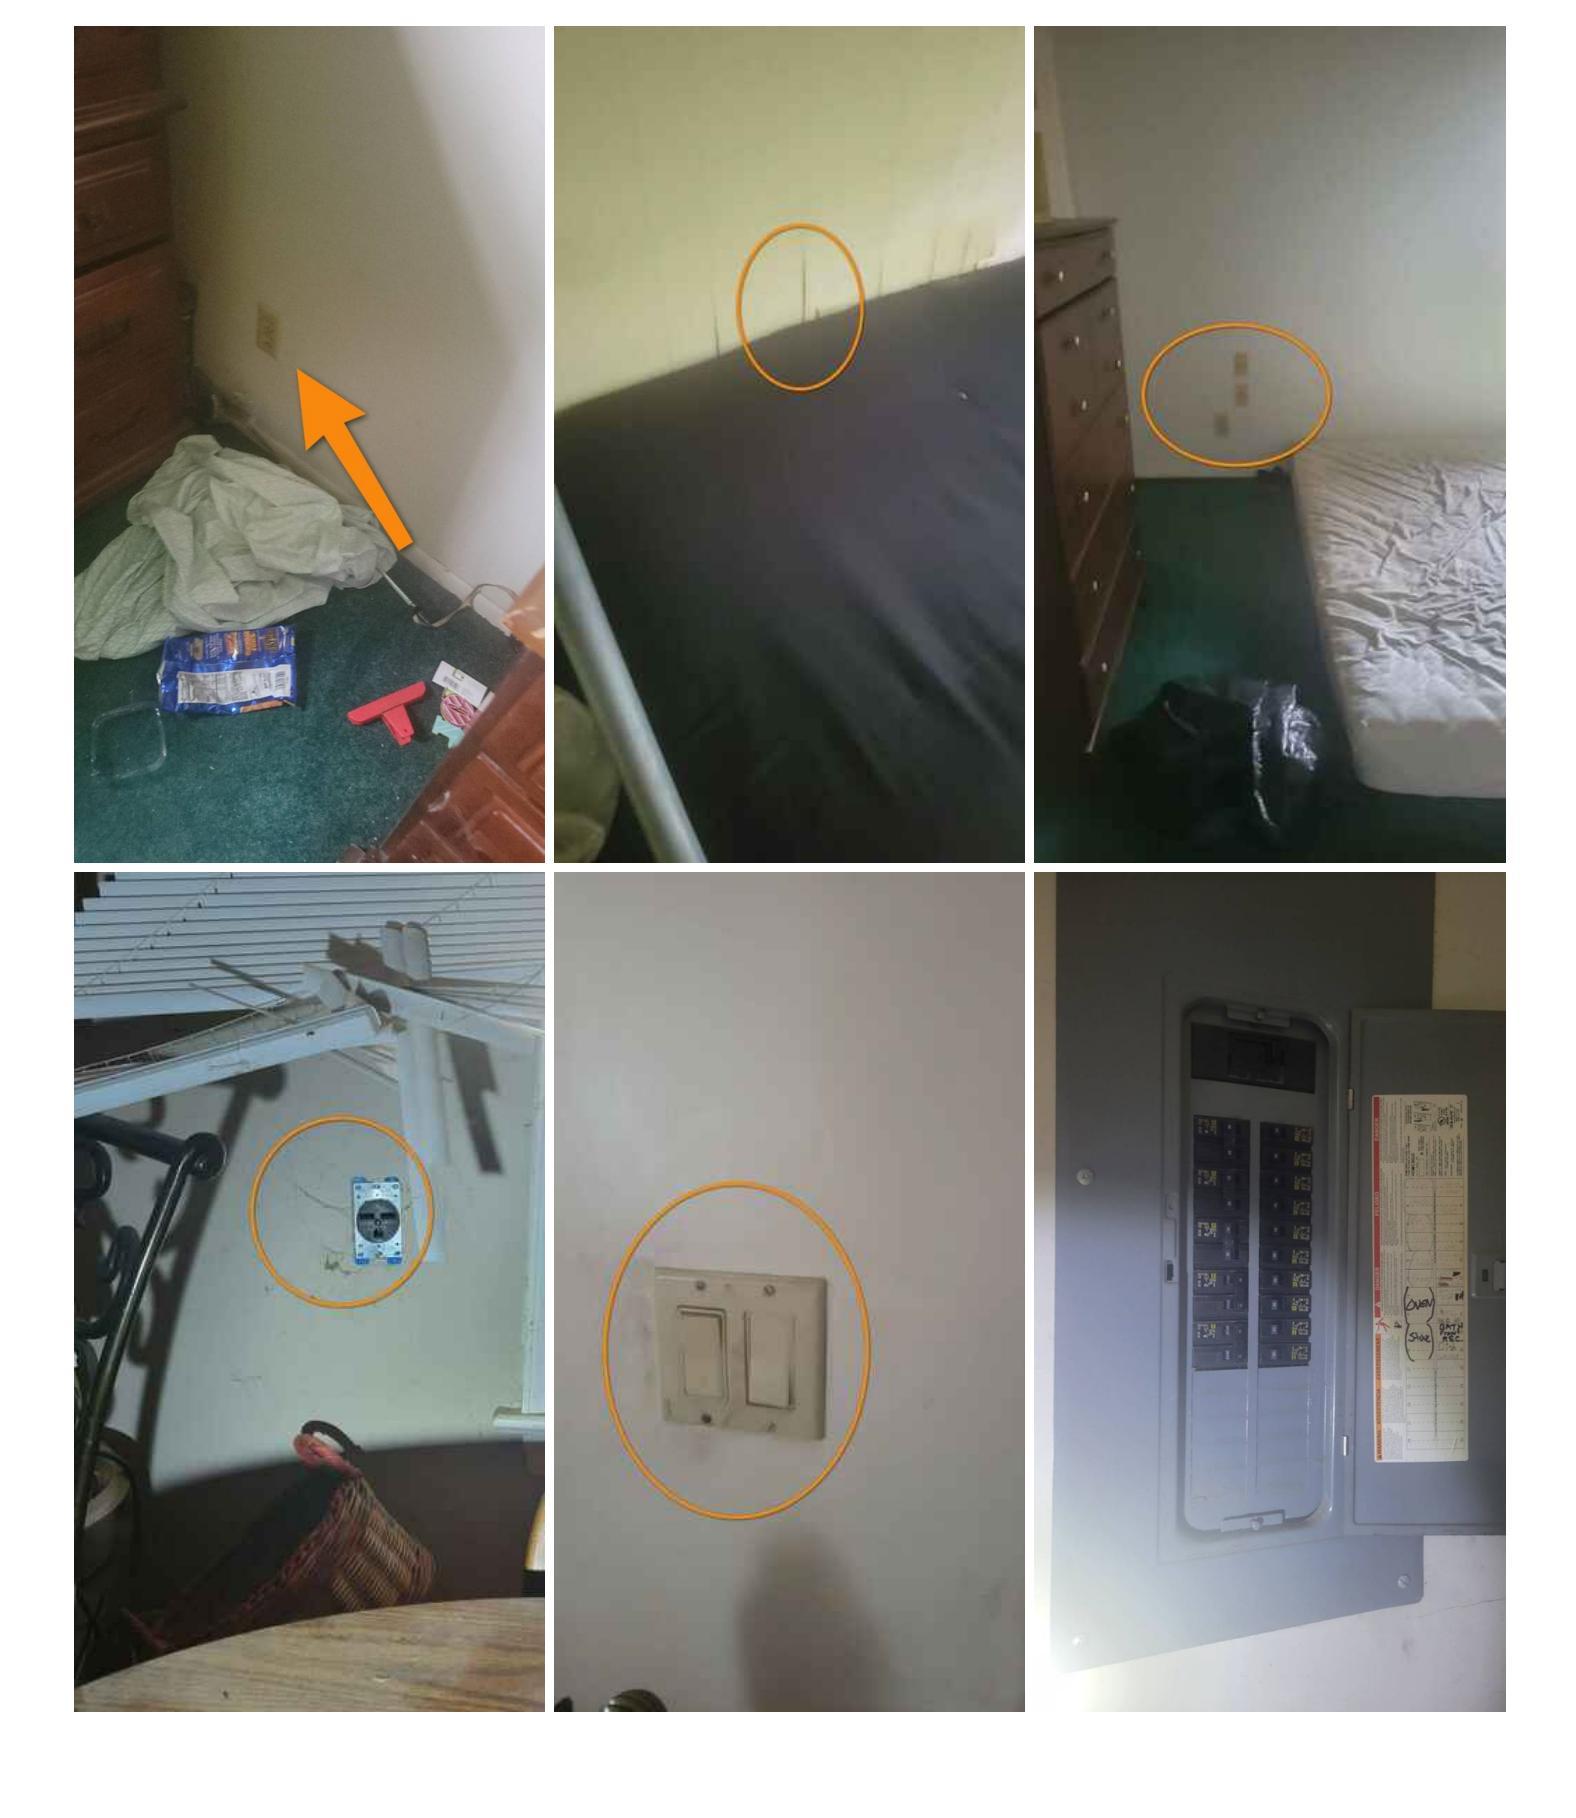
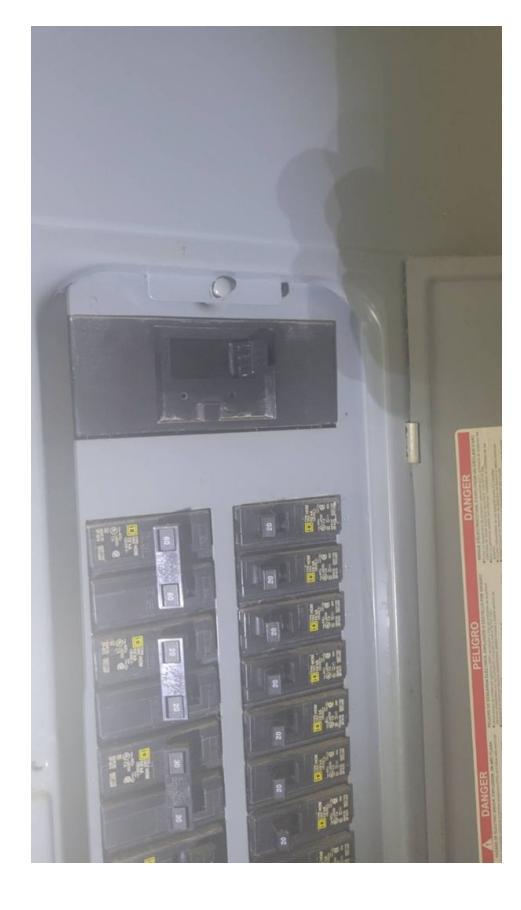
Loose outlets or receptacles were noted during the inspection. It is recommended to engage a qualified contractor to evaluate and repair these issues.

Recommendation Contact a qualified electrical contractor.

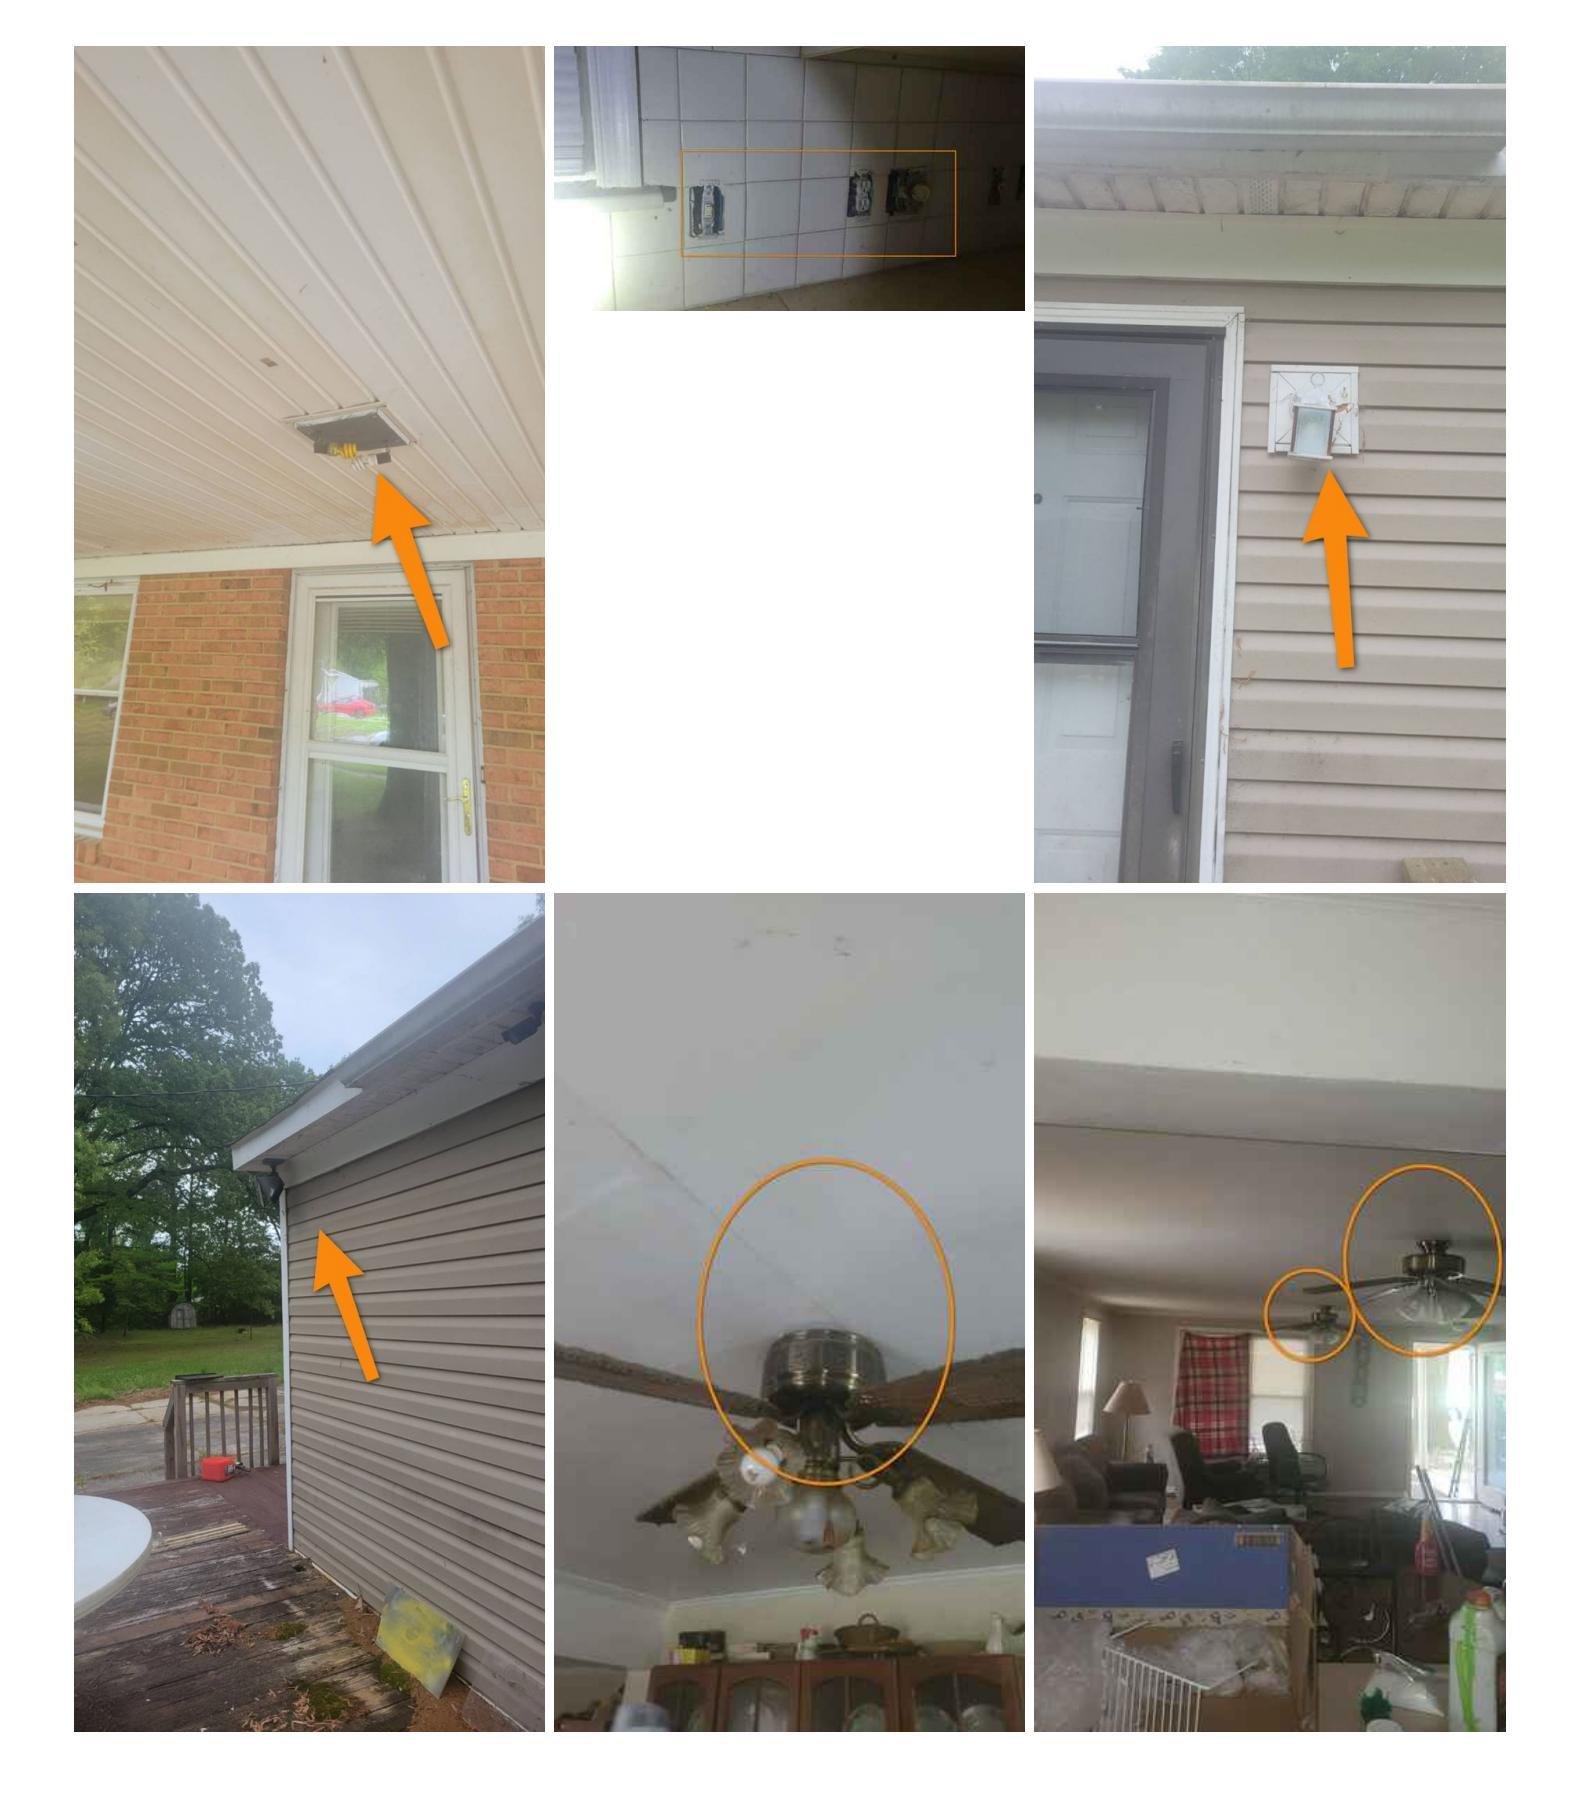
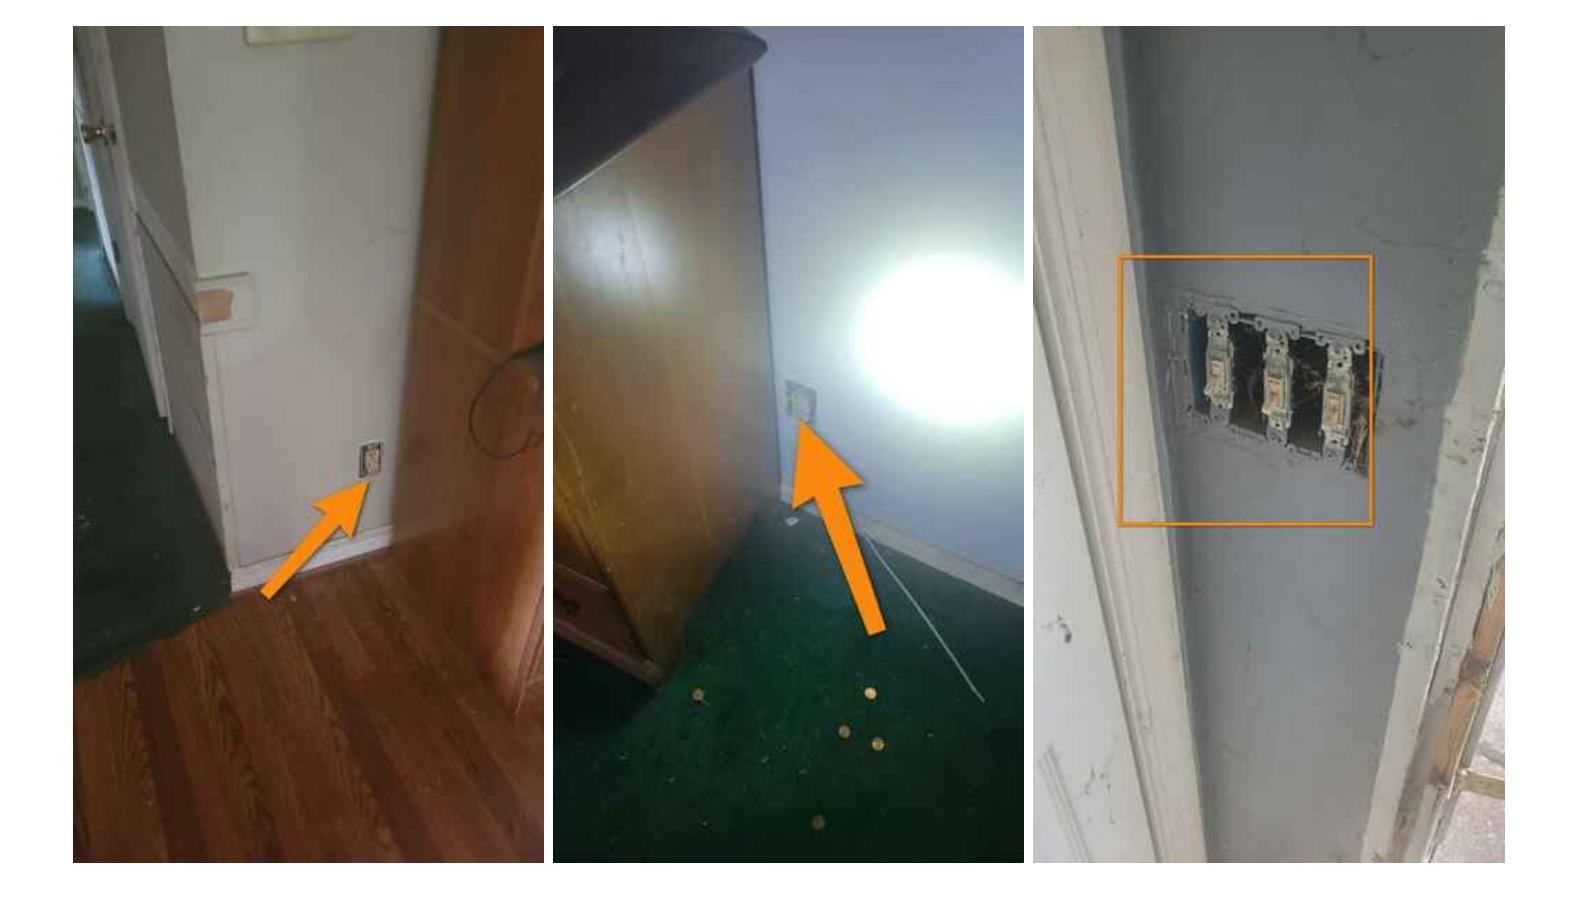
8.3.2 Switches & Receptacles COVERS MISSING OR DAMAGED/LOOSE LIGHT FIXTURES

Several light fixtures were observed to be damaged or loose during the inspection. Additionally, one or more receptacles, switches, or lighting fixtures were found to be missing covers. It is recommended to enlist the services of a qualified contractor to evaluate and address these issues promptly.

Contact a qualified electrical contractor.

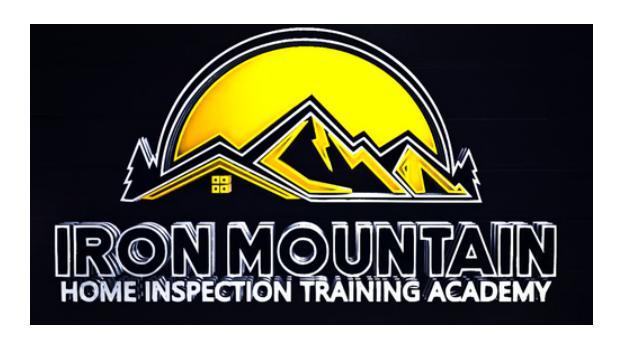
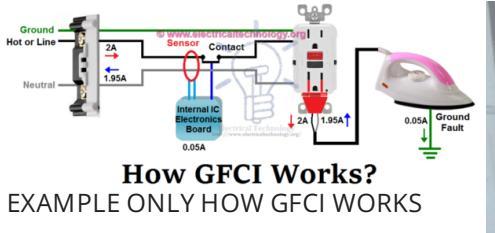
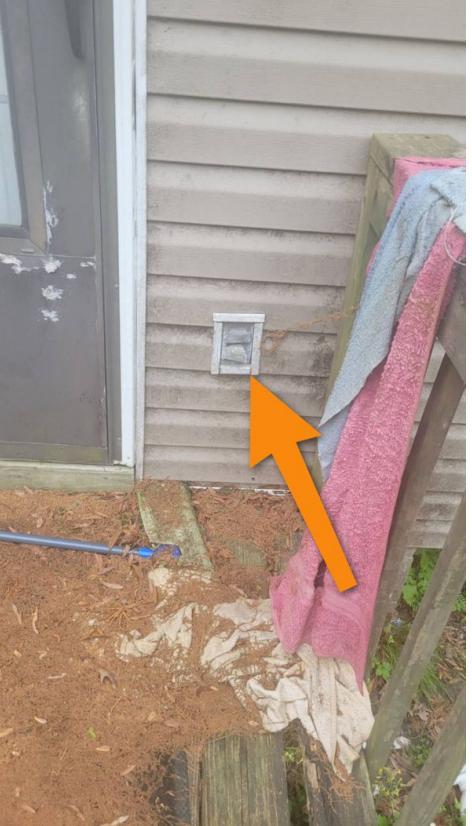
8.3.3 Switches & Receptacles **OUTDATED GFCIS** ALL AREAS WITH IN 6 FEET OF WATER

Outdated GFCIs were identified in the home.

As the power was off during the inspection, it is reasonable to expect other electrical issues such as open grounds and shorts. Therefore, it is recommended to have an electrician evaluate and repair the electrical system for optimal safety and functionality.

Recommendation Contact a qualified electrical contractor.

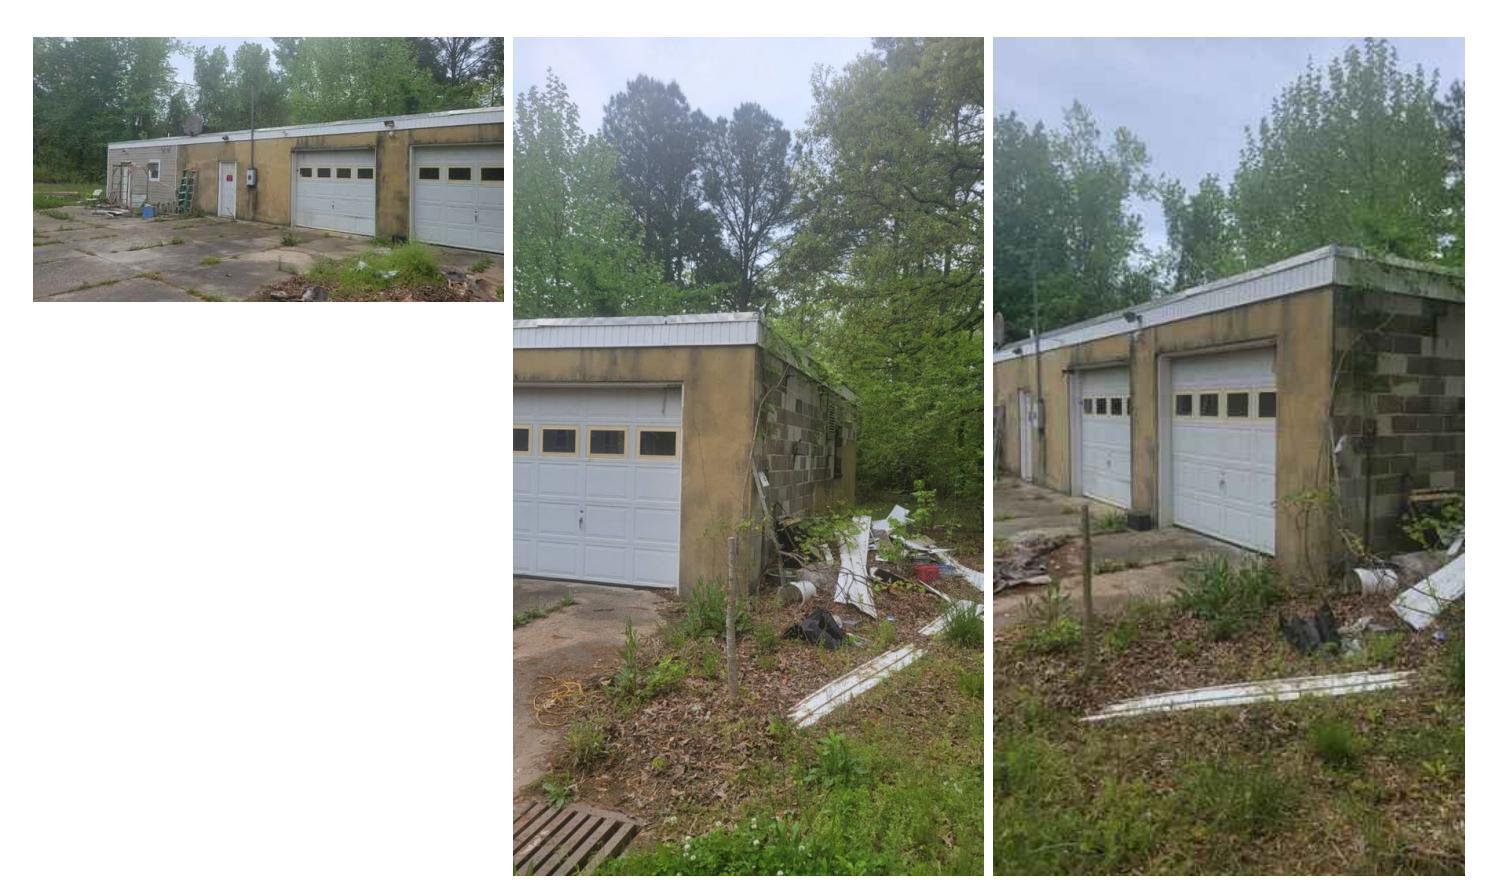
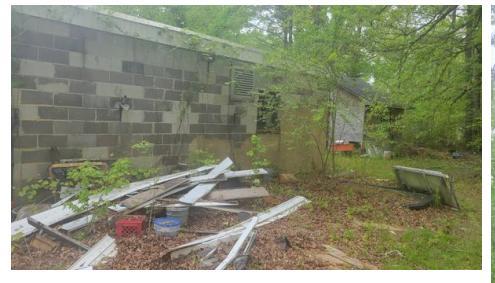
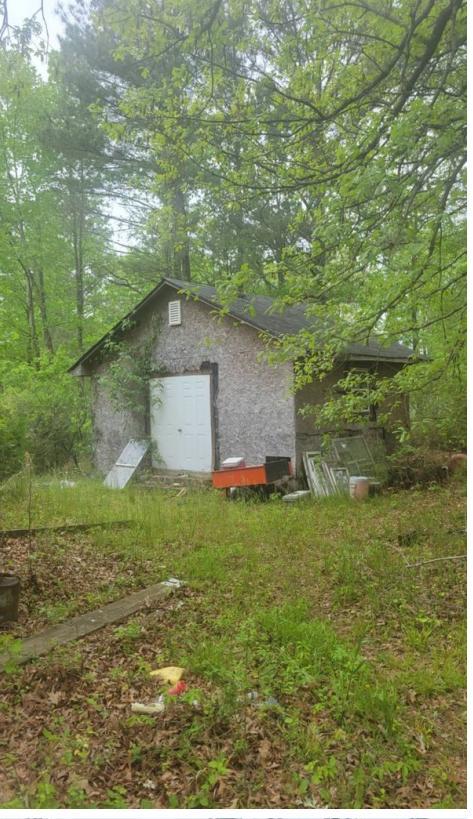
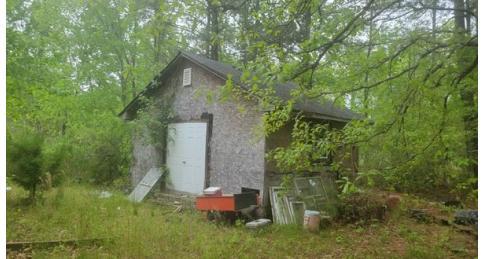
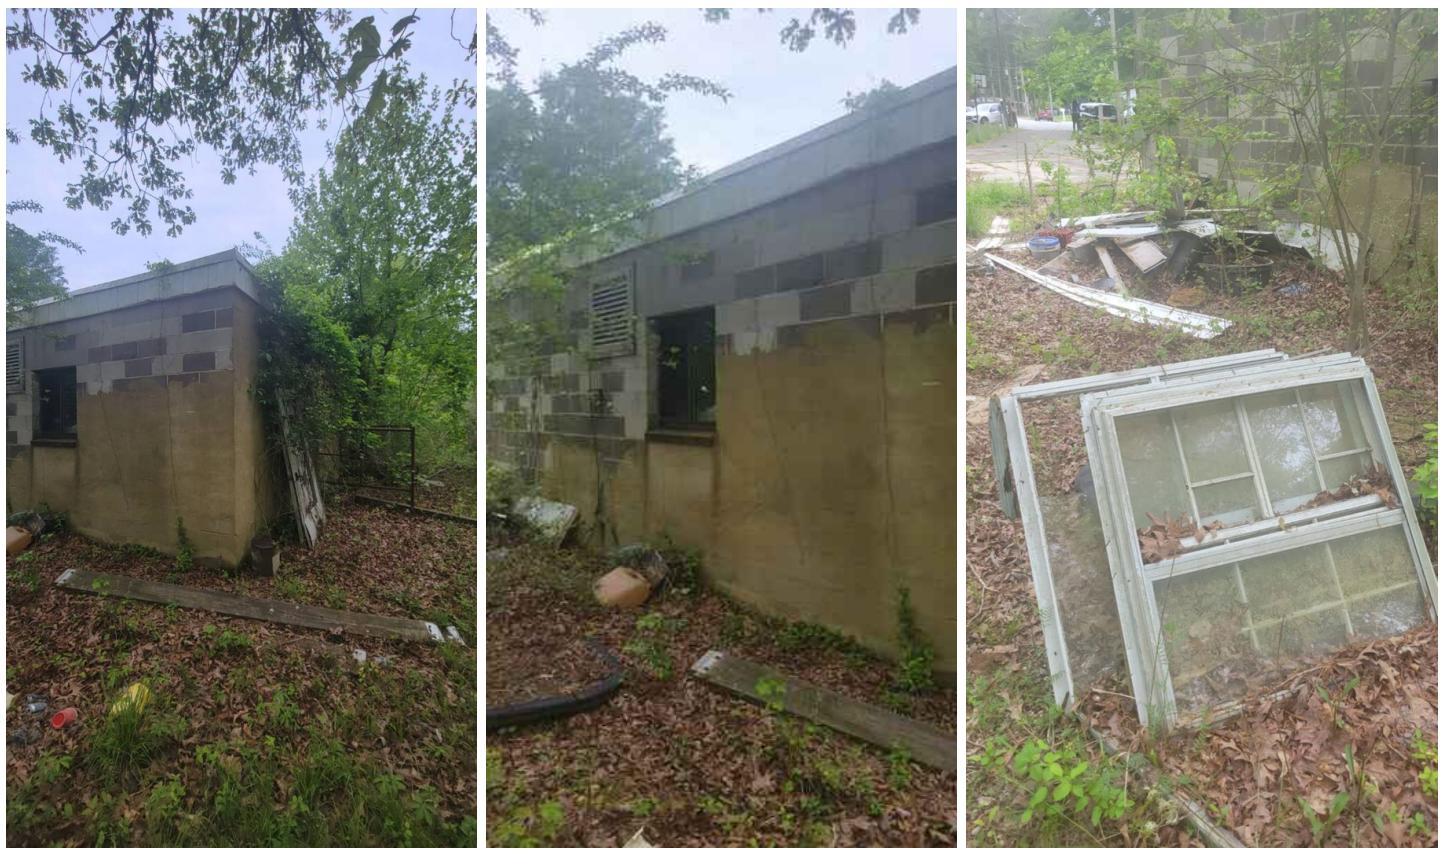
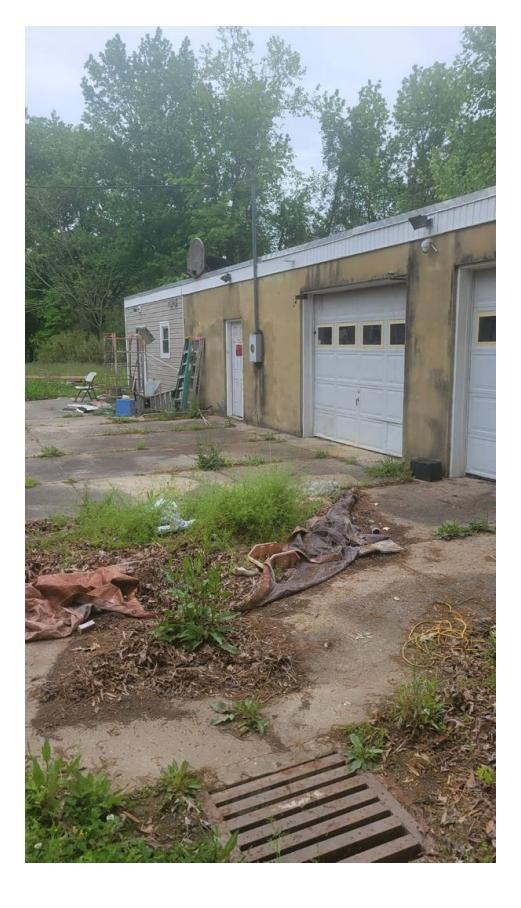
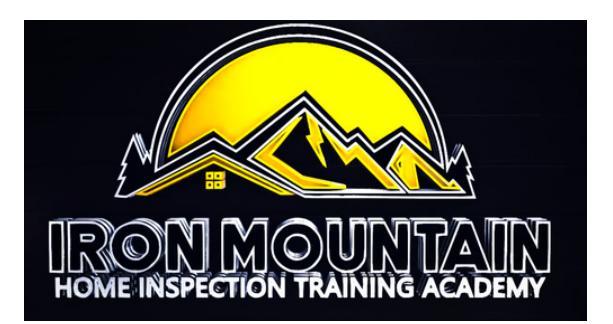
9.1.1 Ceiling, floor, walls and fire walls, garage door, windows and entrance doors **REAR BUILDING: EXTERIOR DEFECTS**

Multiple exterior defects were observed on the rear building, which consists of concrete blocks with a combination of siding and stucco-like material as its exterior finish. Cracks and damage are evident in multiple areas, suggesting substandard workmanship. The flat roof is improperly sloped, resulting in leaks into the interior of the property. Additionally, the absence of gutters on the building exacerbates water-related issues, which may lead to electrical problems. Debris is scattered around the structure, and there are loose, damaged, or aged light fixtures on the exterior. Evaluation and repair are recommended.

Behind the rear building is a smaller shed structure that remains unfinished, lacking protection from the elements. This condition may compromise the stability of the shed. It is advisable to engage a general contractor or shed builder to evaluate and repair the shed structure.
