SAMPLE REPORT FOR TRAINING (SUMMARY/DEFECTS ONLY)

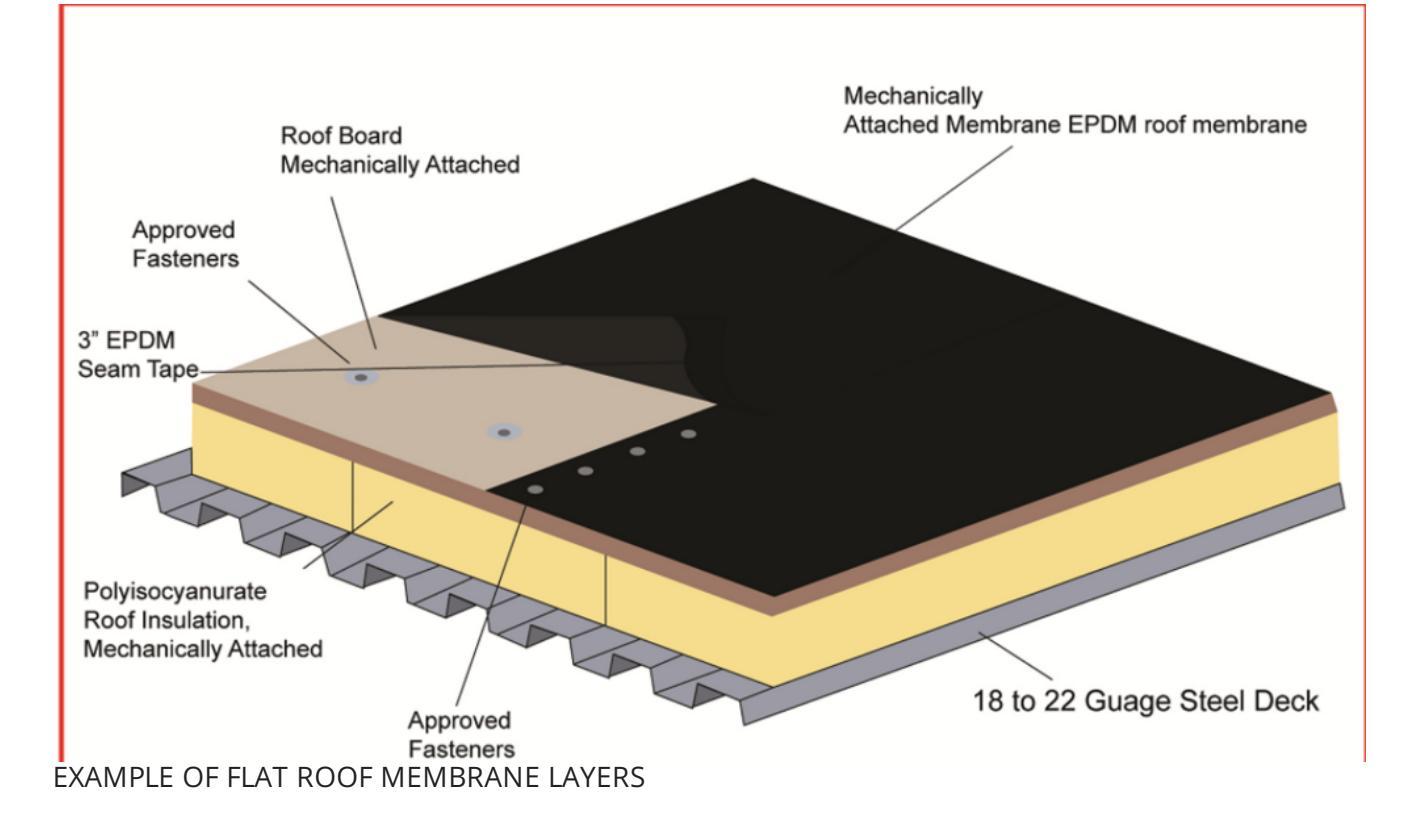
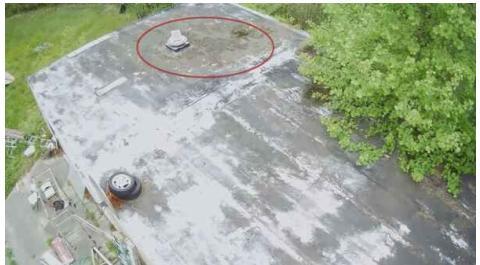
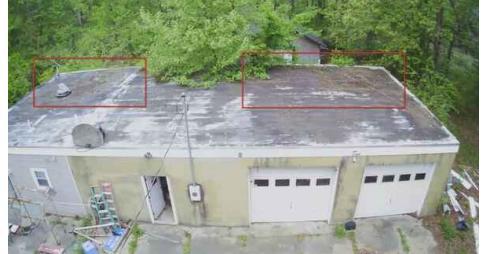
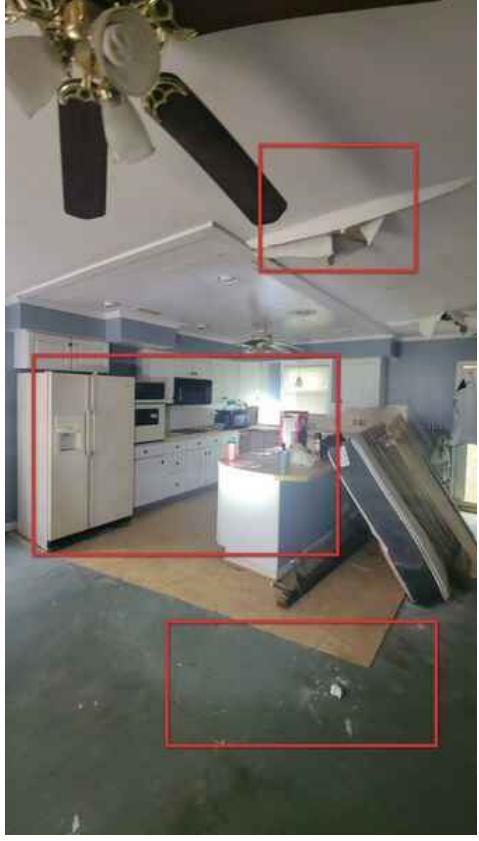
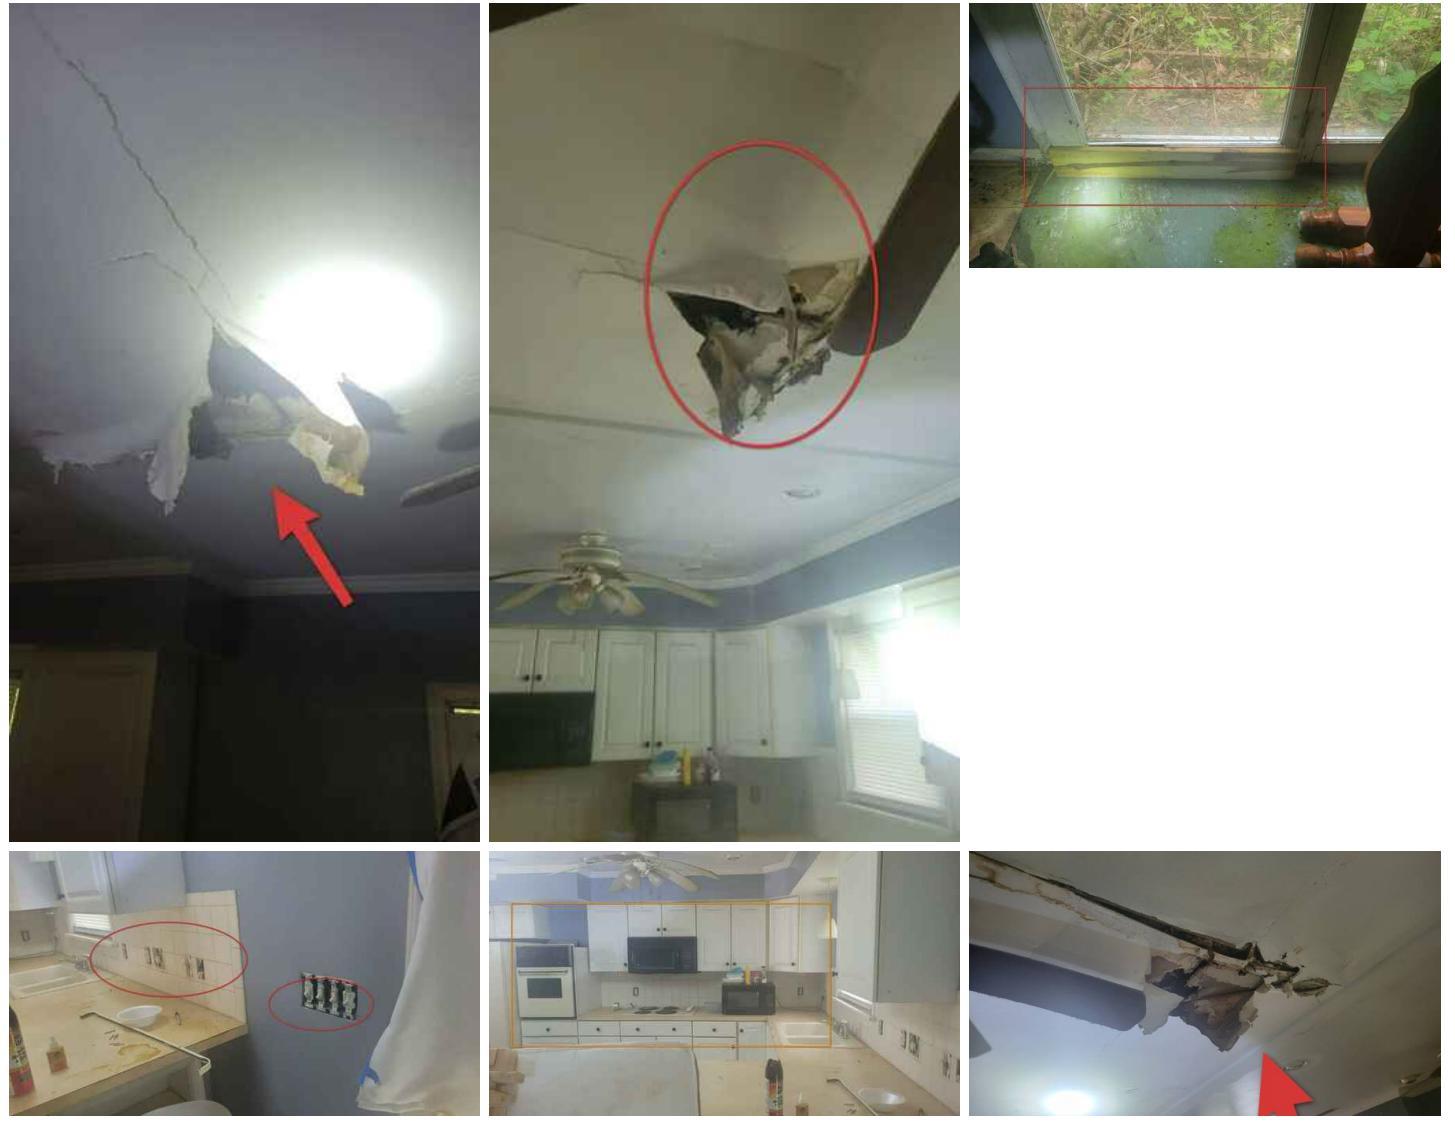
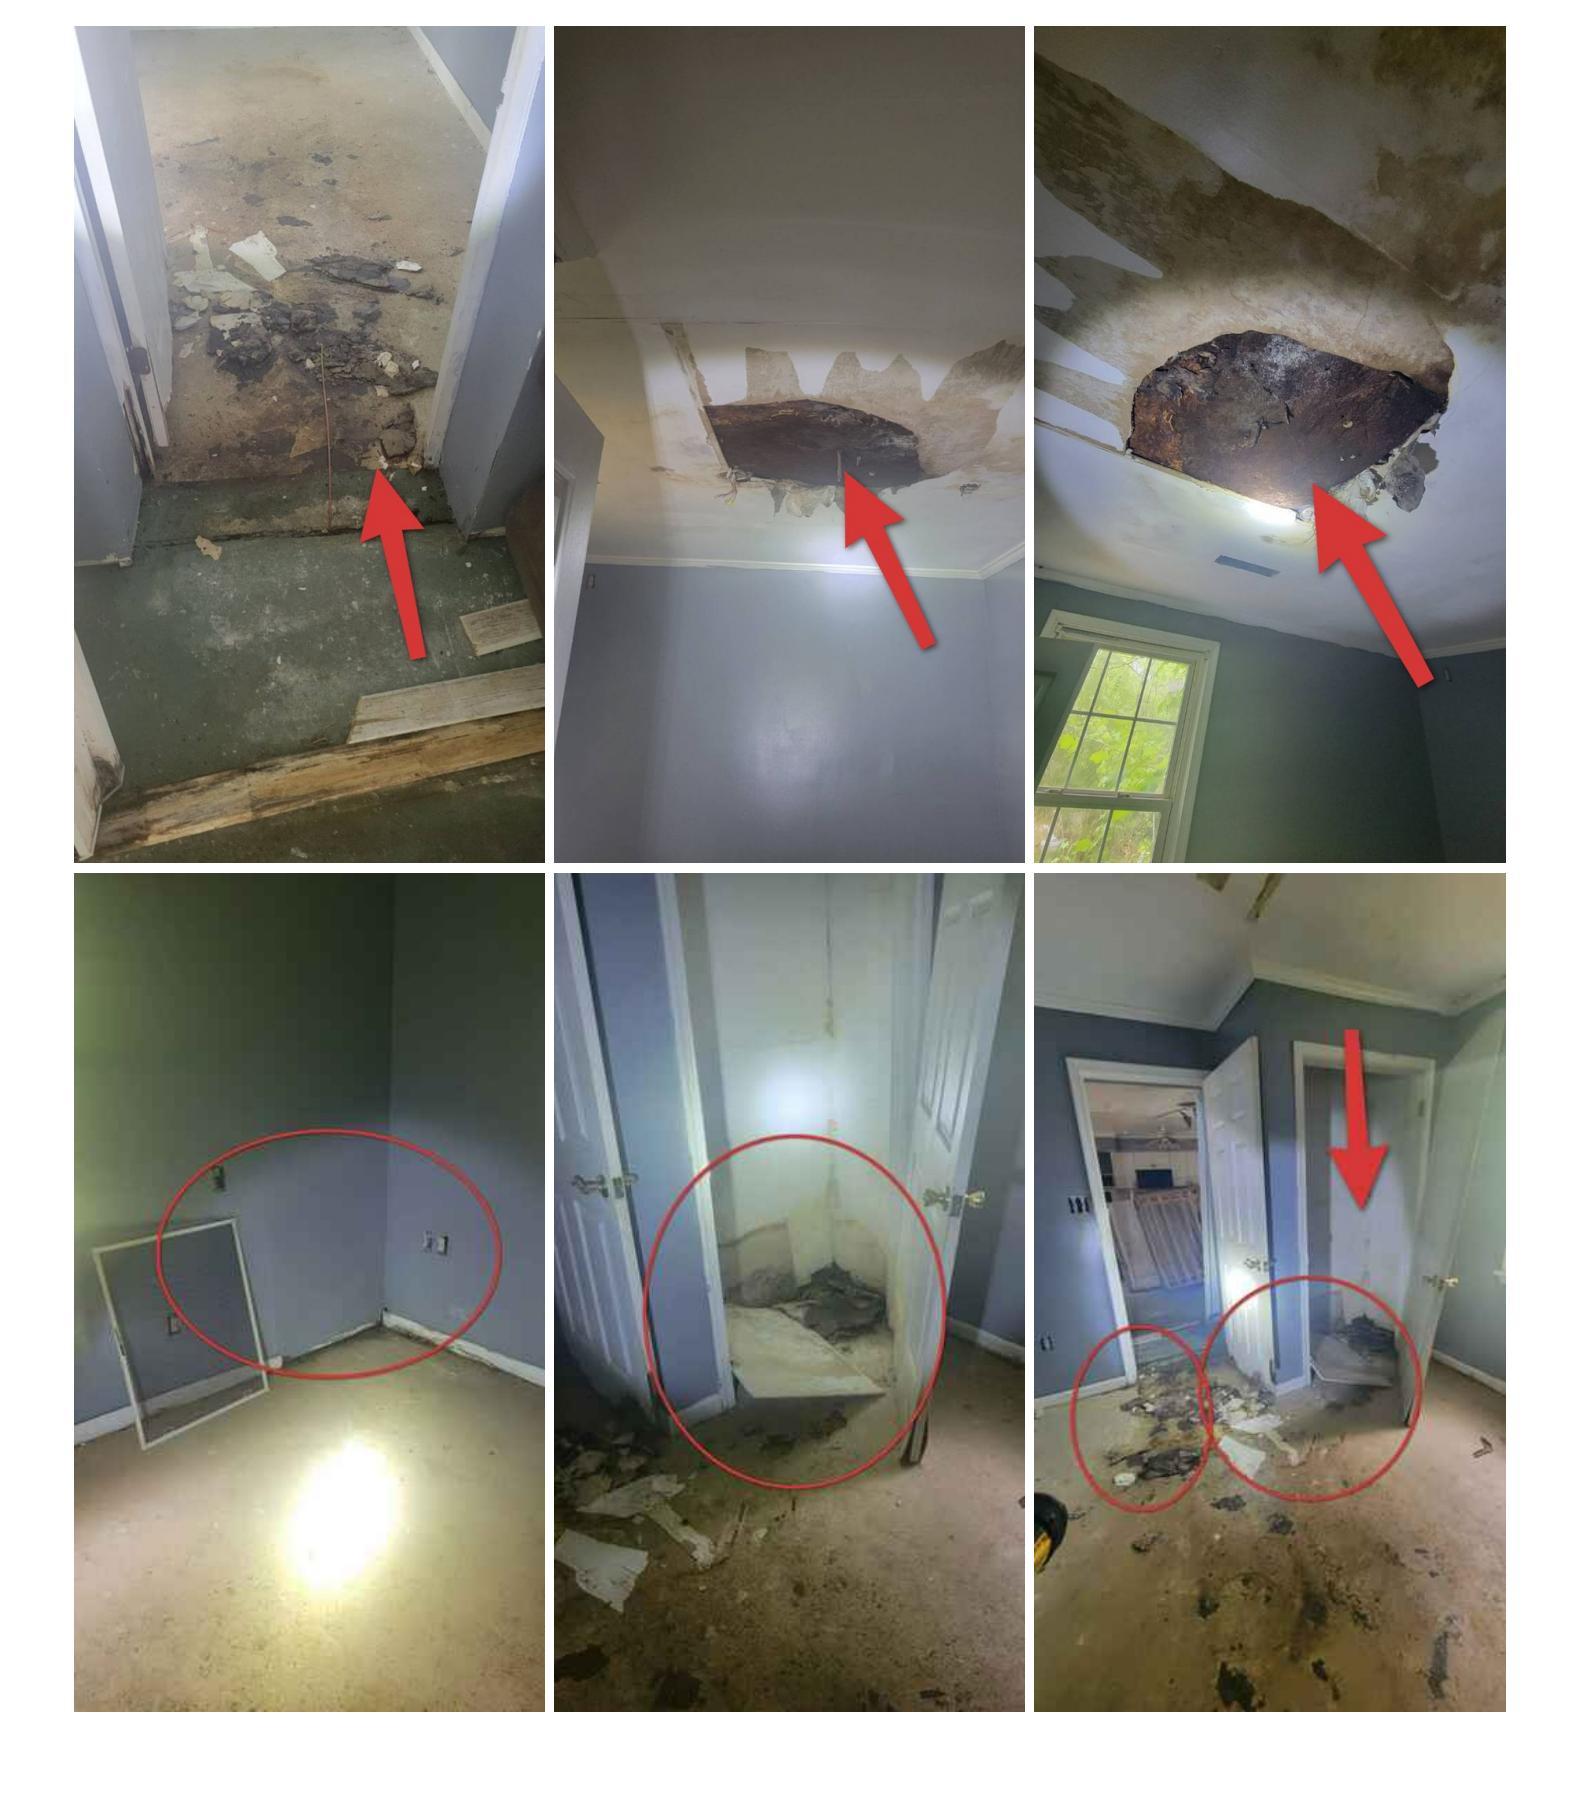
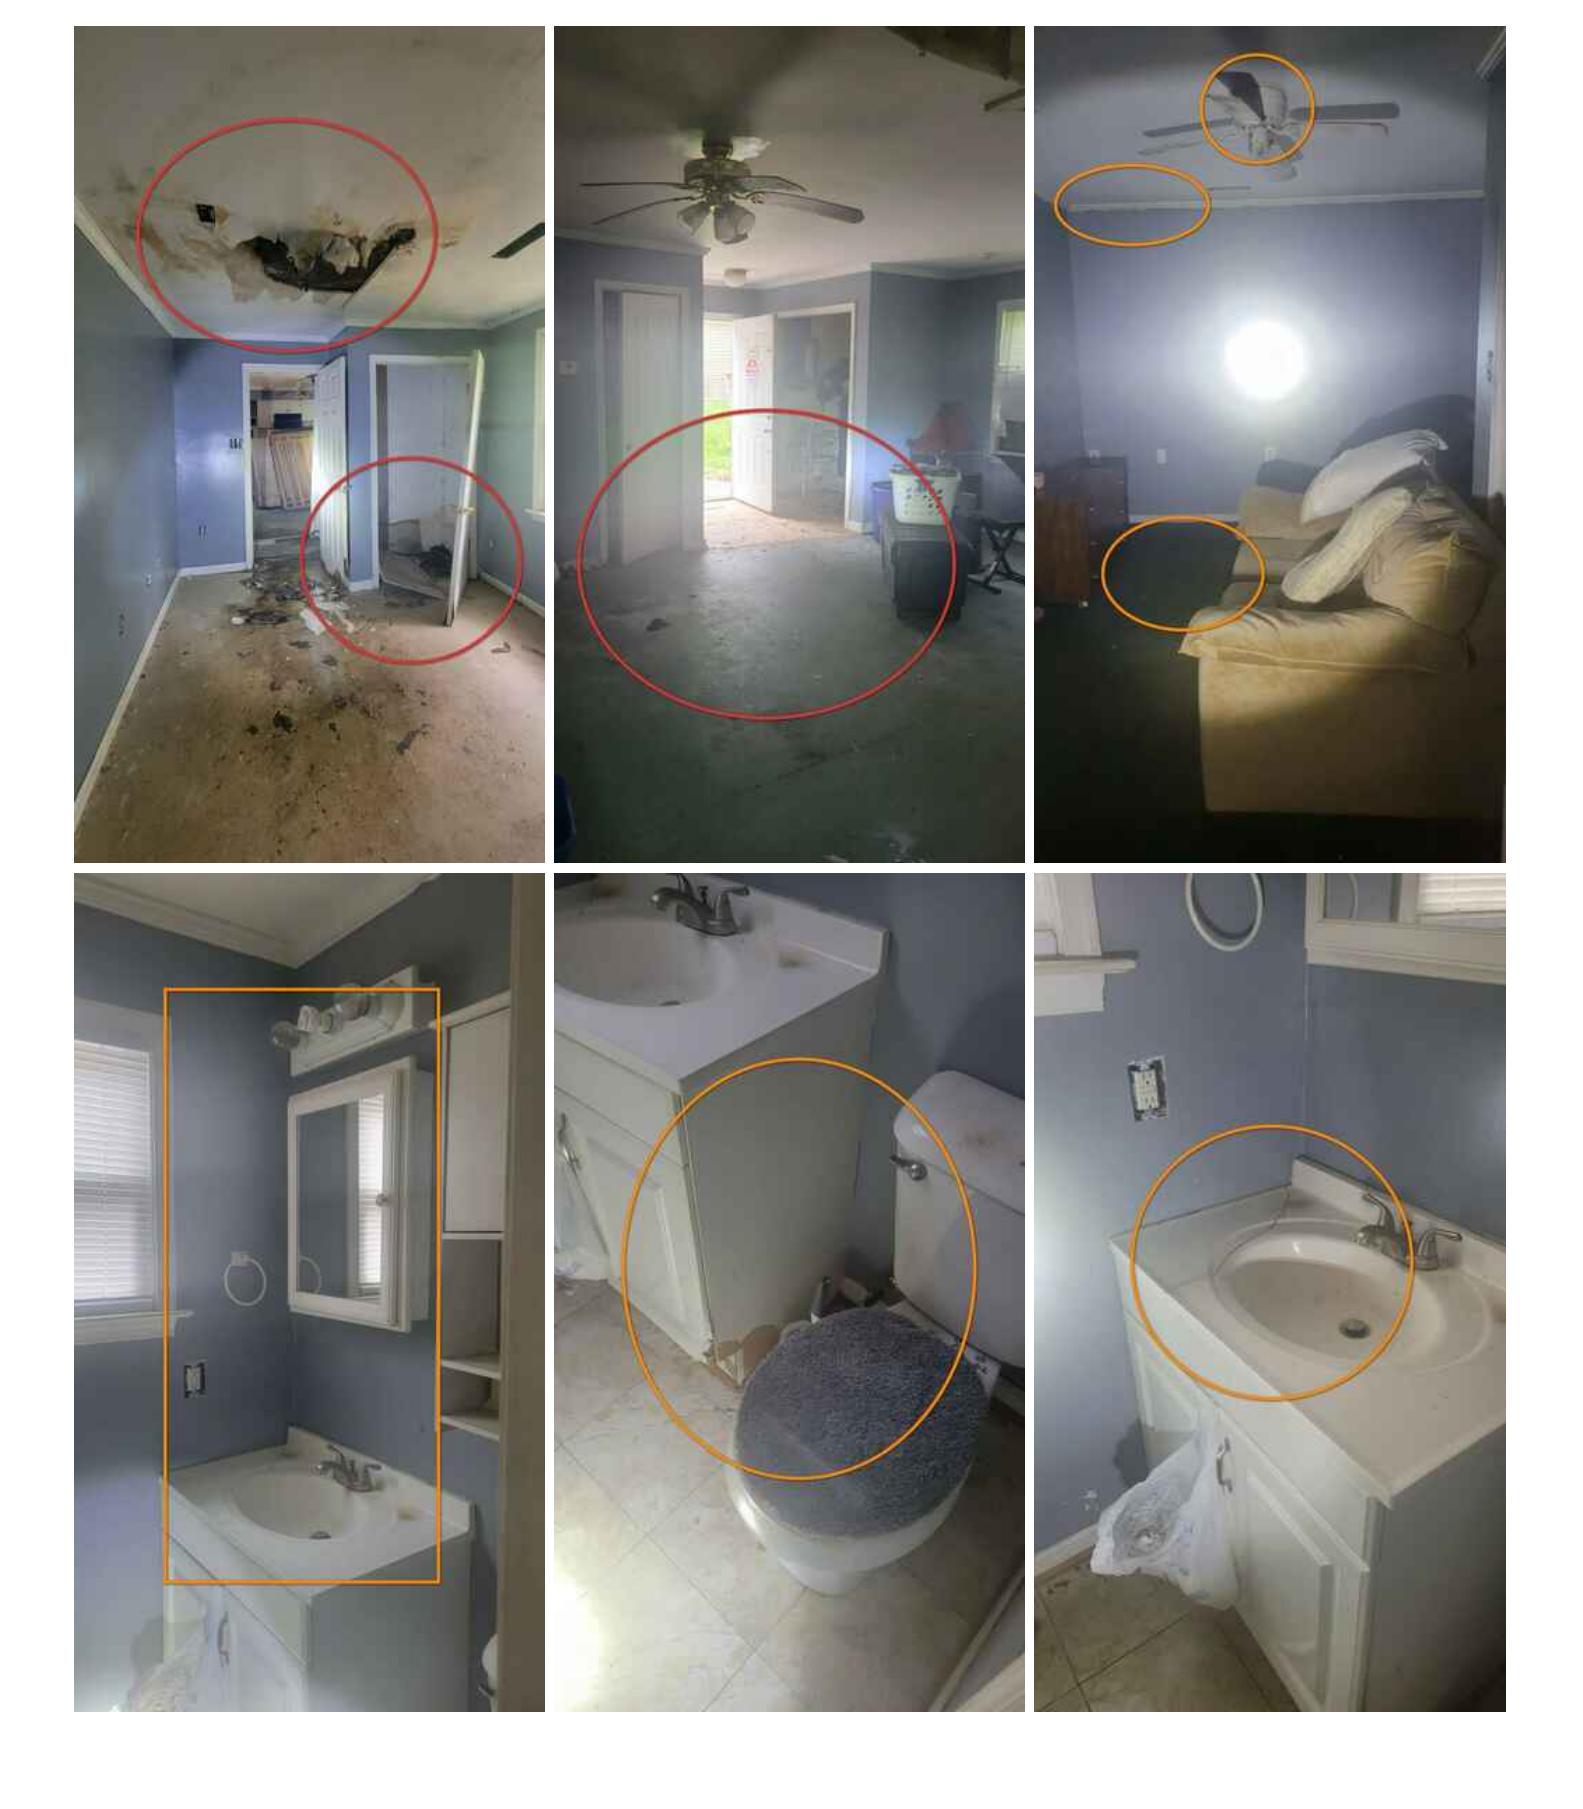
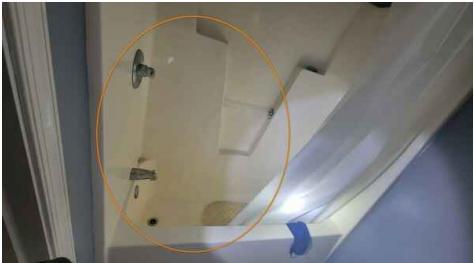
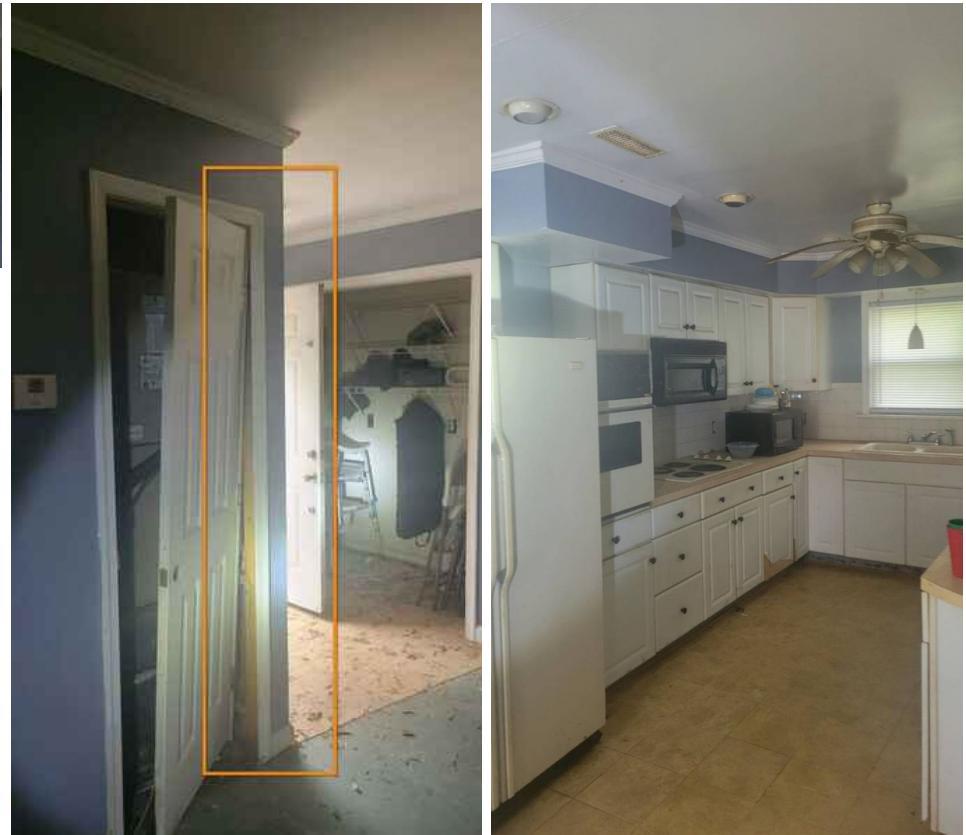
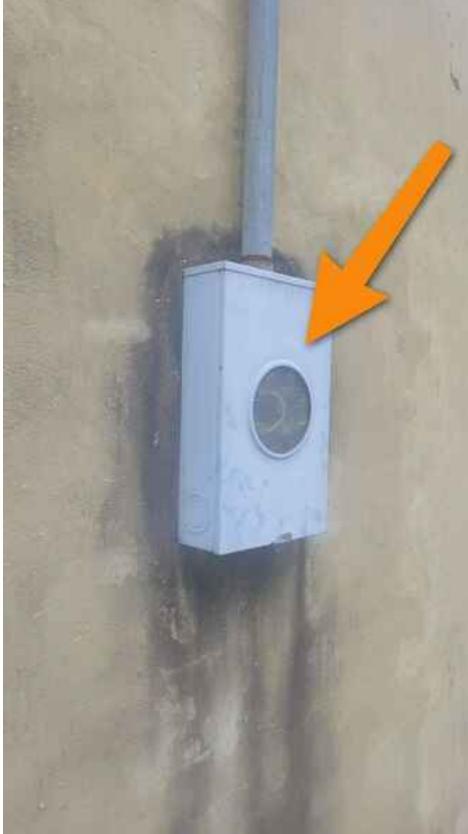
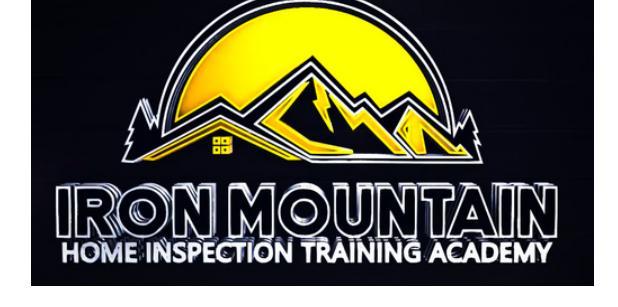
9.1.2 Ceiling, floor, walls and fire walls, garage door, windows and entrance doors **REAR BUILDING: INTERIOR DEFECTS**

Numerous interior defects are evident in the rear building. The flat roof has failed, resulting in water leakage throughout the structure, affecting multiple areas. Water pooling on the roof has left impressions, indicating improper slope (flat roofs are not entirely flat). Additionally, water is infiltrating the garage section of the building. The building is deemed unsafe due to the risk of ceiling collapse from water weight on the structure.

The extensive water damage has compromised the electrical system. Although the meter is disconnected, it is likely that wiring and light fixtures on the ceiling and in parts of the wall have been damaged. An electrical contractor is recommended for assessment.

The rear glass doors are damaged, with a hole in the bottom covered by a wood block. The kitchen exhibits signs of general wear, with missing or non-operational plumbing, and multiple lights and switches lacking covers, likely affected by water intrusion. Cabinets show signs of typical wear. Appliances are aged and damaged, and the flooring throughout the building is also damaged. Countertops show signs of wear, and the kitchen sink and faucet are in poor condition. GFCIs need to be installed in this area.

Water has leaked into the closet area, weakening the wall, base of the structure, and the entire closet area. In the bathroom, the sink is cracked, the vanity is loose, plumbing is poorly installed, and the toilet base and faucets are loose or damaged.

Ductwork in the ceiling is likely damaged from moisture intrusion. The roof sheathing, roof framing, ceiling framing, wall framing, parts of the structure and drywall have all been affected by the moisture intrusion from the failed flat roof.

A qualified contractor is recommended to evaluate and repair the building. Due to the extensive work required, an experienced general contractor is preferred. It is advisable to map out a schedule and contract for large repairs to avoid issues with money and time.

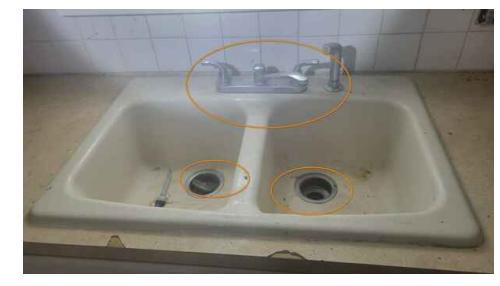
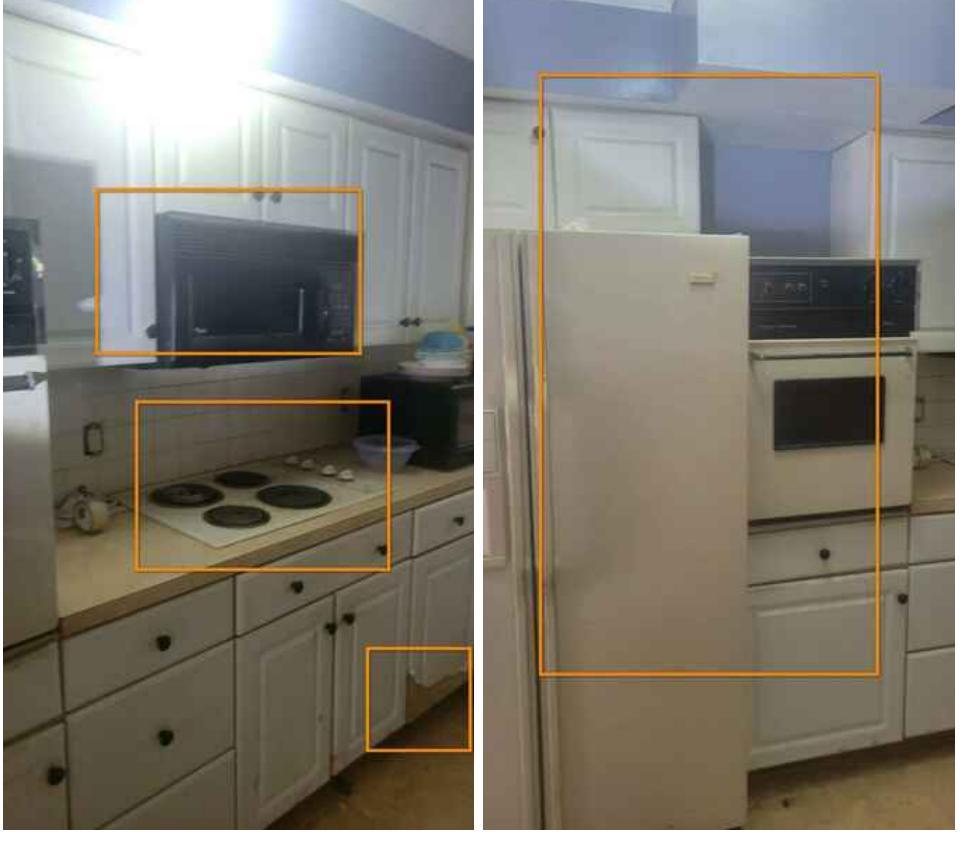
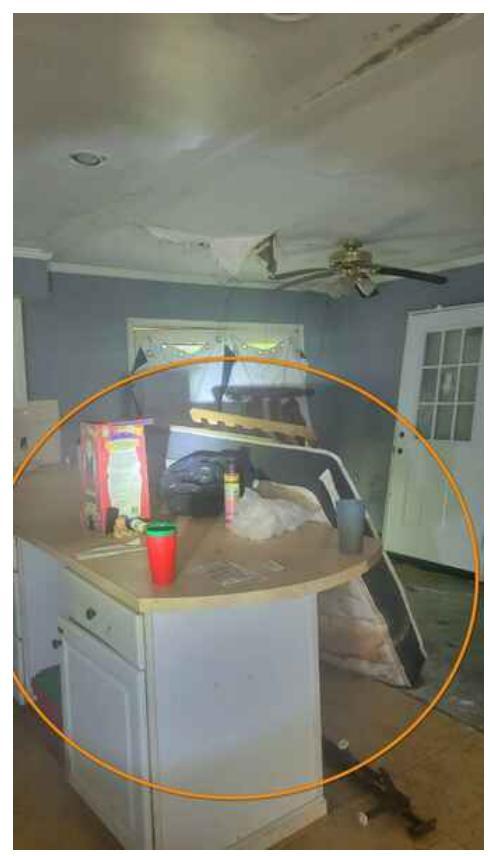
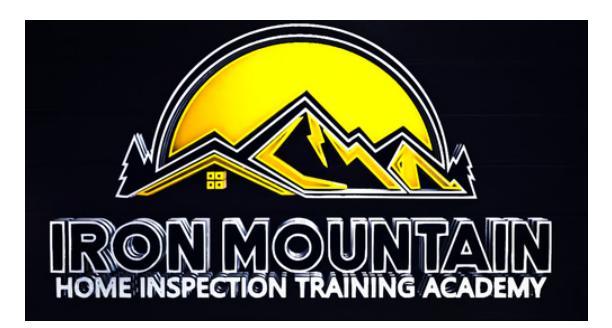
9.1.3 Ceiling, floor, walls and fire walls, garage door, windows and entrance doors **GENERAL ISSUES IN KITCHEN**

The rear building features a full kitchen with several defects: the cabinets exhibit signs of wear and damage, the appliances show signs of aging and damage, the countertops display signs of damage, and both the flooring and backsplash show signs of wear. Remediation is recommended.

To address the cabinet issues, they can be remediated by sanding and painting them or replaced entirely with new cabinets.

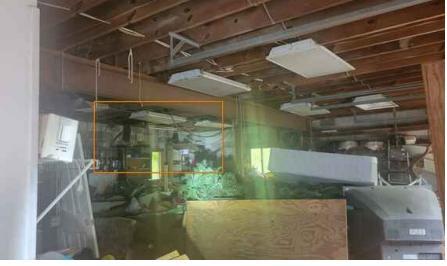
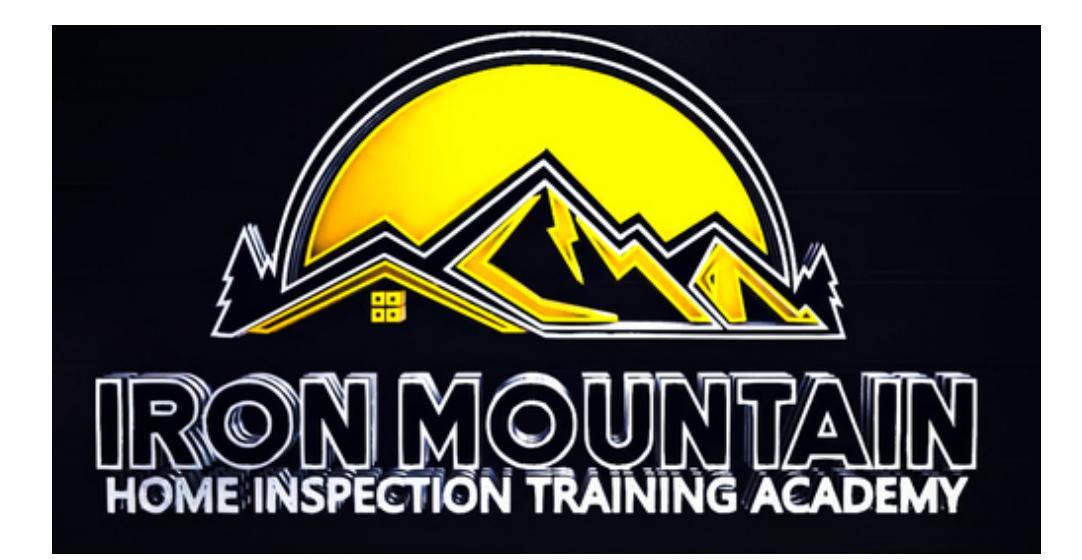
9.1.4 Ceiling, floor, walls and fire walls, garage door, windows and entrance doors **DEFECTS FOR GARAGE SIDE OF REAR BUILDING**

The garage section of the rear building is experiencing water leakage into the structure. It has a separate electrical panel, but the panel cover has been removed and wiring is hanging out. It seems that previous work was being performed on the panel, and this area also contains switches and receptacles. It is advisable to have an electrician conduct a full diagnostic on both buildings and recommend repairs. With three panels and two meters on the property, there is a significant amount of wiring installed, so an electrician is recommended for evaluation and repair. Additionally, a roofer should be recommended to replace the roof.
