Iron Mountain Home Inspection Training Academy

SUMMARY PDF HOME INSPECTION REPORT FOR TRAINING PURPOSES (DEFECTS ONLY)

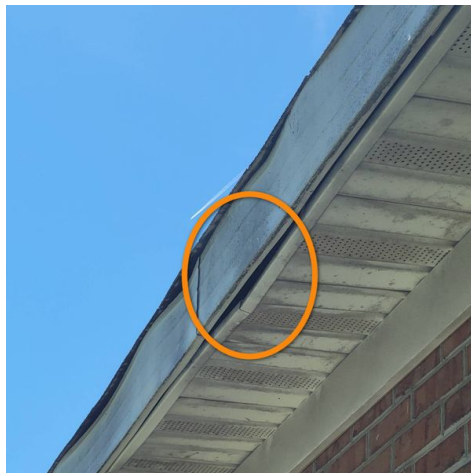
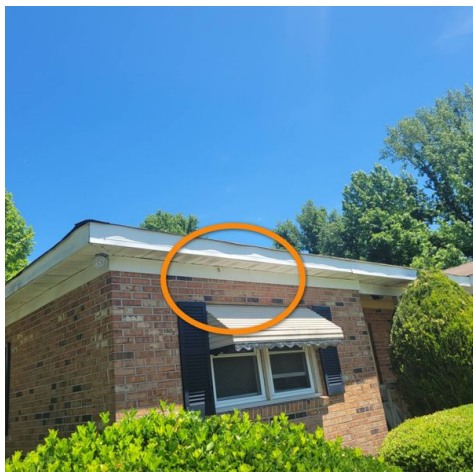
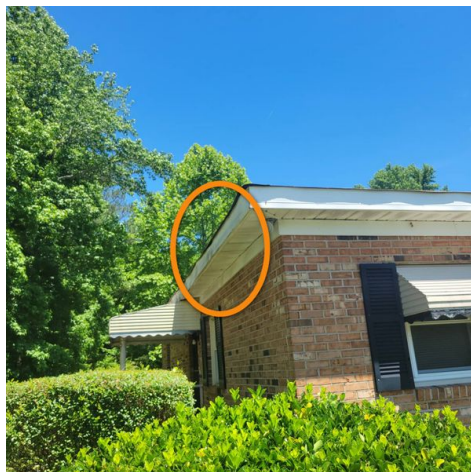
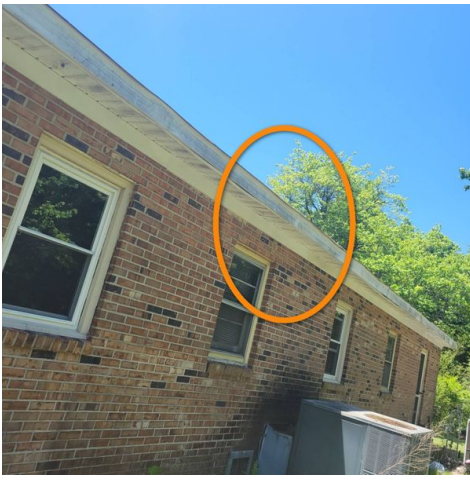
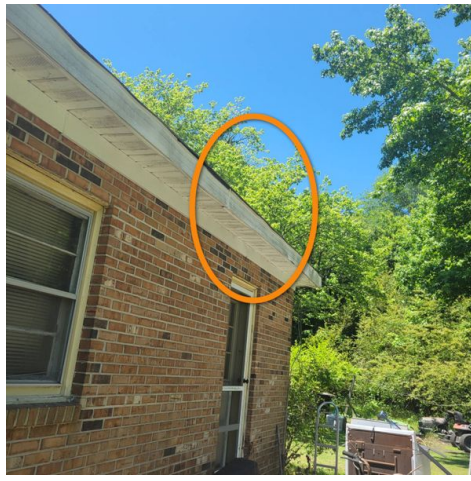
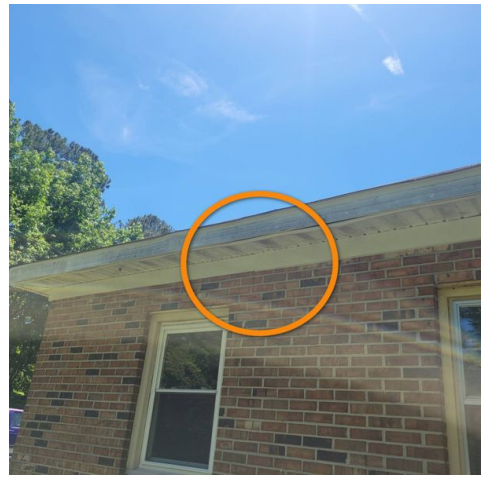
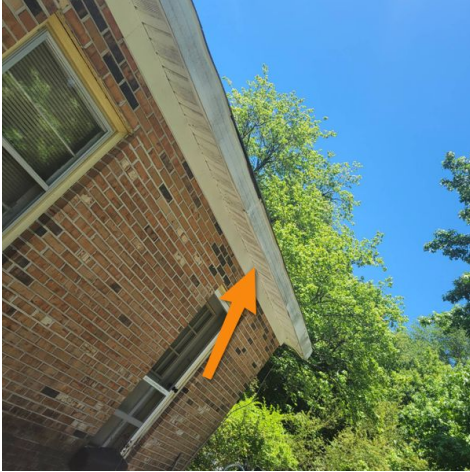
FASCIA AND SOFFIT LOOSE OR SEPARATED

During the inspection, it was observed that the Fascia and soffits exhibit signs of being loose or separated. Such conditions can lead to water infiltration around the roof edges. In some instances, the lumber beneath the metal flashing may have incurred damage due to this looseness. These components are typically secured to the home with nails and can be tightened to prevent moisture intrusion. It is recommended to seek evaluation and repair from a qualified contractor to address these issues effectively.

Contact a qualified roofing professional.

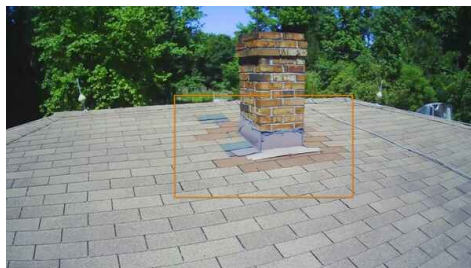
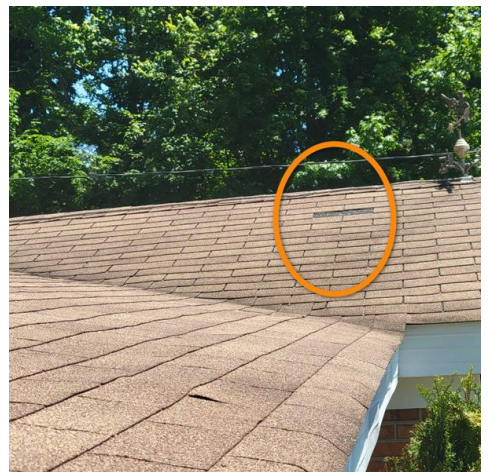
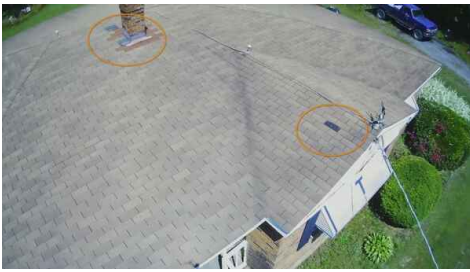
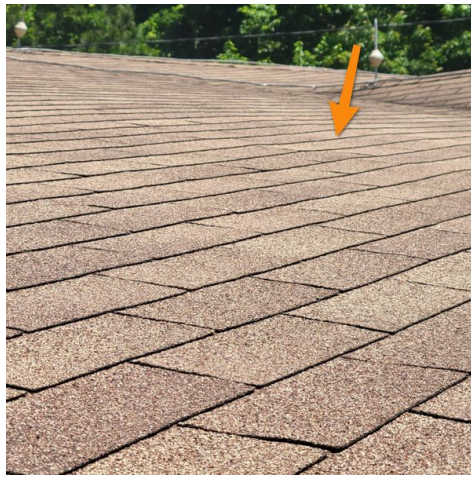
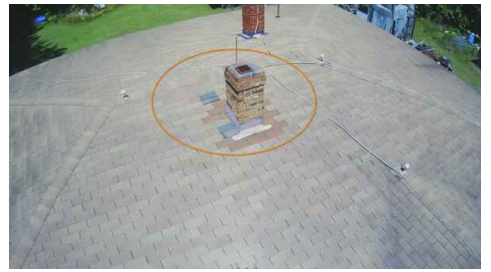
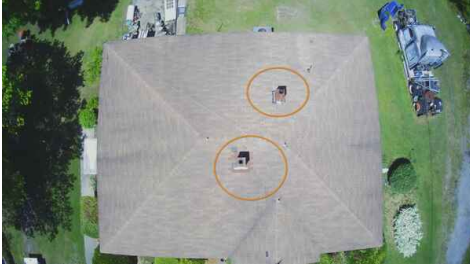
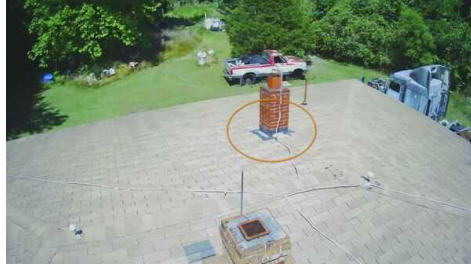
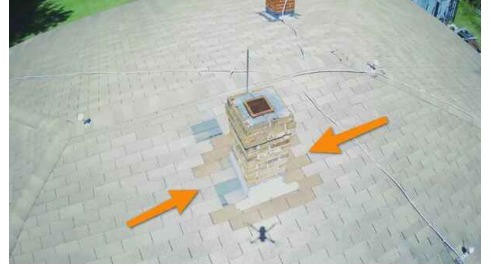
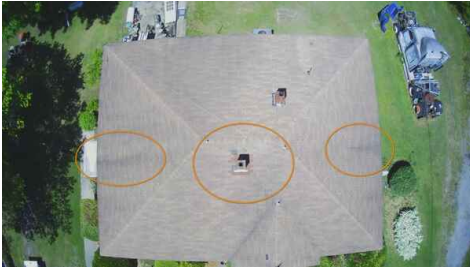
THE ROOF IS NEAR THE END OF ITS SERVICE LIFE

The roof shows signs of significant wear, nearing the end of its serviceable life, with leaks evident within the living area. These leaks may stem from damaged flashing around the chimneys, this area has been patched. Missing shingles and a wavy appearance on the roof indicate aging roof sheathing, a common occurrence (aged roof sheathing in attic). When replacing the roof, it's advisable to address the chimney flashing to prevent future issues. Moisture intrusion in the attic has also been observed, alongside uncapped chimneys. Concerning the moisture stains on the ceiling, no additional water sources were identified in the visible attic areas. *Recommend a roofing contractor to evaluate and repair or replace this roof.*

Contact a qualified roofing professional.

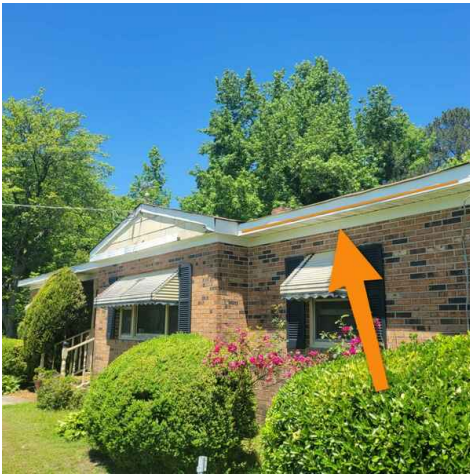
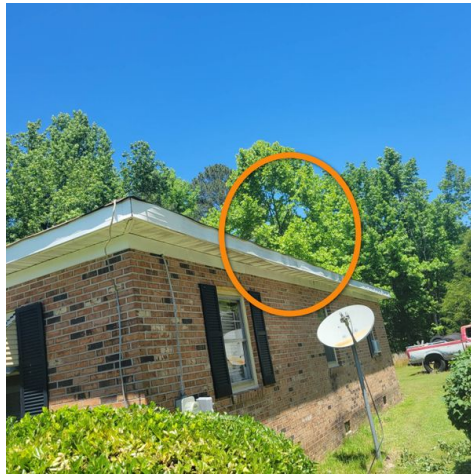
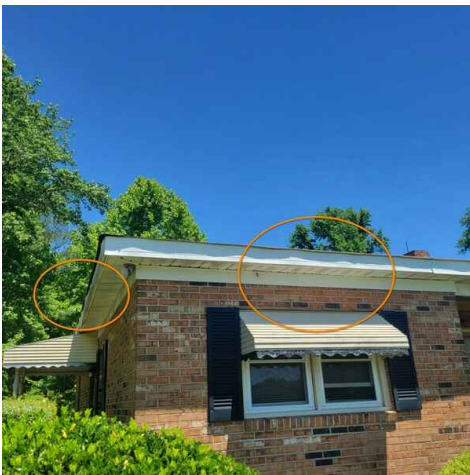
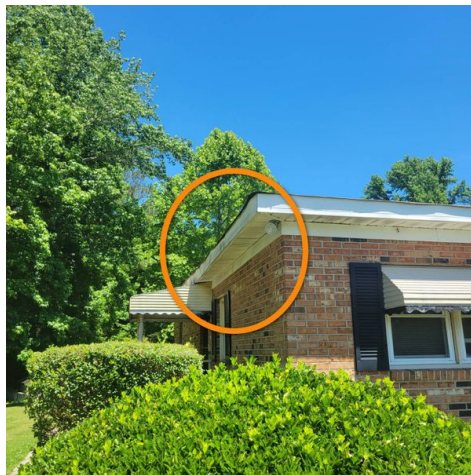
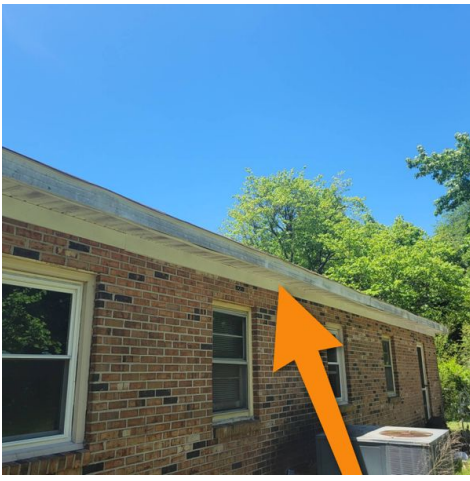
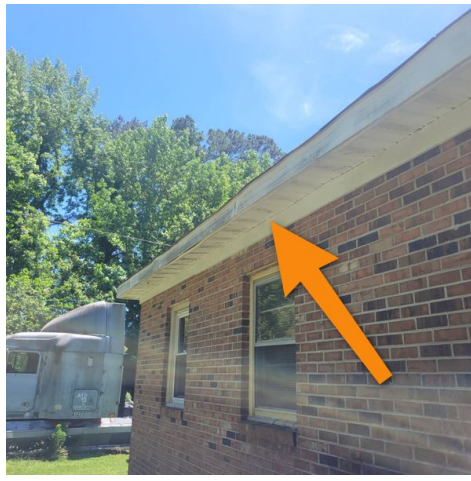
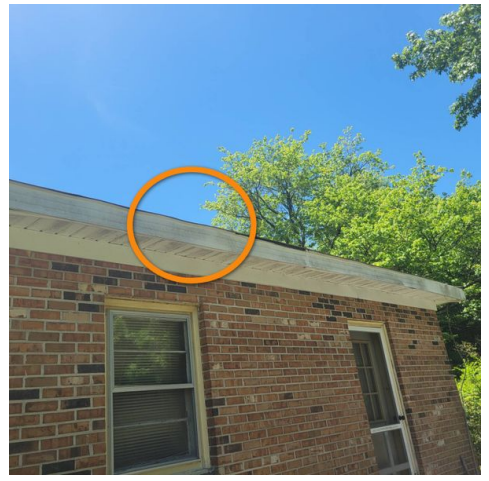
NO GUTTERS INSTALLED

It is advisable to install gutters to divert water away from the home, helping to prevent potential water damage. Additionally, the presence of a hipped roof provides ample space for gutter installation, as all four sides feature a fascia.

Recommendation
Contact a qualified gutter contractor

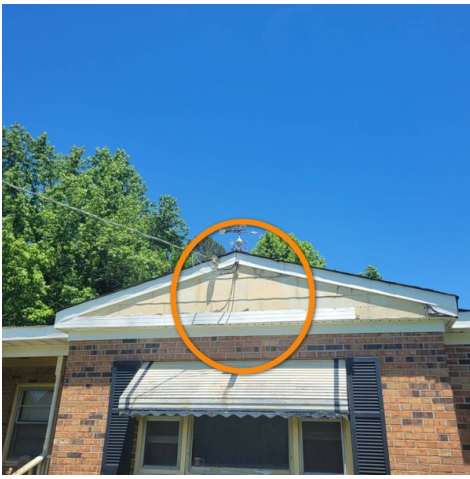
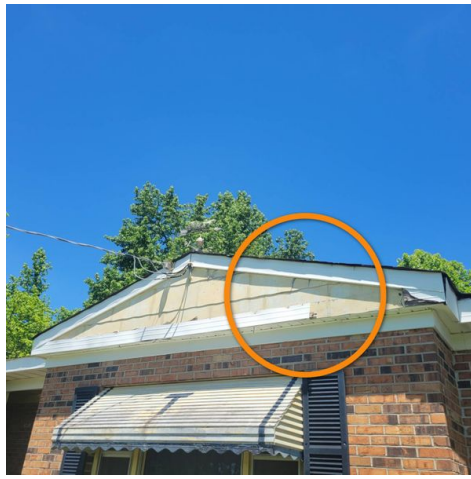
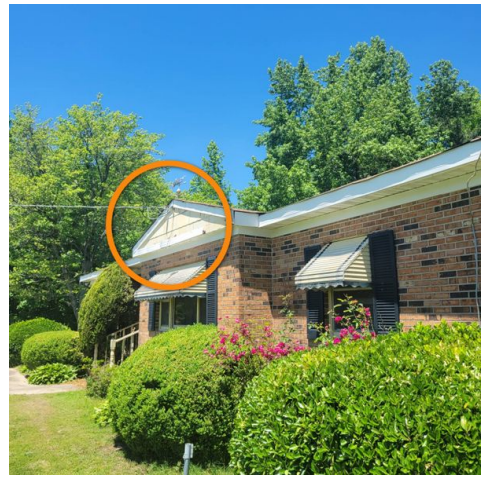
3.1.1 Siding, Flashing & Trim, exterior doors, eaves, soffit vents, windows and fascia
ASBESTOS SIDING OBSERVED
EXTERIOR (FRONT ONLY)

1. Asbestos shingles observed at the time of inspection. Recommend a qualified contractor to evaluate and remedy.
2. Asbestos siding can be encapsulated, painted, replaced or a combination of repairs can be performed. It is recommended not to disturb asbestos shingles. Recommend a qualified contractor to evaluate and repair.
3. Note: This only effects the front section of the home. The easiest way to mitigate this is to have it painted or to have vinyl siding installed over the shingles.

Contact a qualified siding specialist.

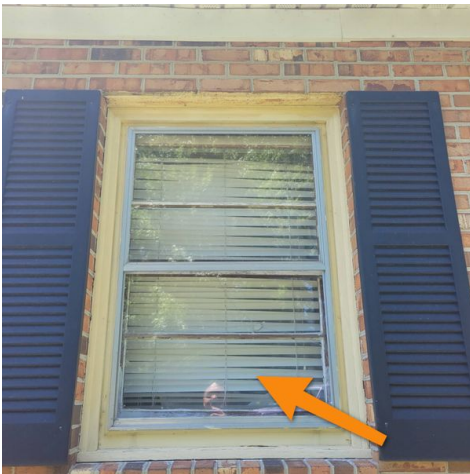
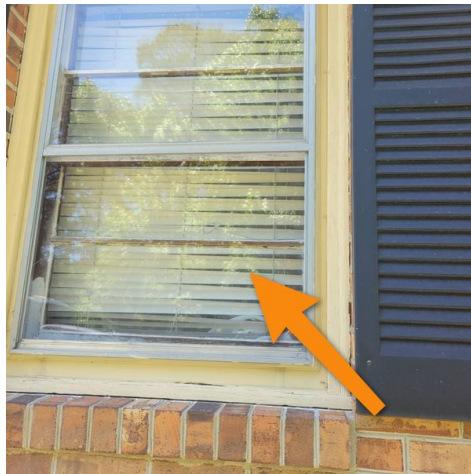
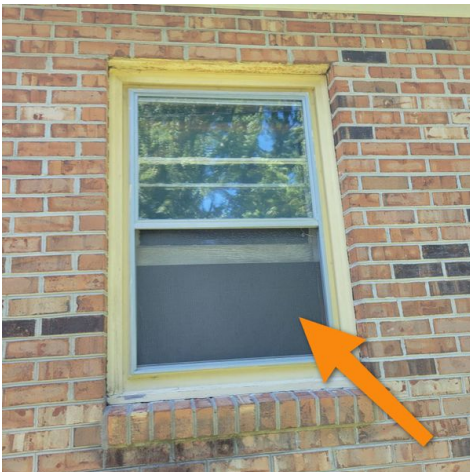
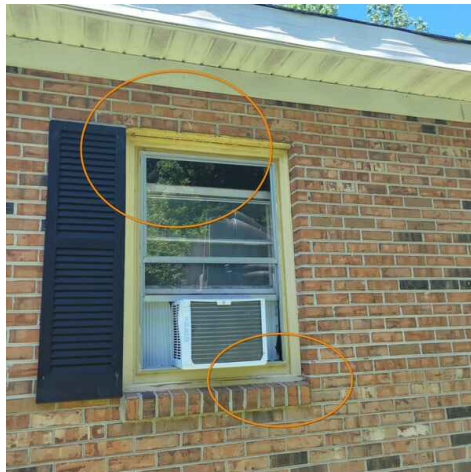
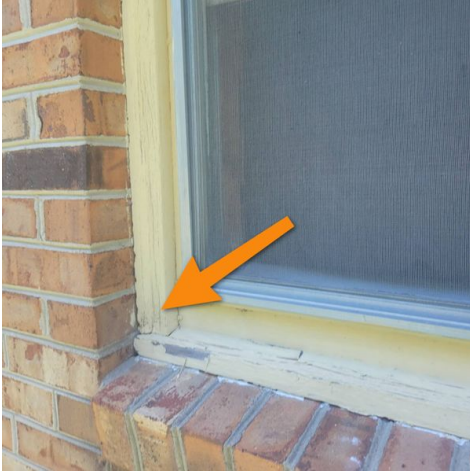
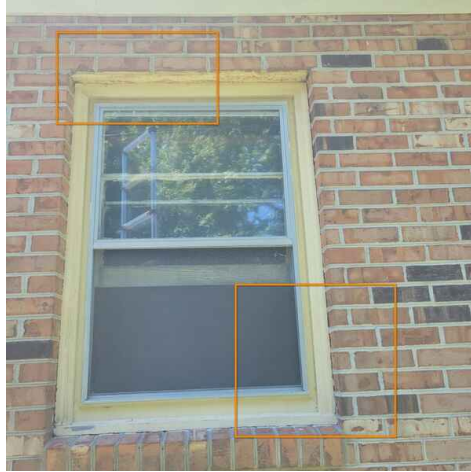
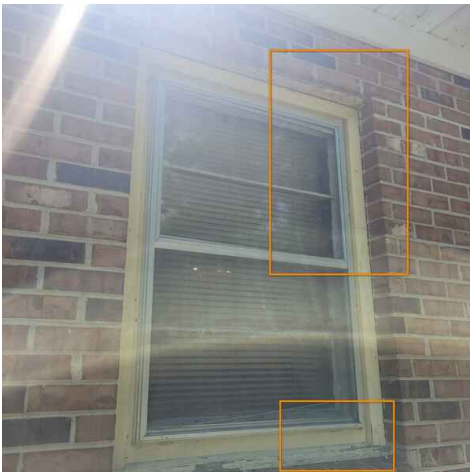
3.1.2 Siding, Flashing & Trim, exterior doors, eaves, soffit vents, windows and fascia
CRACKED OR DAMAGED WINDOW/WINDOWS ARE IN POOR CONDITION

1. Multiple windows are cracked or damaged. The majority of the windows in poor condition. These windows are wood-framed, and several have cracked glass and damaged locking mechanisms, while others are missing screens. It is recommended to have these windows replaced.
2. Rusted lintels are observed on the tops of the windows. This is common for the age of the home.

Recommendation
Contact a qualified window repair/installation contractor.

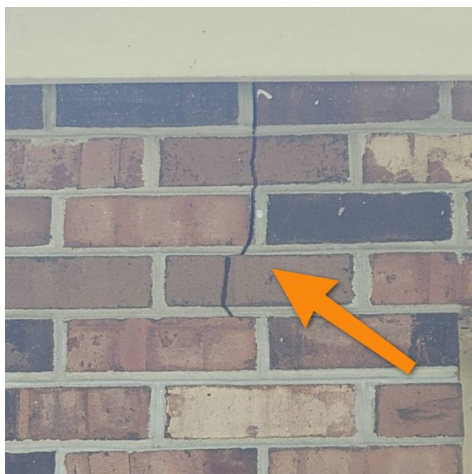
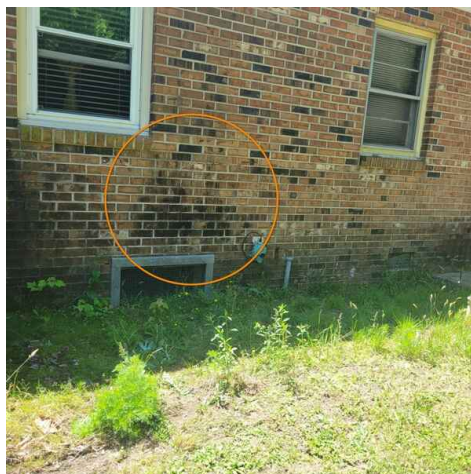
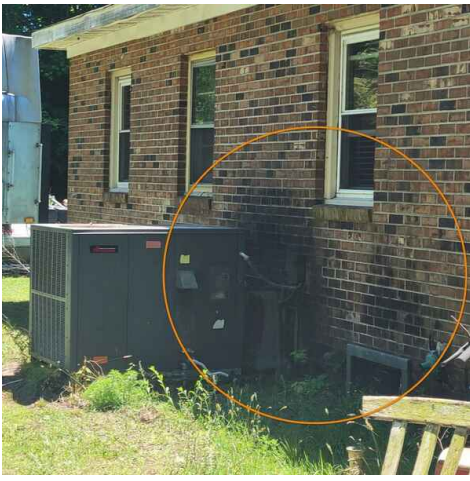
HEAVY SETTLEMENT/EXCESSIVE STAINING ON EXTERIOR BRICK WALL

- 1. Heavy settlement of the home's foundation is observed at the time of inspection. Recommend a qualified contractor to evaluate and repair.
- 2. Excessive staining observed on the exterior brick. Recommend having the home pressure washed.

Recommendation
Contact a foundation contractor.

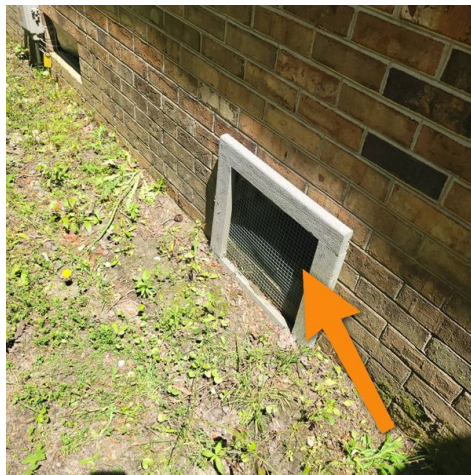
EXAMPLE ONLY (NEW CRAWL SPACE COVER)

1. Damaged crawl space cover or no crawl space cover observed. A tight seal on a crawl space cover helps to keep moisture, rodents and insects out of the crawl space. Recommend a qualified contractor to evaluate and repair.
2. See the example below of a new crawl space cover. These covers are sold in two parts, the top cover slips over the base to create a seal.
3. *There is excessive mold/fungus like substance in the crawl space due to this cover having a screen on it and the crawl space not being sealed.*

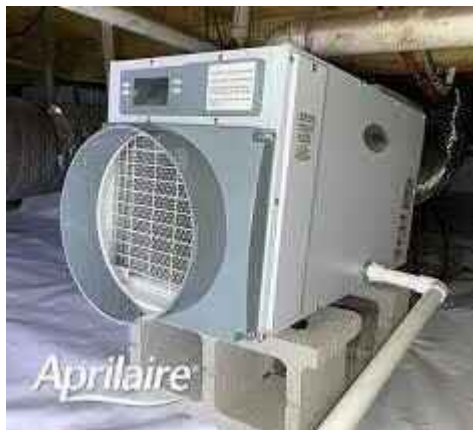
*EXAMPLE ONLY CRAWL SPACE ENCAPSULATION BEFORE AND AFTER

1. There was either no moisture barrier or only a partial one installed in the crawl space. Additionally, the insulation in the crawl space has been removed, which is a minor issue. Furthermore, there is mud and standing water present in the crawl space, leading to excessive mold growth.

Contact a foundation contractor.

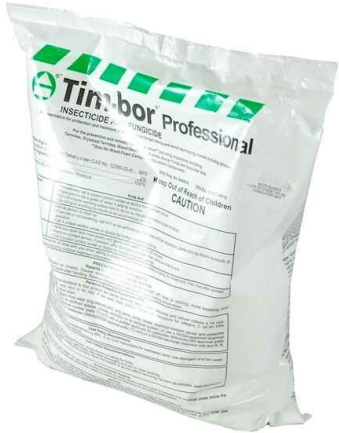
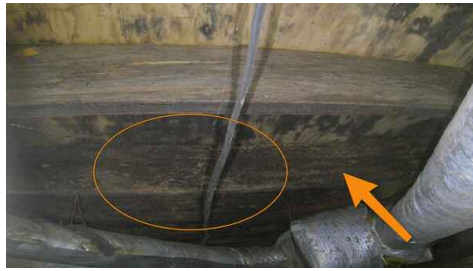
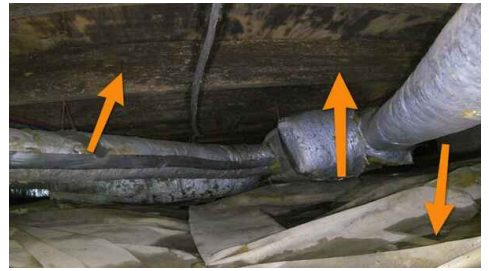
Excessive fungus and mold growth were observed in the crawl space. This is partly attributed to the crawl space cover not being sealed, allowing moisture to accumulate. Additionally, standing water was found under the home, and the barrier beneath the home is damaged. Remediation is necessary for this area. While simple treatments may suffice in some cases, the extensive mold growth has led to the softening and weakening of the joists and structural supports due to compromised lumber.

Recommendation
Contact a foundation contractor.

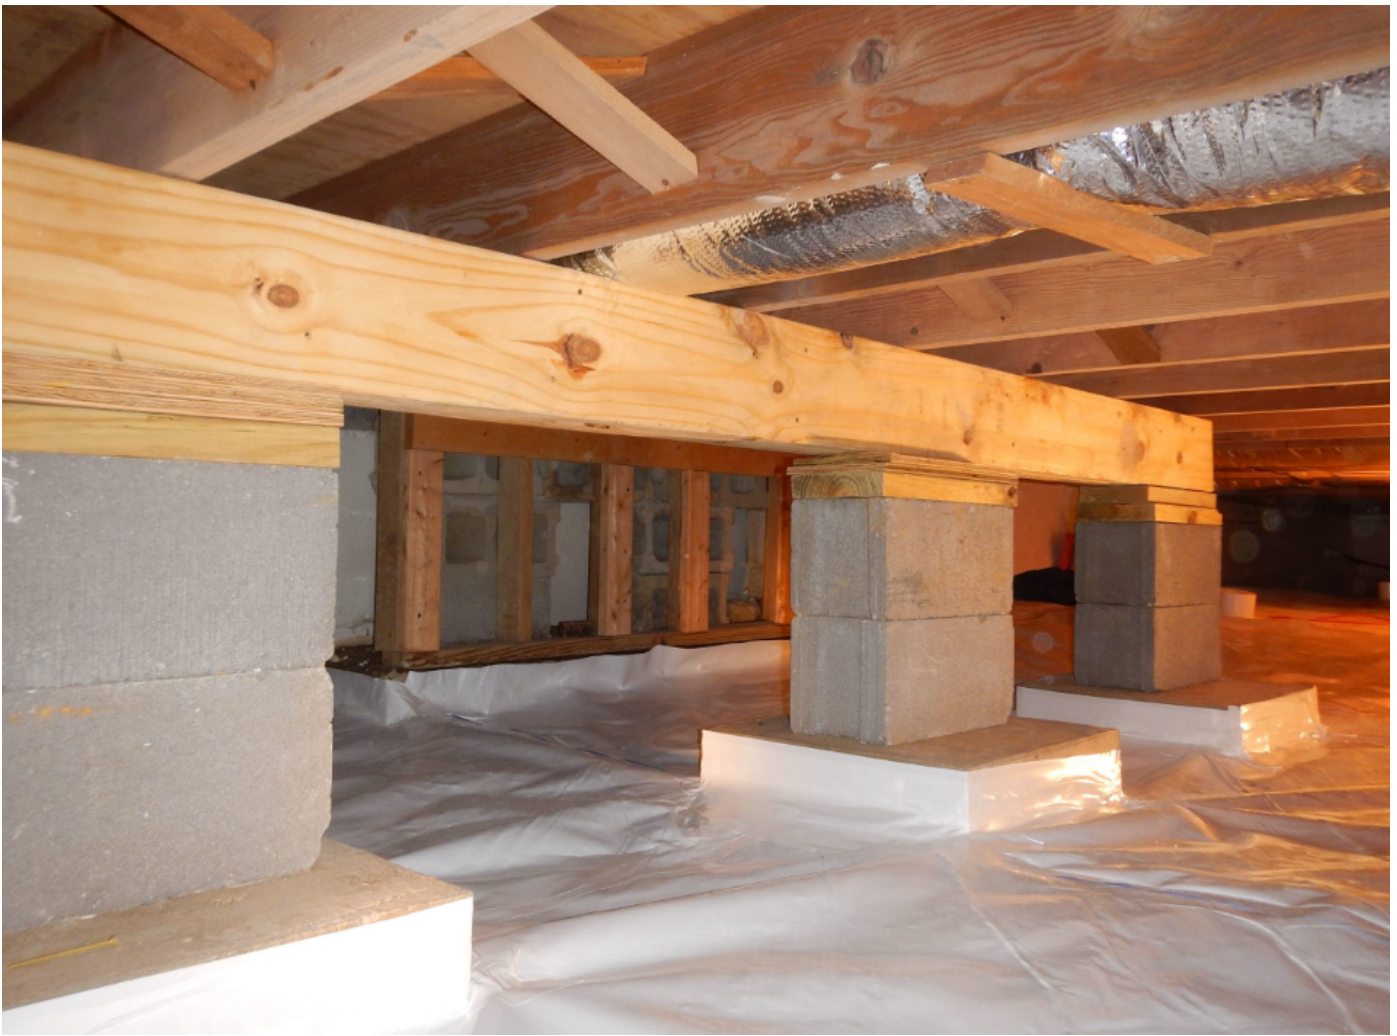
The property, constructed in 1967, is now 57 years and 5 months old. The crawl space is in poor condition, with excessive mold growth that has compromised the integrity of the joists and various areas of the structure. As a result, sections of the floor in the home have become soft and uneven. It is recommended to engage a foundation contractor to evaluate and address these issues. Necessary actions include fungal treatment, joist sistering or replacement, adding additional piers for support, securing the sill, installing a proper door, and adding additional girder beams and concrete or metal piers under the sagging areas of the floor to reinforce the structure. **The damage in this homes crawl space is considered to be excessive.**

Recommendation
Contact a qualified professional.

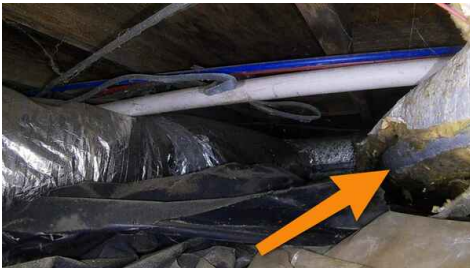
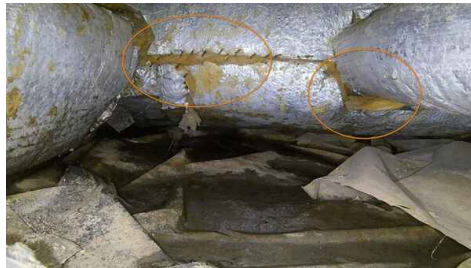
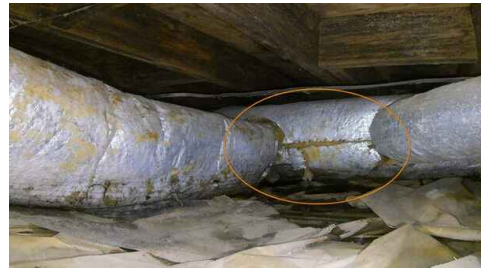
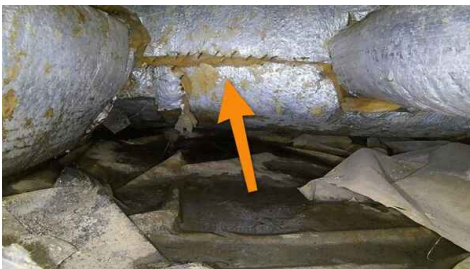
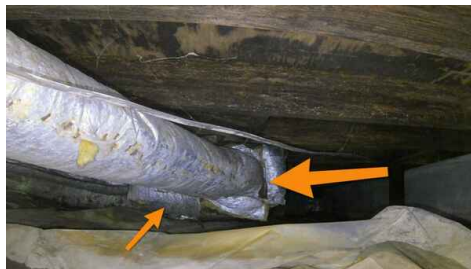
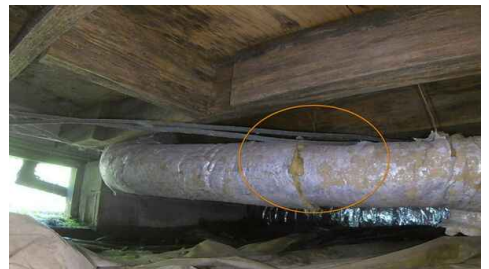
1. Damaged duct work observed at the time of inspection. Recommend a qualified contractor to evaluate and repair.
2. The ducts are connected; however, there are holes in the ducts that cause some AC/heat loss. The vent covers in the home are also aged.

Contact a qualified HVAC professional.

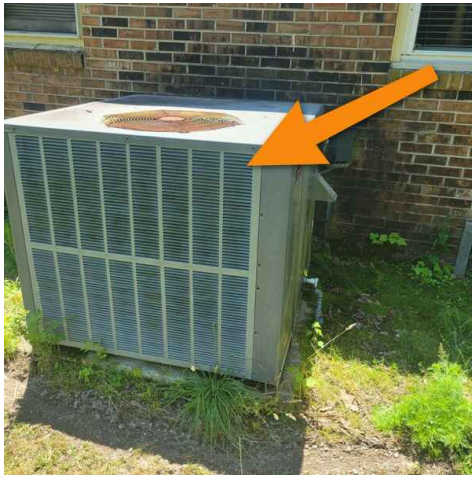
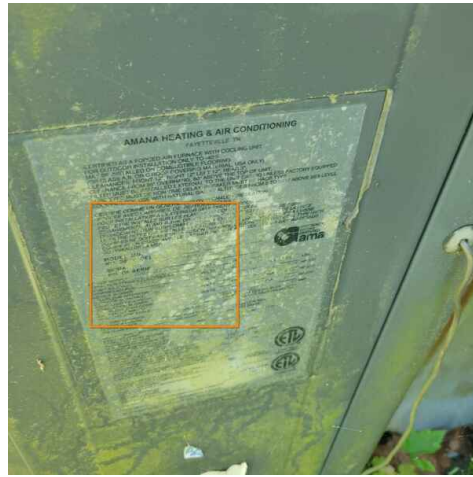
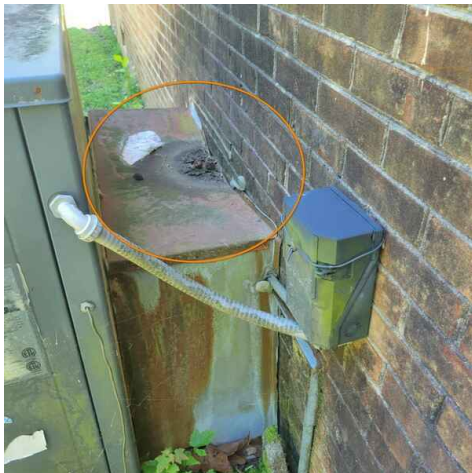
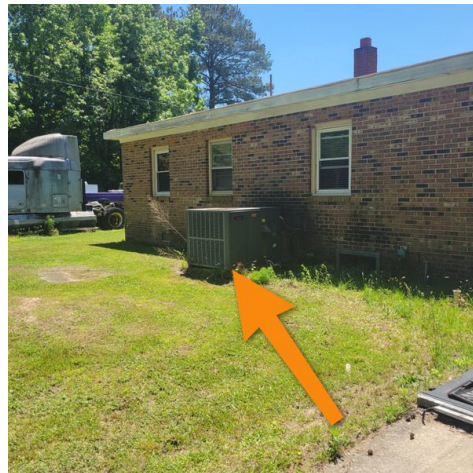
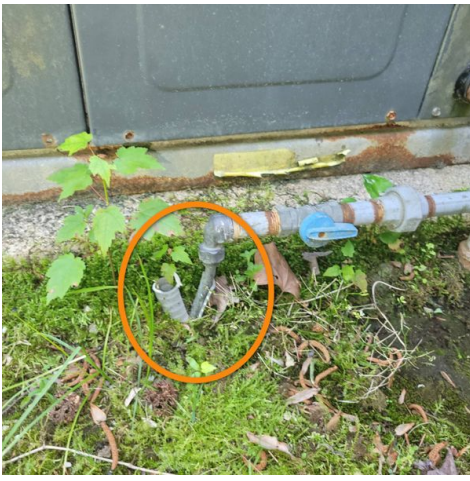
Modern air conditioners can typically last between 15-20 years, benefiting from advancements in technology. However, older units like this one generally have a lifespan of around 12-15 years. The longevity and efficiency of an A/C unit depend on various factors, including regular maintenance throughout its lifetime and adherence to manufacturer specifications.

It's advisable to prepare for the replacement of this unit. The unit is currently operational. The gas line also shows some signs of wear, and the main duct cover is rusted which is allowing water into the crawl space.

Recommendation
Contact a qualified heating and cooling contractor

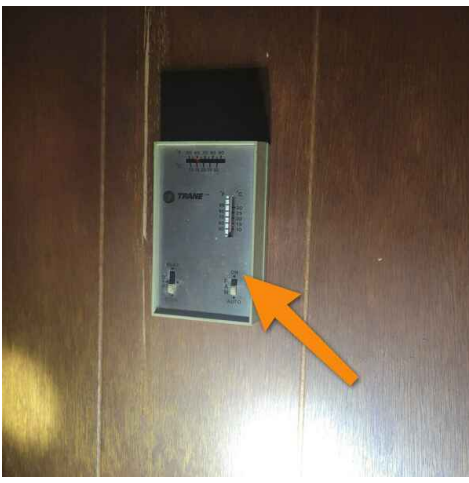
5.2.1 Normal Operating Controls/distribution system/Presence of installed heat/ac source

UPGRADE THERMOSTAT

Aged thermostat observed. Consider having the thermostat upgraded.

Contact a qualified HVAC professional.

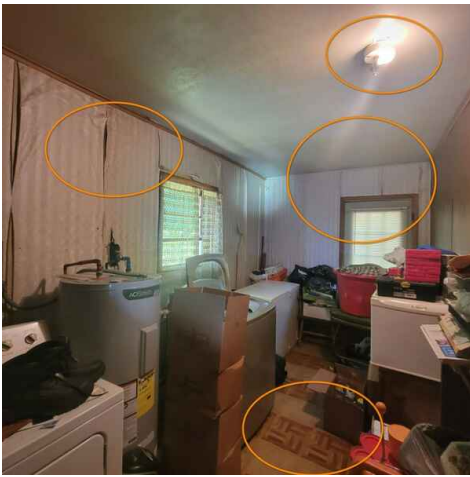
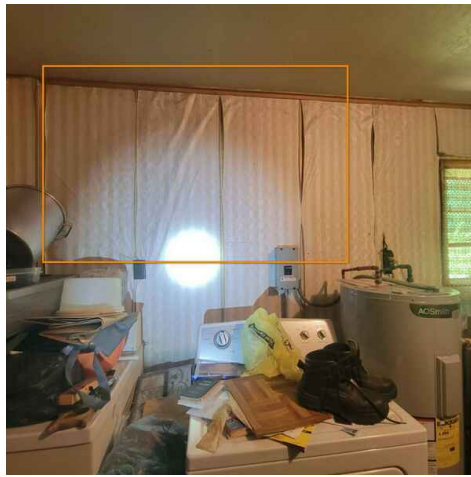
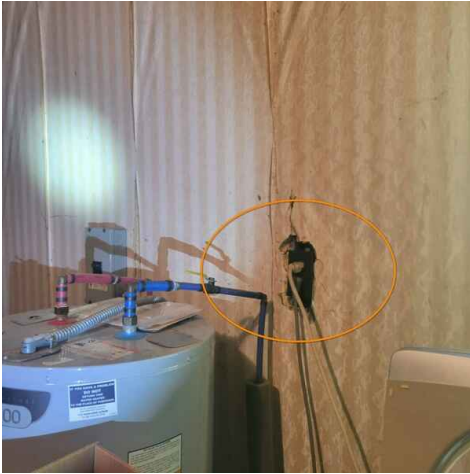
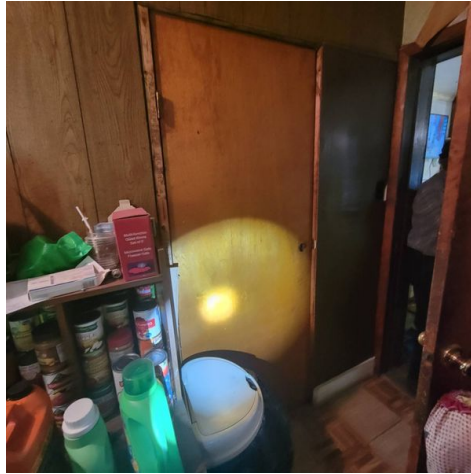
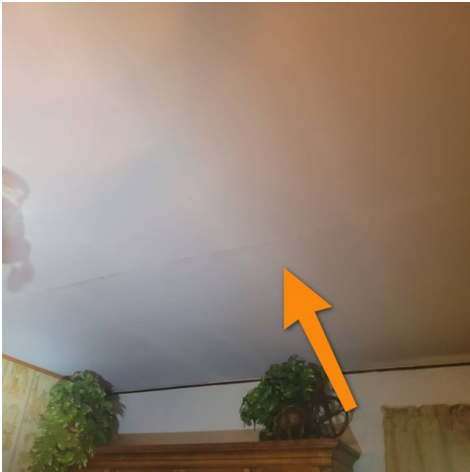
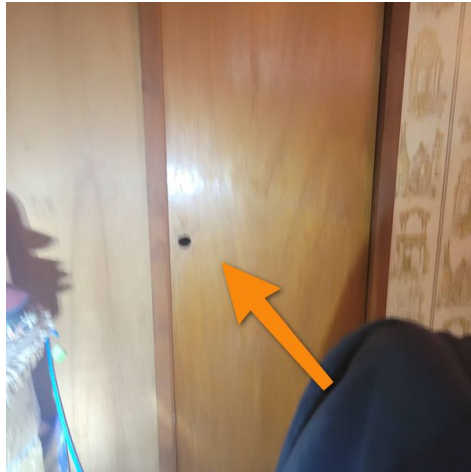
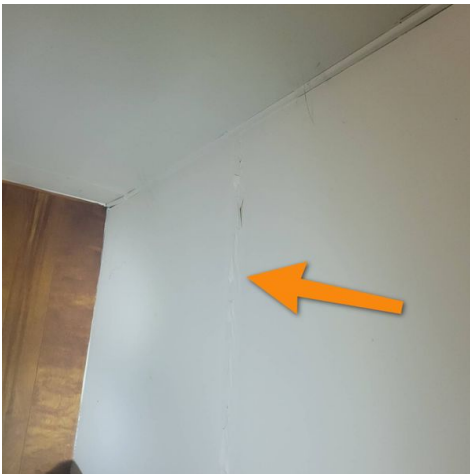
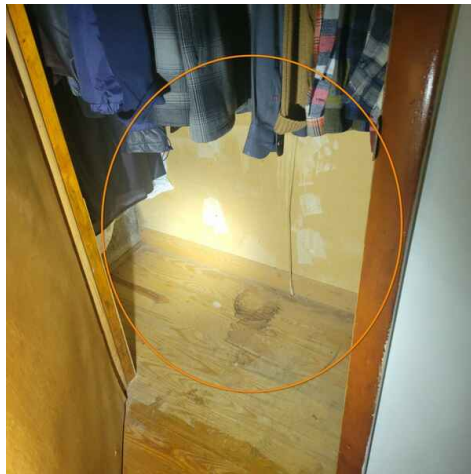
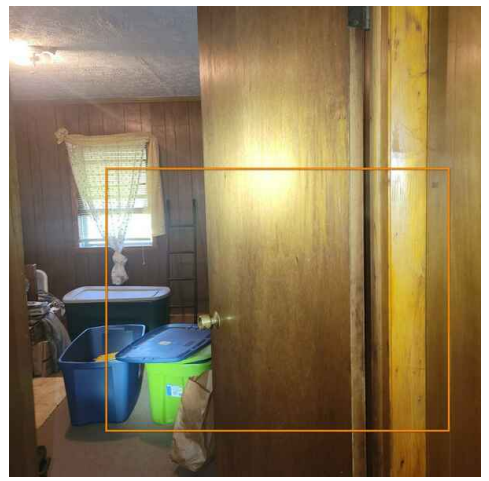
6.1.1 Interior doors, windows, floors, ceilings

MULTIPLE DEFECTS: INTERIOR (GENERAL COSMETIC DEFECTS)

This home has numerous cosmetic defects attributable to its age, wear, and DIY construction. The laundry room's wallpaper is peeling, various walls show poor painting, and cracks have appeared due to settlement and issues in the crawl space (refer to crawl space recommendations). Additionally, the doors have loose hardware and general cosmetic damage, and several parts of the home remain unfinished. Walls and ceilings have stains and are generally in poor condition.

1. Clear the home of all items, including removing wallpaper and materials from walls and ceilings. If keeping the doors, remove them at this stage. Remove the damaged textured ceiling and have the area sanded and prepared for paint.

2. Apply a black paint barrier to the entire floor to protect it and tape all areas near the bottom of the wall with painter's tape.
3. Scrub all walls and ceilings with soap and water, allowing them to dry thoroughly. Patch holes and nail pops in walls and complete all drywall work to repair damaged walls and ceilings.

5. Sand and stain doors and replace hardware if not getting new doors. Paint window frames as needed. Note: wood plank panels can be removed or they can be re-nailed and, sanded and painted to avoid having to remove the glue from the walls.

Contact a qualified professional.

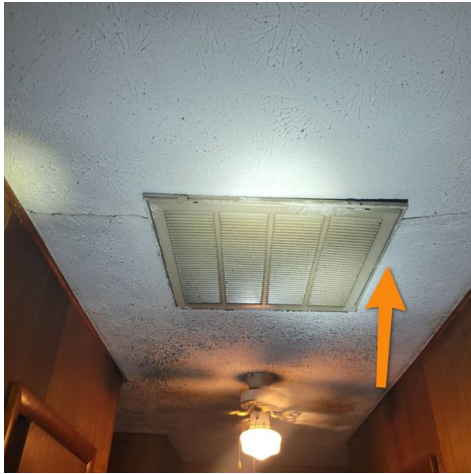
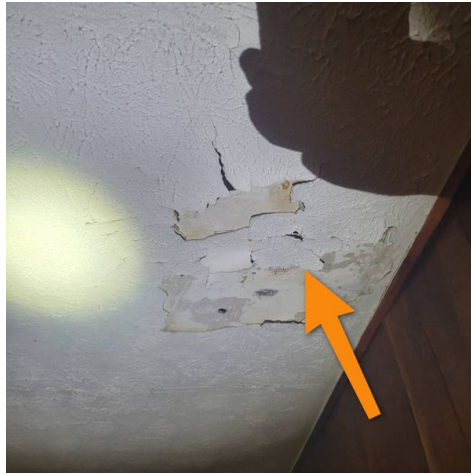
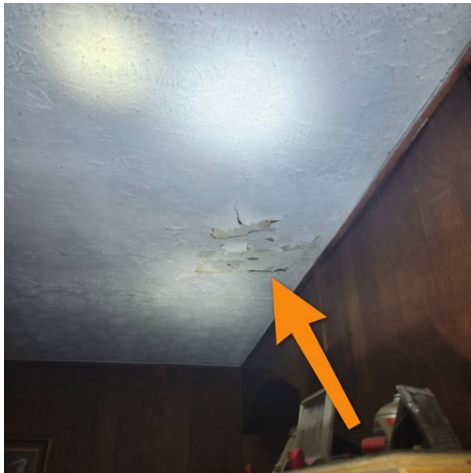
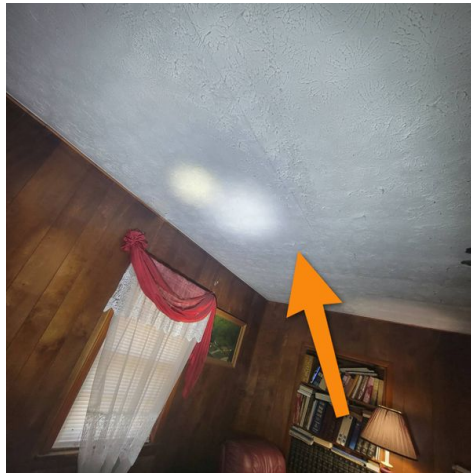
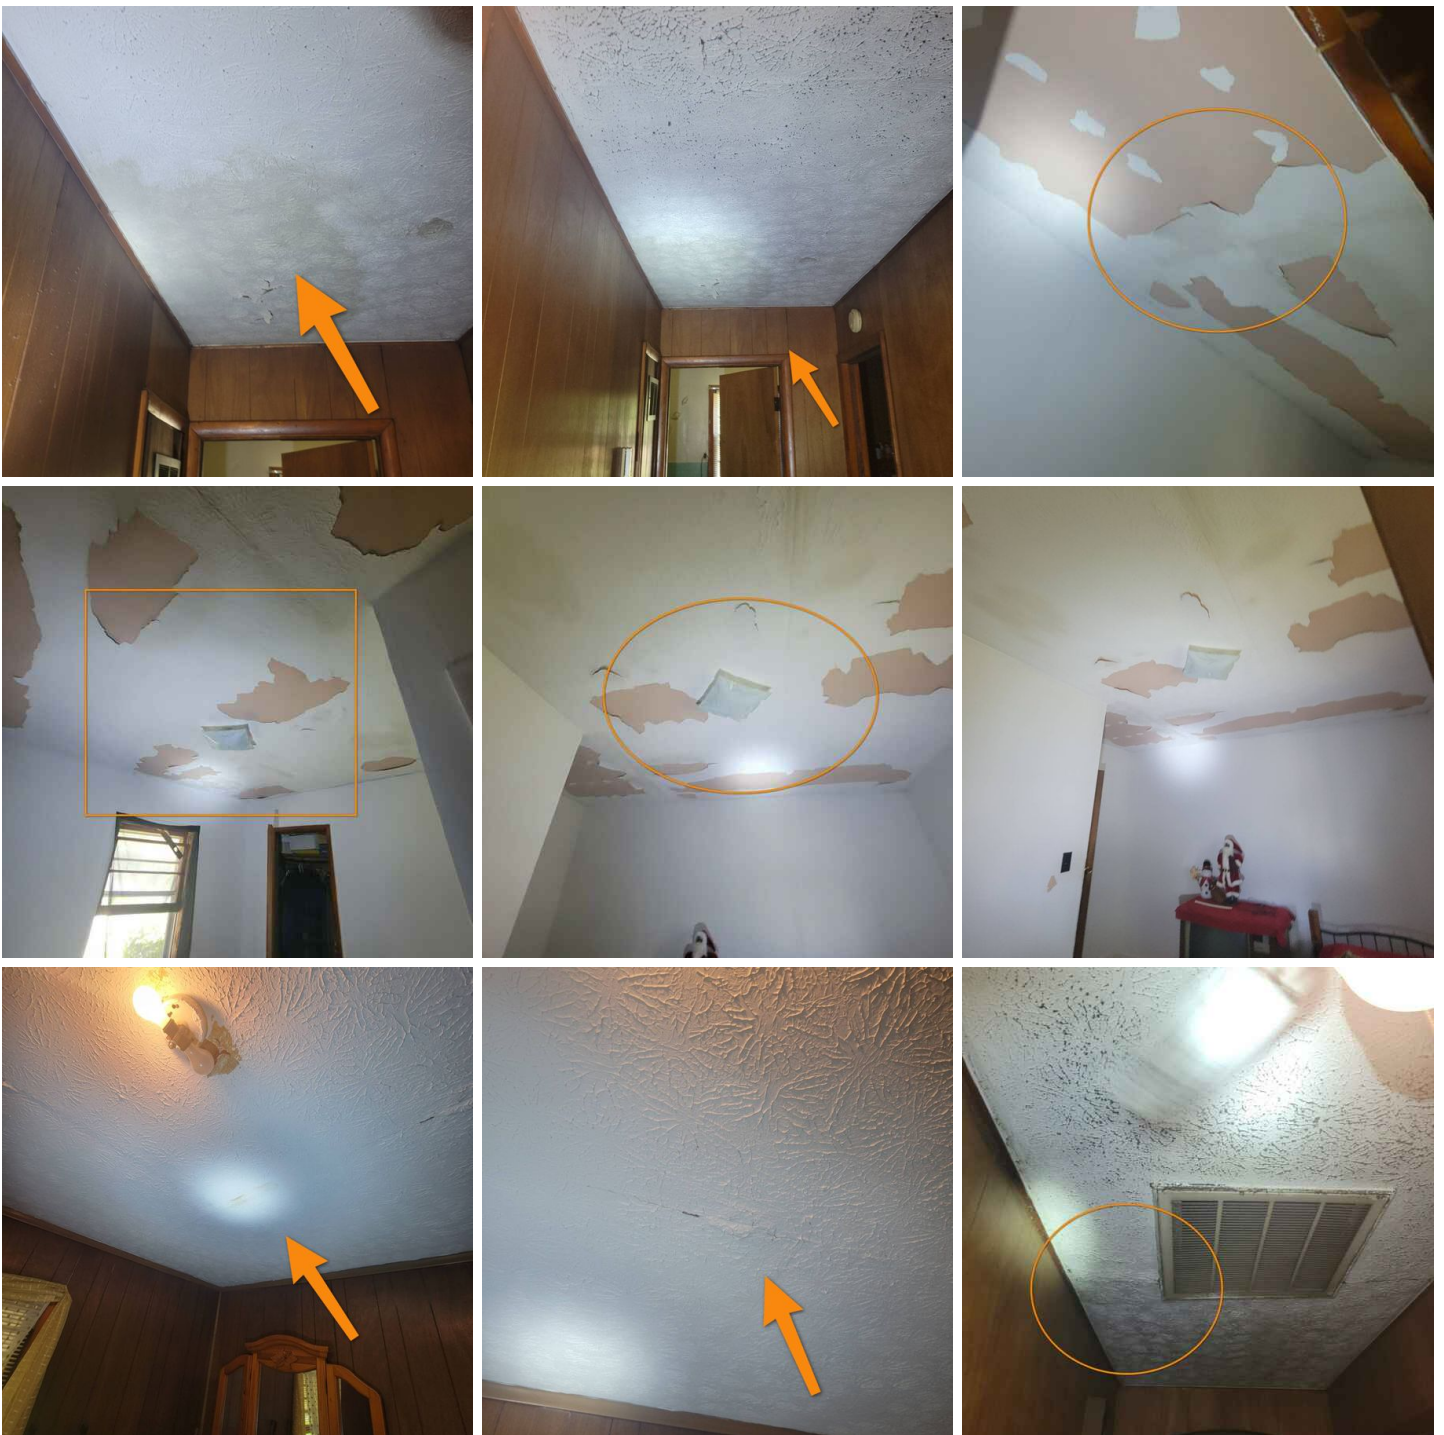
6.1.2 Interior doors, windows, floors, ceilings

DAMAGED CEILING/DAMAGED CEILING TEXTURE MATERIAL/POSSIBLE COLLAPSING CEILING

Multiple sections of the ceiling display substantial cracks, with portions in the hallways and bathrooms showing signs of collapsing. Additionally, moisture stains are evident in multiple areas of the ceiling. The stains in the living room likely stem from a previous leak at the base of the chimney, which has been patched on the roof. Furthermore, the textured ceiling throughout the home appears aged, poorly installed, and is peeling in various areas. It is advised to enlist the services of both a drywall contractor and a painting contractor to assess and address these issues.

Popcorn ceilings can indeed become brittle over time and may start to break off or crumble, especially if they're disturbed or if there's moisture damage. Due to concerns about asbestos, which was sometimes used in older popcorn ceilings, many homeowners opt to remove or cover them with a different finish.

Contact a qualified professional.

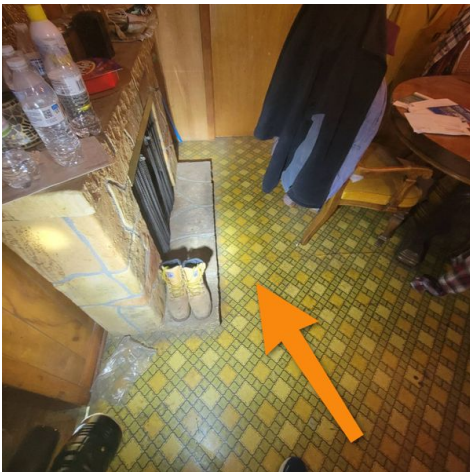
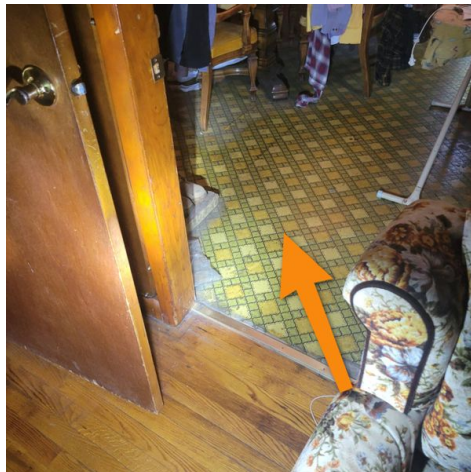
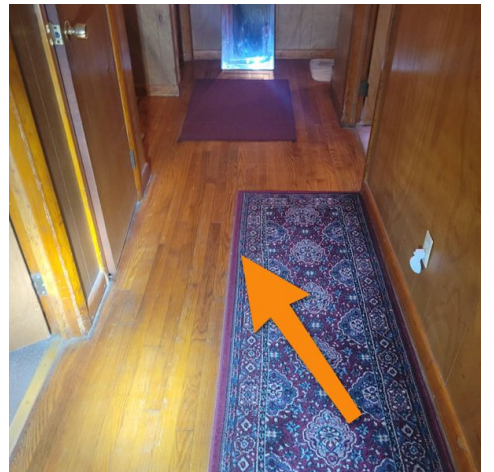
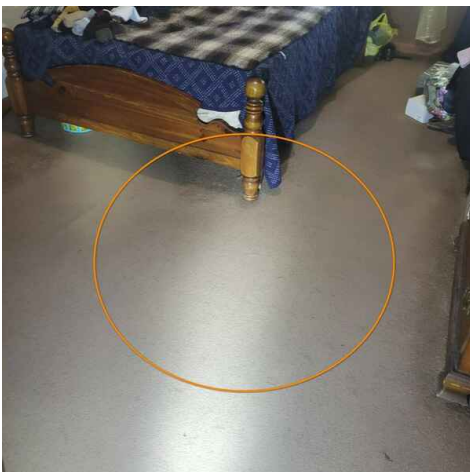
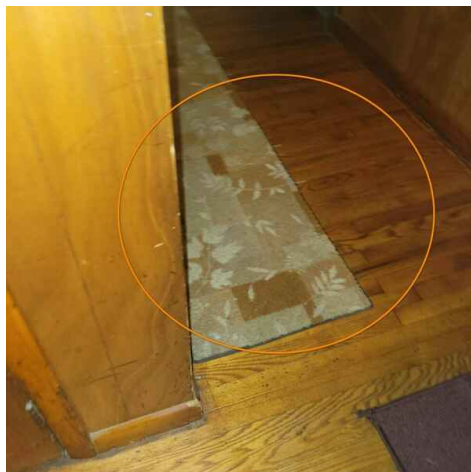
6.1.3 Interior doors, windows, floors, ceilings

UNLEVEL/SOFT FLOORS

1. Unlevel floors observed at the time of inspection. Recommend a qualified contractor to evaluate and repair.
2. Multiple areas of the floor in the home are soft. This is due to compromised floor joist and subflooring in the crawl space. Excessive mold growth has weakened the structure. Repair by a foundation contractor is recommended prior to replacing or refinishing the flooring in the home. See the crawl space section for recommendations.

IMAGE: AREA UNDER UNLEVEL/SOFT FLOORING/CRAWL SPACE DEFECTS (SEE CRAWL SPACE SECTION)

Recommendation
Contact a qualified professional.

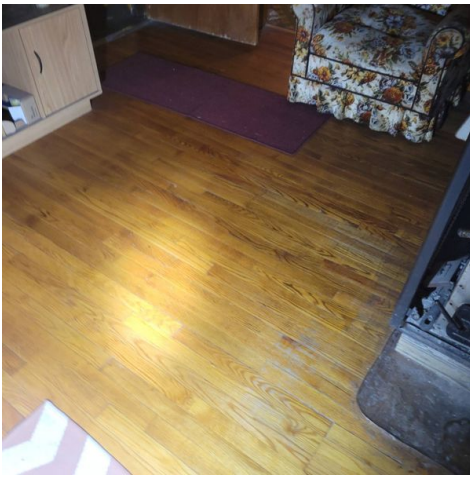
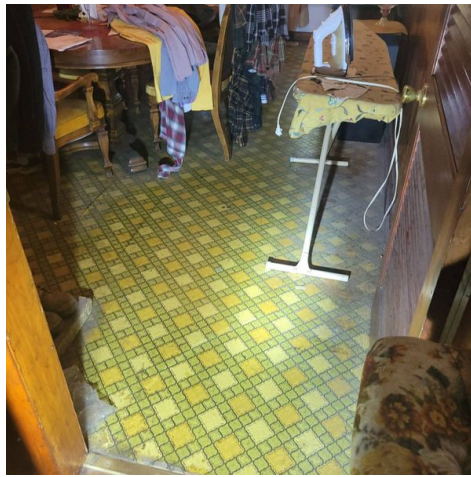
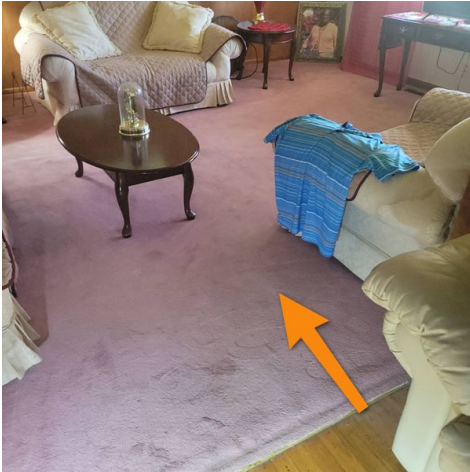
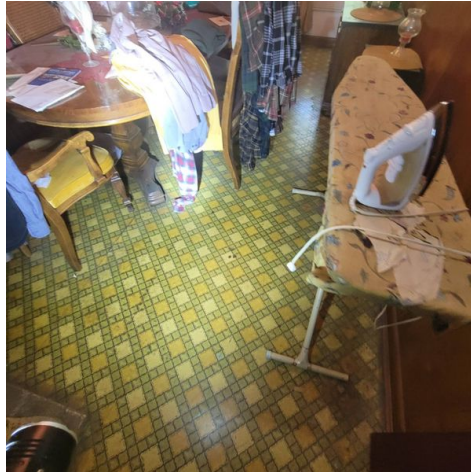
6.1.4 Interior doors, windows, floors, ceilings
WORN FLOORS/CARPET
INTERIOR

1. Worn floors/carpet/or unlevel floors observed at the time of inspection. Recommend a qualified contractor to evaluate and remedy.
2. Carpets can be steamed clean, patched or replaced. Carpet patching involves a contractor cutting out damaged pieces of the carpet then sewing in a new piece.
3. Hardwood flooring can be re-sanded and stained. This is recommended to be completed after large scale painting and drywall projects.

Recommendation
Contact a qualified flooring contractor

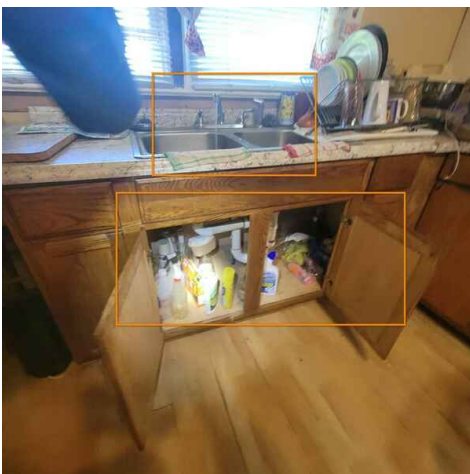
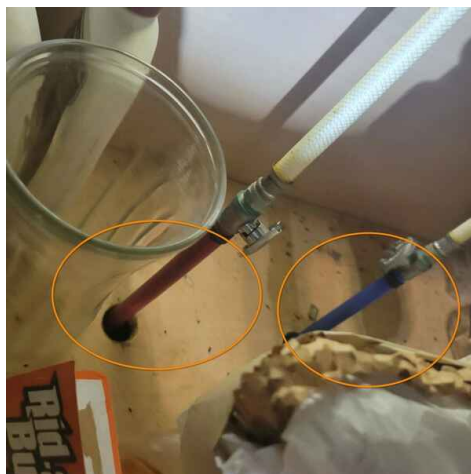
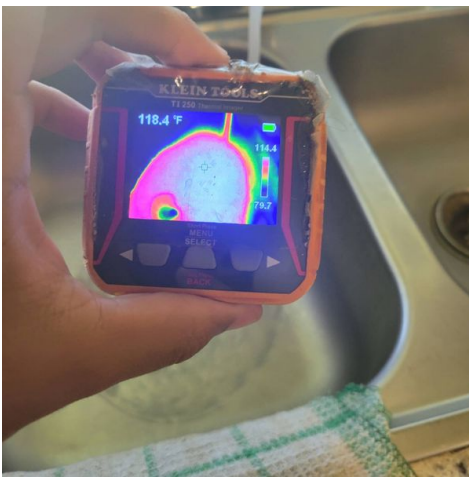
6.2.1 Counter tops & Cabinets and kitchen appliances

MULTIPLE DEFECTS: KITCHEN SINK

The sink exhibits signs of aging, with loose plumbing lines and a need for garbage disposal servicing. It's crucial to ensure the drain is configured as a P-trap rather than an S-trap or U-trap. A P-trap is necessary to prevent sewer gases from entering the home and to maintain proper drainage. Despite these issues, many of these defects are expected given the property's age and minimal updates.

Contact a qualified plumbing contractor.
