Iron Mountain Home Inspection Training Academy

SUMMARY PDF HOME INSPECTION REPORT FOR TRAINING PURPOSES (DEFECTS ONLY)

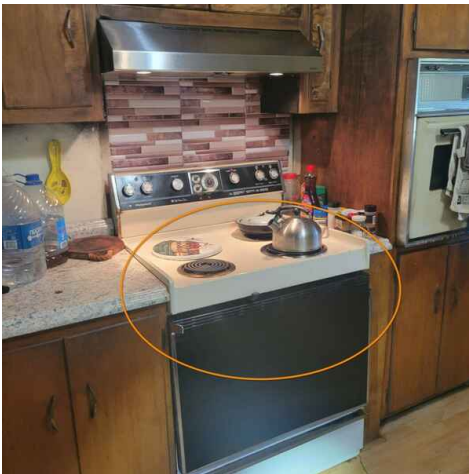
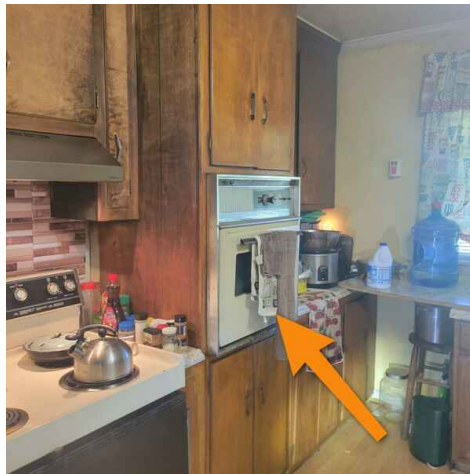
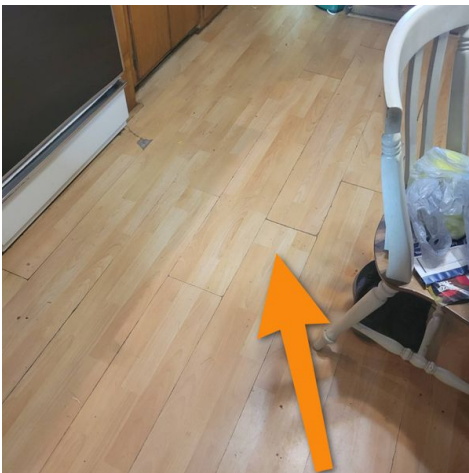
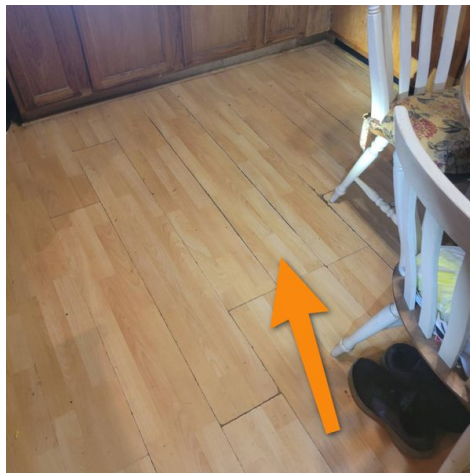
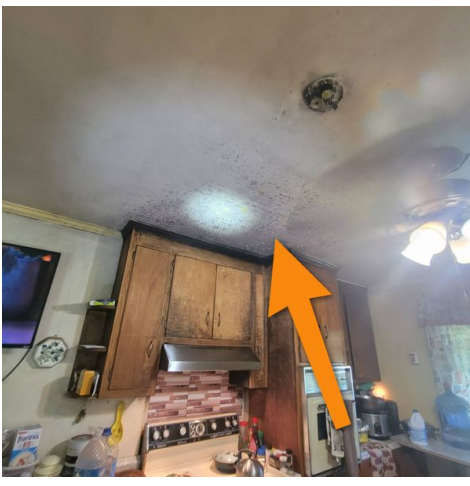
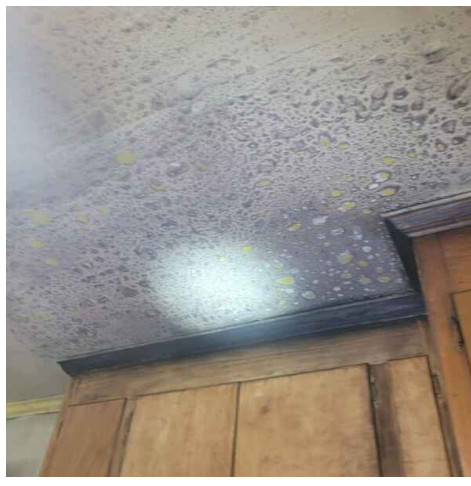
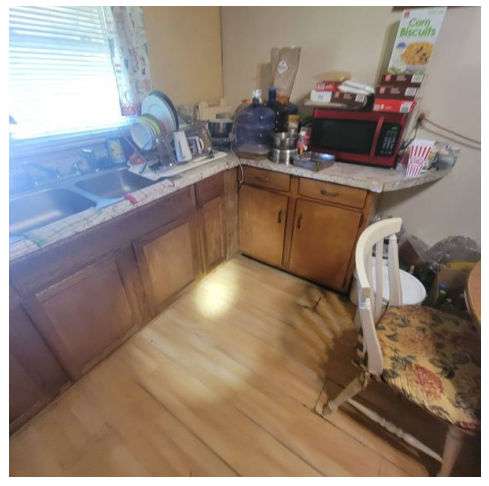
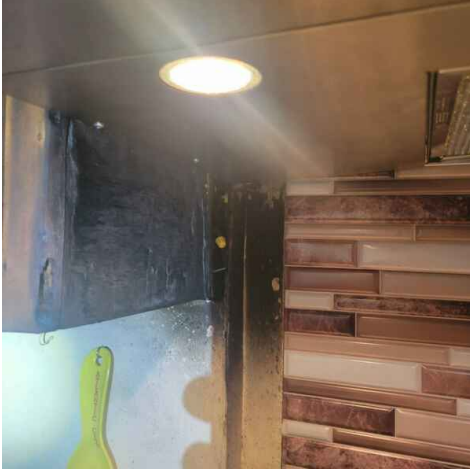
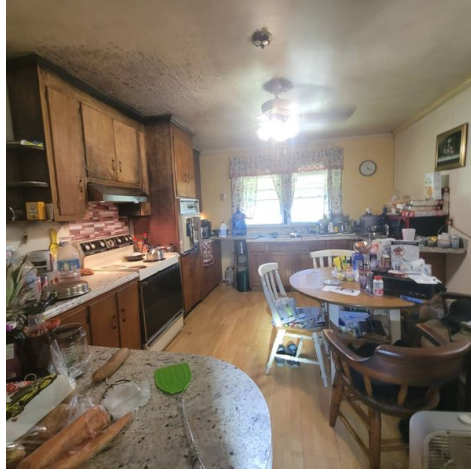
6.2.2 Counter tops & Cabinets and kitchen appliances

MULTIPLE DEFECTS: KITCHEN

Contact a qualified professional.

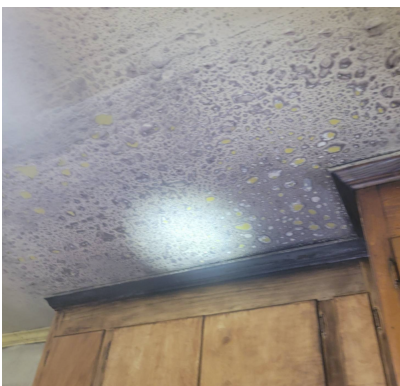
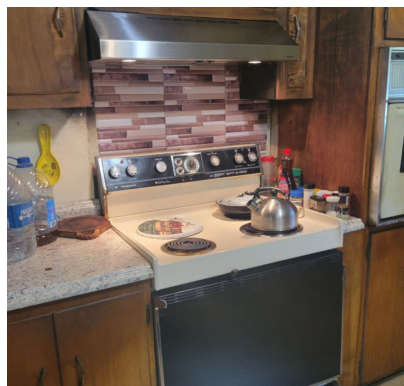
6.2.3 Counter tops & Cabinets and kitchen appliances

Safety Hazard

Evidence suggests a past fire in the kitchen, likely originating under the stove hood where capped wires are visible. This area likely served as the point of ignition, leading to burn markings on the ceilings, indicating a potential electrical fire. It is crucial to have the electrical system evaluated and upgraded by a qualified electrician to mitigate any further risks or issues. Immediate attention and repair are recommended to ensure safety and prevent potential future incidents.

Recommendation
Contact a qualified professional.

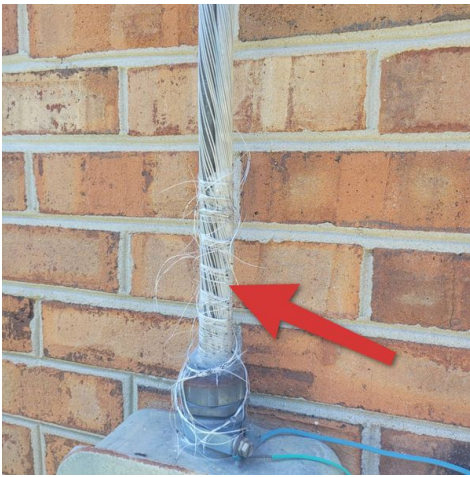
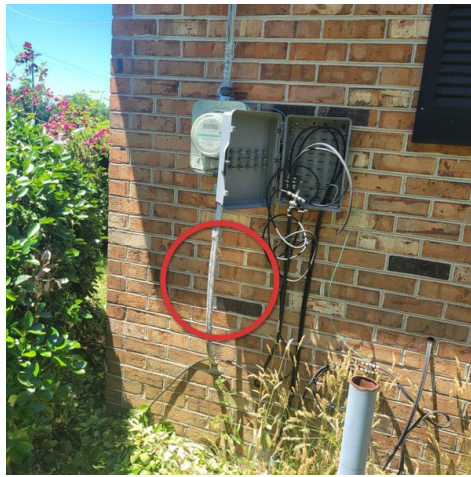
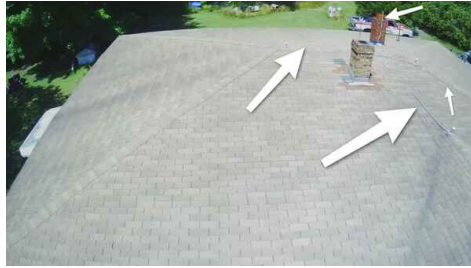
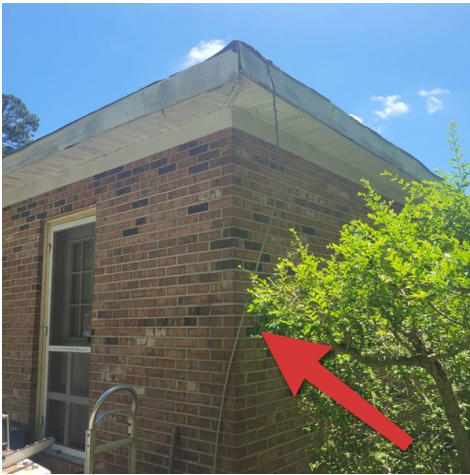
8.1.1 Service Entrance Conductors

ENTRANCE CABLE IS IN POOR CONDITION

The service entrance wires are damaged, indicating a safety issue. Contact the utility company or an electrician for evaluation and repair. Additionally, consider upgrading or replacing the meter base, as multiple meters are installed on the property. Ownership and responsibility for maintenance of the utility pole on the property should be clarified, especially concerning wiring for additional structures. Consulting professionals will provide clarity and ensure compliance with safety standards.

Contact your local utility company

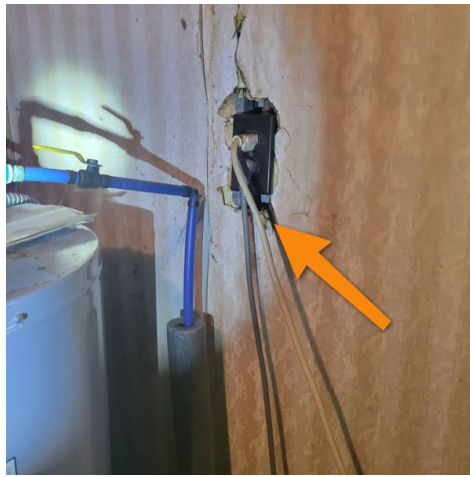
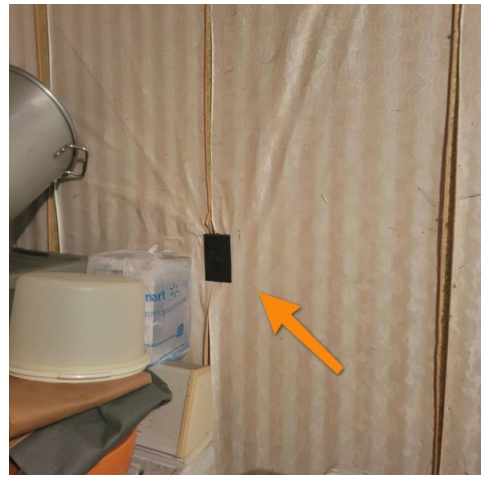
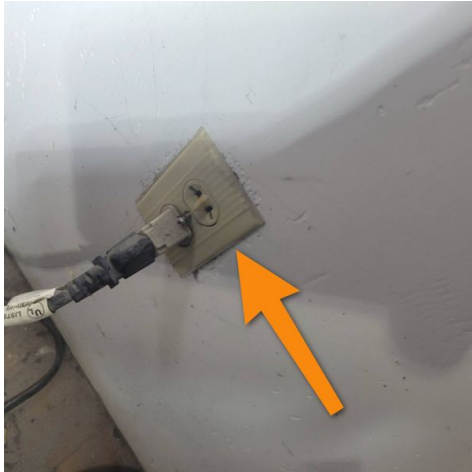
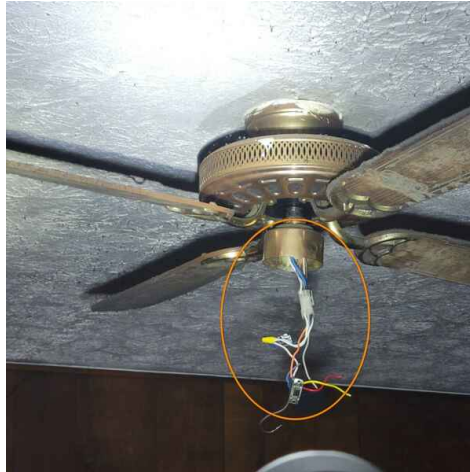
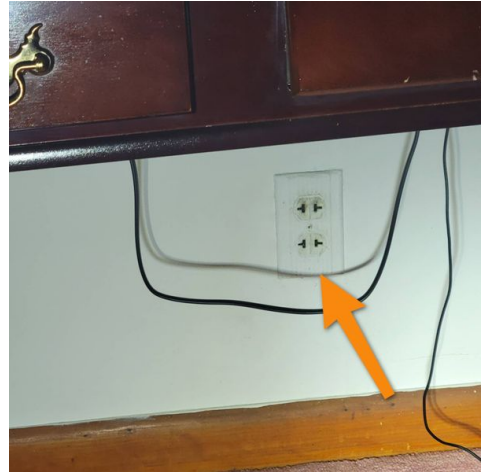
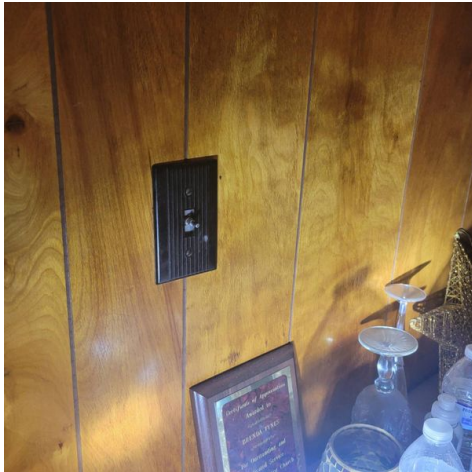
MULTIPLE DEFECTS: ELECTRICAL RECEPTACLES

1. The receptacles throughout the home are loose and show signs of aging. As they are two-pronged, they lack proper grounding. Additionally, the absence of GFCIs poses a safety concern, particularly in areas where water is present, such as within 6 feet of sinks. Several light fixtures also exhibit instability and potential wiring issues, suggesting possible DIY installations. Cover plates are missing or damaged. There most likely will be some degree of electrical problems in this home that will be experienced that require a diagnostic from an electrician. Upgrading these elements is recommended to ensure electrical safety and compliance with modern standards.

Contact a qualified electrical contractor.

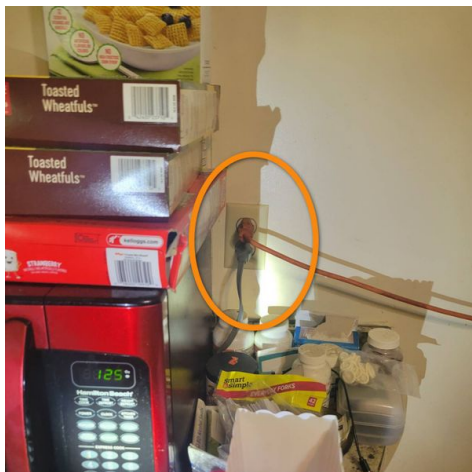
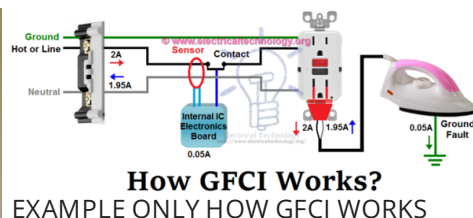
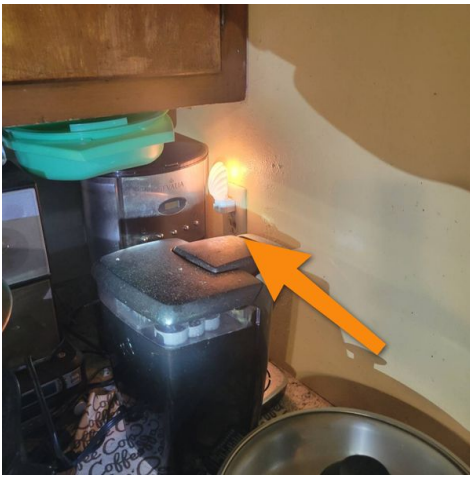
ALL AREAS WITH IN 6 FEET OF WATER

NO GFCIS INSTALLED

Contact a qualified electrical contractor.

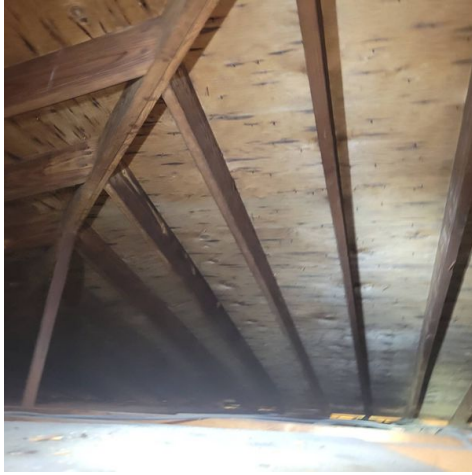
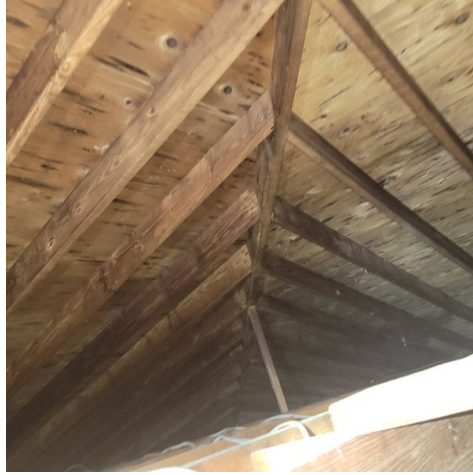
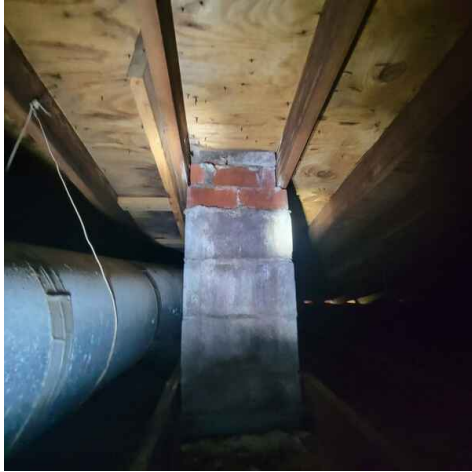
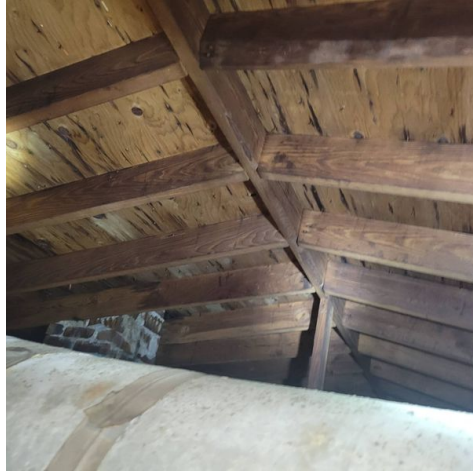
MULTIPLE DEFECTS: ATTIC AREA

Limited access to the attic was noted due to an undersized door. Moreover, insulation is absent in this space, necessitating blown-in insulation using specialized equipment. Moisture damage to the roof sheathing was observed, a common issue addressed during roof replacements. Typically, new sheathing is installed, and chimneys are reflashed before re-insulating the area. Old ductwork from previous appliances remains in the attic. Prior to adding insulation, it's advisable to address any repairs to ceilings and light fixtures. The lack of insulation facilitates easier access for electrical cable securing. Installing a properly sized attic door is recommended for convenient entry. Additionally, due to its spaciousness, additional storage can be accommodated in this attic, typical for hip roofs with sloping sides. Evaluation and repair by a qualified contractor are advised.

Recommendation
Contact a qualified professional.
